Fracture analysis of the planet support used in a nuclear power plant

Abstract. In this paper, the fracture analysis of the planet support, which was made of aluminium alloy and used in an electric actuator, was investigated. The laboratory analysis was conducted to find out whether there are defects generated during manufacturing process. Besides, the finite element analysis was carried out to calculate the maximum tensile stress and compared it with the material strength. The mechanism of the fracture was found to be low-cycle fatigue.

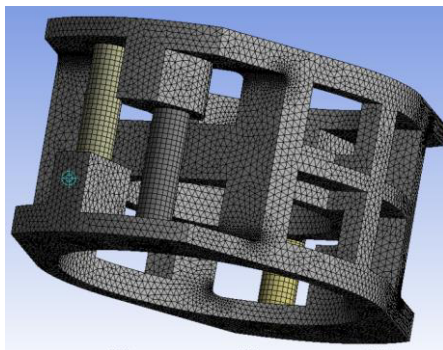
Figure 4. The 3D mode of the planet support.

A 3D mode of the planet support was created to show the stress distribution on the structure (as shown in Fig.4). The elastic-plastic mode was adopted in order to consider the non-linear character of the material.

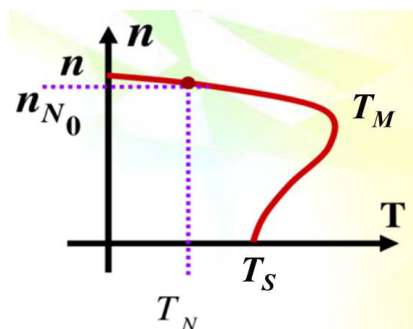
Figure 5. The out-put torque curve of the asynchronous motor.

A typical curve of out-put torque of the asynchronous motor was shown in Fig. 5. As we can see, the out-put torque is high when the motor starts. This start torque is nearly equal to the stall torque of the motor. So the applied load on the planet support was nearly 840N•M which corresponds to the maximum out-put torque of the electric actuator (stall torque).
