Assessment of structural condition of steel bridge in Brandýs nad Orlicí

Abstract. This paper deals with structural condition assessment of historical steel through arch bridge in Brandýs nad Orlicí. Structure was dynamically tested to obtain mode shapes and eigenfrequencies on non-loaded structure and to estimate logarithmic damping decrement after traffic loading. Material properties were verified. Calculation model was created to validate its statical and dynamical behaviour. Article focuses on comparison of calculated results and properties of real structure upon excitation.

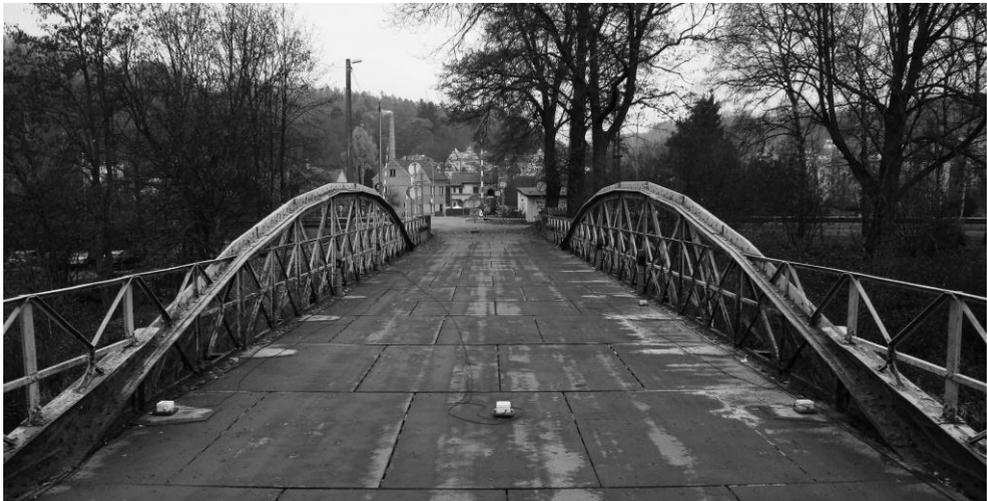
Fig. 2. Example of sensor assessment during modal analysis.

Structure was tested in two states [2]. Dynamic response was recorded in idle non-loaded state, where the dynamic response of the structure is caused by natural and technical seismicity without the need of using vibration exciter. For this state the operational modal analysis was performed. In second state the bridge was opened for traffic and dynamic response due vehicular and pedestrian loading was recorded to estimate logarithmic damping decrement.

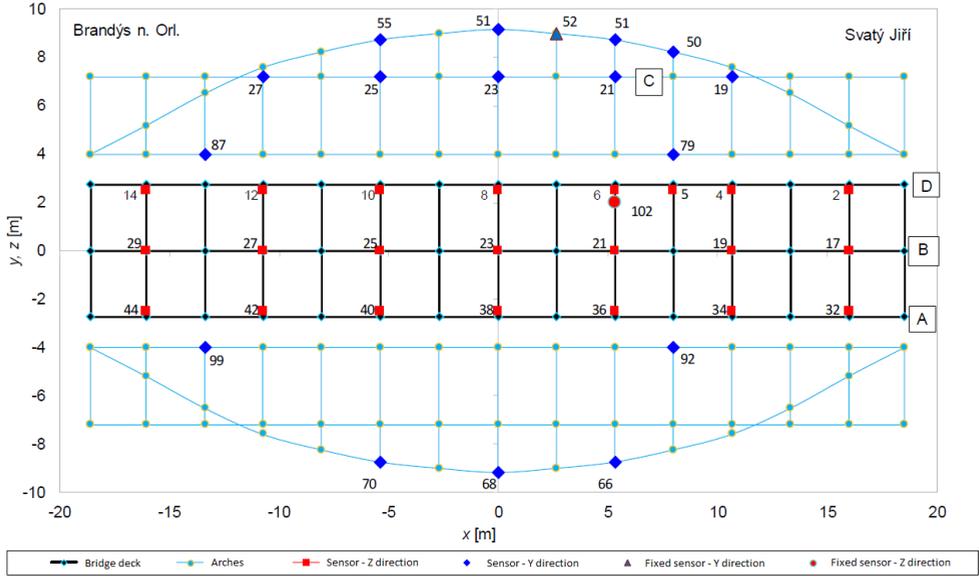
Fig. 3. Sensor's placement along the structure.

Dynamic behaviour was measured using 8 piezoelectric acceleration sensors in vertical and horizontal direction. Sensor's placement is shown in Fig. 3.
