# Risks of the Durability of Large-Panel Buildings Elevations in Reference to the Conclusions from Technical Conditions Audits

**Abstract.** In article the problem of durability of elevations of large-panel technology buildings is analyzed. In Poland this is a serious technical issue because it has an impact on the whole country. Heat loss through infiltration, the possibility of mold growth and general breakdowns are also reasons for increasing user discomfort. In article the results of the diagnostics presented in the literature and the authors' analysis and diagnostic results are presented. Article also presents conclusions regarding to the durability of applied insulation systems ETICS and the need to strengthening the layers connections of the facade panels.

### **3 Results of technical inspections in years 2005-06 and 2016-17 in Warsaw**

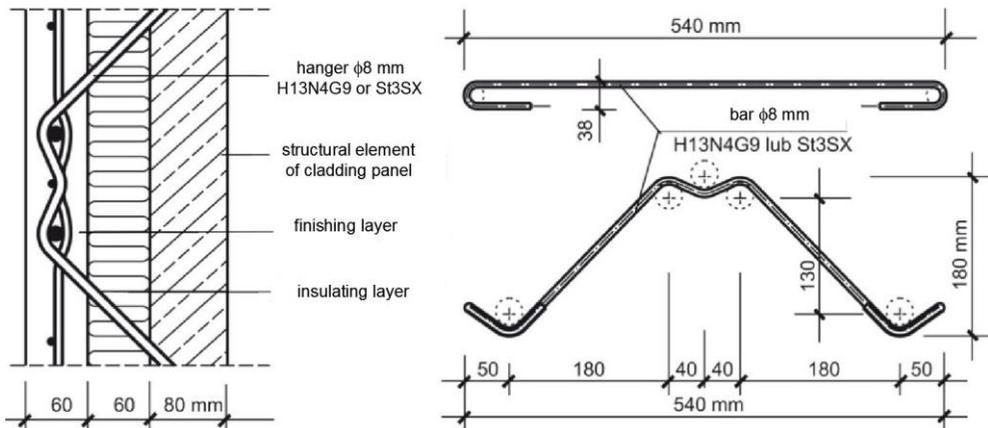
Both insulation and textured finishing layers were fixed to the structural panel by means of fasteners specified as "hangers" (Figure 1), made of steel bars. The effectiveness of the connection of the two concrete layers determines the durability of such external wall.

**Fig 1.** Construction of a connection of prefabricated wall elements in a Wk-70 system

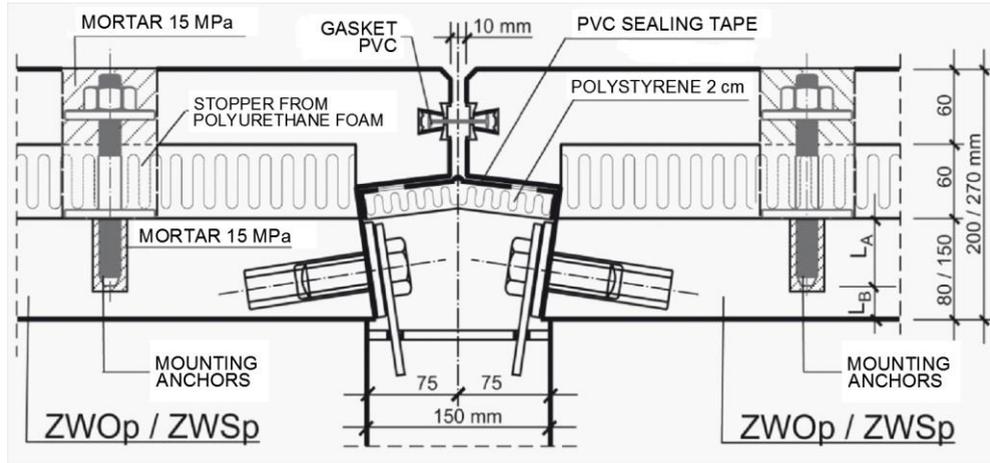
**Fig. 5.** The concept of connection reinforcing of prefabricated slabs (Janusz Krentowski)

The fact that reinforcing the joints of multipanel layers during buildings insulation is not commonly used is not the result of lack of solutions to apply. There are many options from different manufacturers. One of the co-authors of the present article has proposed his own patented solution to the problem of reinforcing the bonding of prefabricated slab layers (Figure 5).

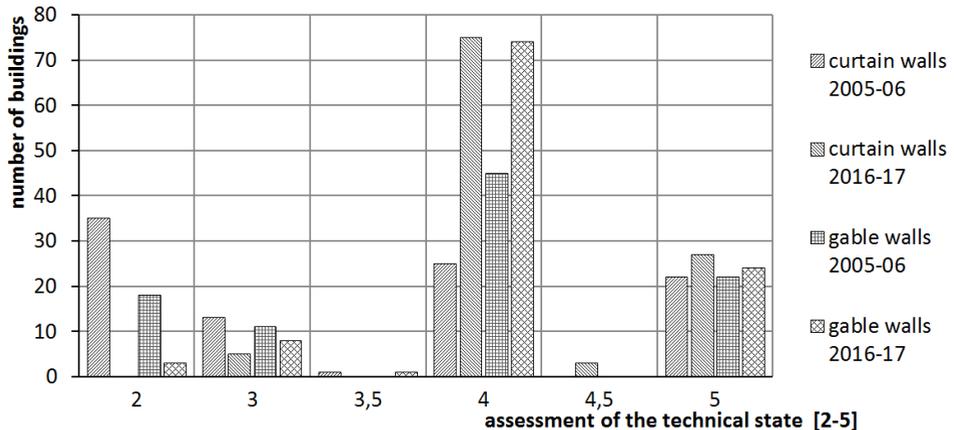
A well-made and preserved insulation layer on the façade wall significantly improves the operating conditions of façade boards and reduces the corrosion rate of interlayer fasteners. This is important for the aforementioned results [1], which speak of the layout mismatches and the type of steel grade. A significant improvement in the façade's technical condition is observed (Figure 7). The vast majority of buildings received a good rating indicating that the façade layers did not show any significant damage nor need repair.

Fig. 7. Evaluation of the state of curtain and gable walls (data collected by Piotr Knyziak)
