# Repair of reinforced concrete beams using carbon fiber reinforced polymer

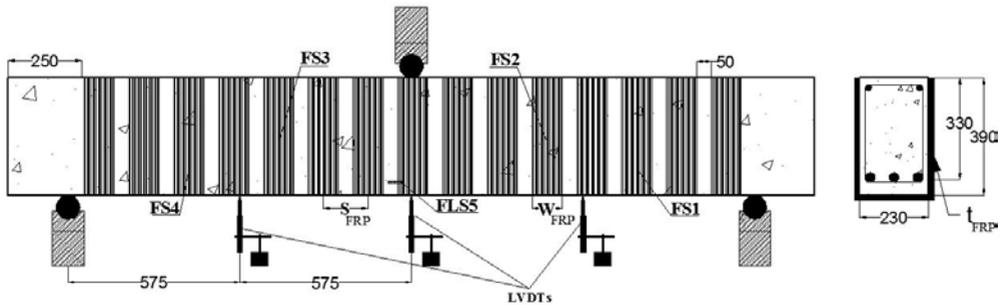
The test setup consisted of a simply supported loading configuration with roller supports and proper instrumentation. The specimens were tested under monotonic static loading in a displacement control mode with 0.01mm/sec loading rate. Meanwhile, strain development, cracking sequence and deflection of beams were monitored during testing. Deflection of the beams were measured using linear voltage displacement transducers (LVDTs) at three different points along the span (i.e. under the loading point and in the middle of both shear spans). Electrical resistance strain gauges were attached to longitudinal reinforcement and CFRP strips to measure the strain development. Fig. 3 shows the test setup, point of measuring the deflection and strain gauges locations. As shown in the Fig. 3, total of 4

external FRP strain gauges (FS1-FS4) were attached vertically to EB-CFRP strips, and one embedded flexural strain gauge (FLS5) was bonded horizontally to the surface of the middle longitudinal reinforcement bar.

**Fig. 3.** Test setup and layout of the beam with EB-CFRP and instrumentations (all units are mm).

Four out of five beams were wrapped with 2 layers (2L) of EB-CFRP in U-jacketing scheme and one beam was repaired with epoxy injection only (0L). It is worth nothing that prior to bonding the CFRP strips, the pre-existing major cracks in the beams were injected with epoxy. The epoxy was injected using the specific pressure pump through the attached vessels (packers) on the surface of the specimens. The EB-CFRP strips bonded to the beams, had a width (wfrp) of 100 mm and a center to center spacing (sfrp) of 150 mm and a net spacing of 50mm as shown in Fig. 3.

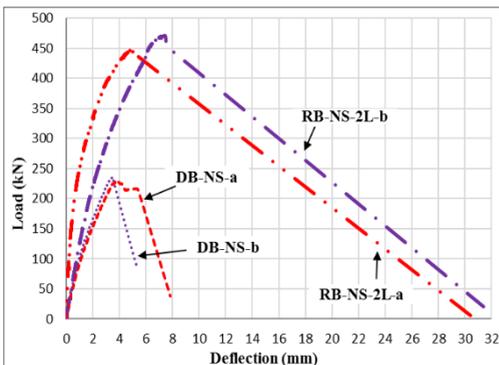
(a)

The load-deflection curves of the reference beams and repaired beams are plotted in Fig. 5. As can be inferred from Fig. 5, repair and strengthening of damaged beams increased the initial stiffness of the beams and reduced the relative deformation at peak load compared to the reference beams which is in agreement with the findings in the literature [27]. The exception was the RB-MS-2L-a that exhibited reduction in stiffness when retested the reason for which was the level of damage existed in this particular beam (a chunk of concrete was missing at the bottom of existing shear crack before repair). The load-deflection diagrams also show that the repaired beams without steel stirrups exhibited very brittle failure by a sudden drop in load resisting. Which is also evident in striking the LVDTs after sudden release of energy as can be inferred from Figure 5a. Whereas, the

**Fig. 5.** Load Vs. Deflection of tested beams, a) Reference and repaired beams without steel stirrups, b) Reference and repaired beams with minimum ratio of steel stirrups.

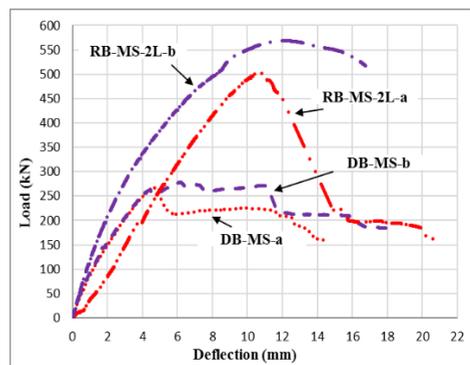
(b)

repaired and strengthened beams that were also reinforced with steel stirrups exhibited relatively ductile behaviour shown in Figure 5b compared to the beams without stirrups.

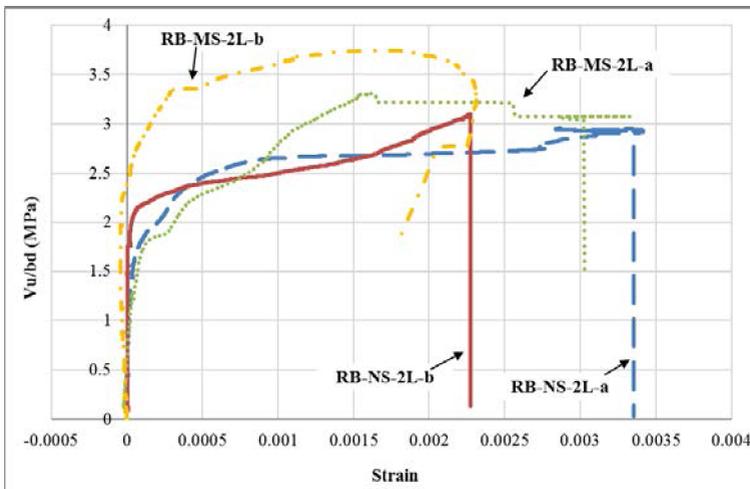
The maximum measured strain responses in CFRP strips are plotted against the average shear stress ( $V_u / bd$ ,  $V_u=P/2$ ) of the repaired beams in Fig. 6. The maximum measured CFRP strains plotted in Fig. 6, are not necessarily the absolute maximum CFRP strain as the strain in CFRP is affected by location of strain gauge relative to the location of crack. The EB-CFRP strips (in specimens namely RB-NS-2L-a, RB-NS-2L-b, and RB-MS-2L-a) did not experience significant strain until flexural shear crack initiated at around 2 MPa shear stress. The crack initiation is inferred by the change in the pattern of stress-strain curve as can be noticed in Fig. 6. Which indicates that the crack started to incline and propagate upward but intercepted by the EB-CFRP strips that started engaging in carrying the load. This process continued until the major shear crack was created and opened significantly resulting in debonding of the EB-CFRP and followed by collapse of the beam. However, the exception was the gauge response in specimen RB-MS-2L-b which shows that FRP started engaging in load resisting at around 2.5 MPa shear stress. This particular beam exhibited local FRP debonding and ended to highest contribution by EB-CFRP compared to the other beams. Moreover, it can be inferred from the curves in the Figure that the debonding was sudden in specimens without steel stirrups (sudden drop) while it was gradual in the specimens with minimum ratio of steel stirrups (dropping and resisting).

Fig. 6. Average shear stress  $V_u$  Vs. maximum CFRP strain responses of repaired beams.
