Fracture Analysis of CNG High Pressure Container using Fractography and Measurement of Property

Abstract. Bursting accidents of pressure containers due to design and manufacturing defects are frequently occurring. Due to high-pressure gas or harmful substances, when this vessel is fractured, it can lead to catastrophic disasters. Especially, in the event of bursting accident of composite pressure vessel for CNG bus, many unspecified people can be damaged. Most of the accidents were caused by problems in the manufacturing process. The manufacturing process for TYPE2 pressure vessel is very complicated such as three drawing processes, two ironing processes and one spinning process. In the middle of process, various heat treatments are performed for imparting toughness and removing residual stresses. It should cause a serious problem such as bursting and fragmentation of the pressure container due to defects of this process. In this research, the fracture cause of CNG vessel is evaluated through fractography and measuring material property using IIT and analysis of chemical composition.

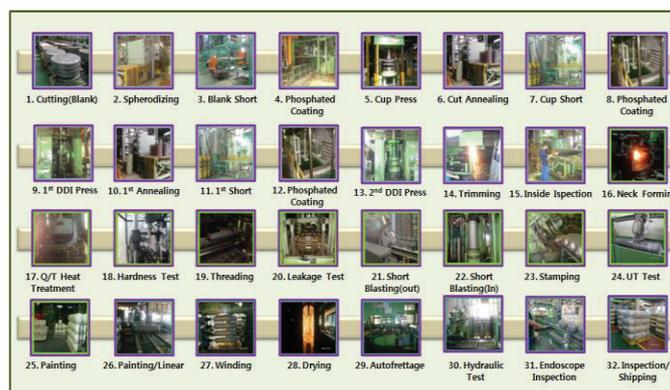
Figure 2. Manufacture process of CNG container

When CNG is stored in the vessel by using a 4-stage reciprocating compressor, the gas inlet pressure of 3.5~4.5 bar can be increased by at least 200 bar. Compressed gas from the vessel is supplied to the inner container of the engine after reducing the high pressure of gas to a working pressure level through a pressure reducing valve. CNG composite pressure vessel for the purpose of containing high pressure gas have complicated manufacturing process. The pressure vessel of CNG vehicles is divided into four types which is dependent on the type of materials and composite materials used. TYPE 2 mainly used in CNG buses of Korea is reinforced with a circumferential direction by hoop wrapping glass fiber on steel liner. The TYPE 2 pressure vessel was made of a metal liner (34CrMo4 material) with epoxy-glass fiber composite material.[5] The composite material was wound around the cylinder part of the metal liner, forming a composite overwrapped pressure vessel. The manufacturing process of fractured metal liner consists of three drawing processes and two ironing processes and one spinning process for finalizing the dome part as show in Figure 2. In the middle of process, various heat treatments such as quenching, tempering, and annealing are performed for imparting toughness and removing residual stresses. The heat treatment process is the key process in the manufacturing of metal materials. Therefore, if there is a defect in the heat treatment process, it may cause a serious problem such as bursting and fragmentation of the pressure vessel.
