Analysis and Experimental Study on Perforation Abnormity of Perforating Gun

Yu Han ^{1,*}, Ma Tao ²

¹China Oilfield Services Limited (COSL) Tianjin Branch, No.1581, Hai Chuan Road, Tanggu Marine Hi-tech Development Area, Binhai New District, Tianjin, China

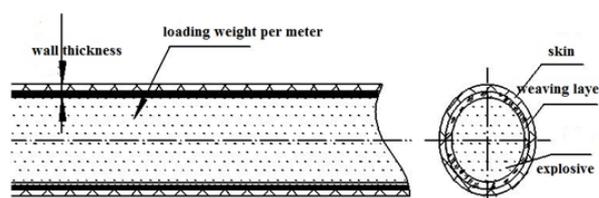
Fig4 Structure of detonating cord

If the density of detonating cord is not enough, it may cause the lateral output shock wave to be insufficient to detonate the shaped charge, cause the shaped charge detonating or burning. The detonating cord is made up by powder, high strength Kevlar weaving layer, and nylon skin (see Fig 4), the main parameter affecting by the powder density.

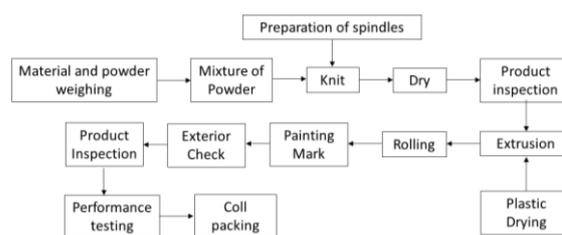
Fig5 manufacturing process of detonating cord

The detonating cord production is product line, every mixing, knitting, extrusion and rolling will produce 800 meters, and because of ultra-high velocity detonating cord must be rolled to increase the density of powder. (see Fig 5). Now COSL using the detonating cord was produced by the product line which imported from Switzerland, this product line is automatic and can detect the density of detonating cord all the time, if occurs density abnormal in the product process, the equipment will alarm and stop automatically.

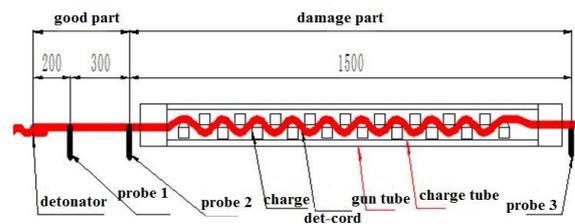
Fig 8 Test plan of broken skin and bend speed of detonating cord

Harm the outside plastic layer of the detonating cord, and bend in the loading gun, at the same time of detonating, to test the velocity on input and output, to compare (see Fig 8 to 10)

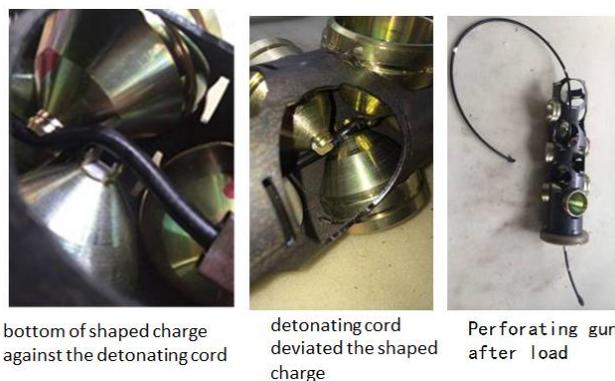
Fig 11 Test Course

In the assemble of shaped charge and detonating cord, according the normal installation, the bottom of shaped charge against the detonating cord, and detonating cord deviated the shaped charge, and record the each blind hole position^[9], observed the blind hole after detonating. The test quantity is 5. (see Fig 11)

When the detonating cord is slightly away from the detonation hole, the shaped charge can be detonated normal. No eliminate the possibility that the detonating cord deviated the detonation hole and caused shaped charge is not detonated.

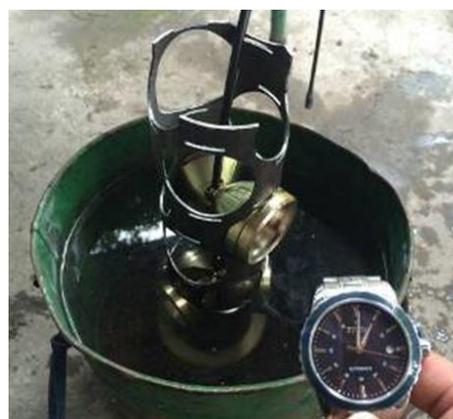
Fig 14 Test status

According the normal loading gun condition to load 5 shaped charge, and put the 3 shaped charge of bottom side into the water after 3 hours, and detonate the perforating gun, to observe the gun body. (See Fig 13 to15)

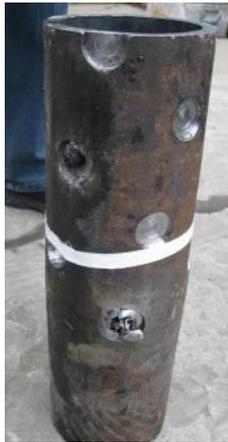
Fig 15 Status after test

2 shaped charge in the air perforating normal, 3 shaped charge in the water perforating normal.

If the perforating gun is water seepage, the shaped charge soaked in water after certain time, the water will go into the powder, and shaped charge performance occurs abnormal phenomenon.
