# Failure of pillar of sports and entertainment hall structure

**Abstract.** This paper deals with the failure of one of the sports and entertainment halls in Poland. The facility was built in the years 1977-85. Its main load-bearing members were three-hinged double-sloped frames with a total span of 45 m. The main girders of the frames were made of glued-laminated timber. The girders rest on reinforced concrete pillars. Because of the considerable expansion forces the facility was founded on concrete padstones. In the summer of 2016 one of the reinforced concrete pillars was found to have failed. It was established that the failure condition was mainly due to construction errors. A way of strengthening all the pillars with additional RC members was proposed.

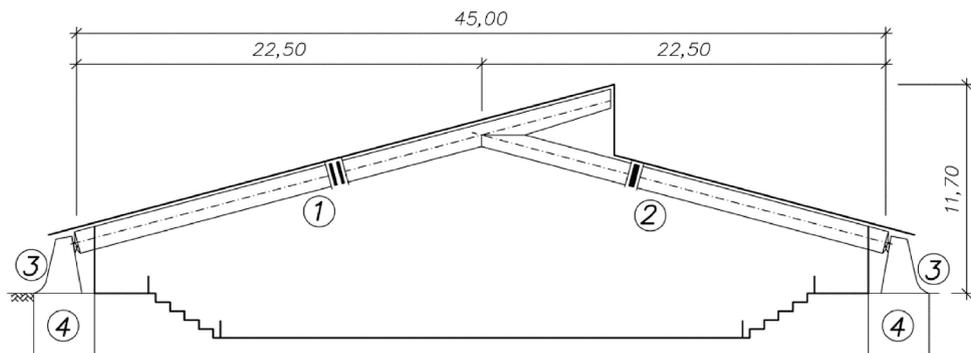
**Fig. 2.** Typical cross section of hall (dimensions in m, description in text) [1].

The facility's principal load-bearing structure consists of 11 three-hinged frames spaced at every 6.00 m. A typical cross section of the frame is shown in fig. 2. On plan the structure occupies a 45 m × 60 m rectangular area. The roof framework is wooden. The main roof girders are made of glued-laminated timber and their dimensions are: 2 × 14 cm × 124 cm (no. 1 in fig. 2) and 28 cm × 124 cm (no. 2). They are joined together with a steel hinge.

The wooden girders rest, via steel bearings, on reinforced concrete columns (no. 3) with a tapered cross section with dimensions  $b \times (h_{\min} \div h_{\max}) = 60 \text{ cm} \times (70 \div 210) \text{ cm}$ . The columns were to be anchored (the anchoring proved to be ineffective) in the 180 cm × 300 cm and 360 cm deep concrete padstones (no. 4).

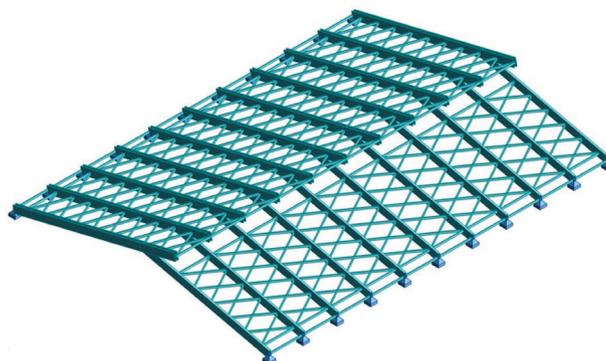
**Fig. 4.** Numerical model of structure [1].

The reactions originating from the roof framework are of key importance for the stress intensity level in the reinforced concrete pillars. In order to determine most accurately their values a spatial bar structure model (fig. 4) was used and static linear analyses were carried out [3].

The roof bracings consisted of two types of bars: full (girder-to-girder) bars and cut (girder-to-bracing) bars. This fact was taken into account in the computational model. The interconnections between the girders and the support were modelled as hinged.
