Analysis of Piping at Kedung Uling Earthfill Dam, Wonogiri Regency, Central Java Province, Indonesia

Abstract. Kedung Uling earthfill dam is located between Eromoko and Wuryantoro district, Wonogiri Regency, Central Java, Indonesia. Water leaked from the dam was found and could decrease volume of dam. The objectives of this study are to identify piping and to recommend for solving piping problem. In order to determine the piping direction and litological pattern, investigation of 10 boreholes with various depth has been carried out. This investigation aim to determine characteristics of soil and rock by analyzing 45 cm of thickness of undisturbed samples and to perform permeability test. Permeability test have been conducted by falling head method with 3 different depths. Leaking at the dam was analyzed by Slide 6.0 software. The results indicated that litology of dam have been identified as claystone, sand and tuff. The piping passed under the eastern abutment of the dam is the accumulation of groundwater in the aquifers formed by 8-10 meters thick layer of sand. The total debit of piping is 17,774 cm³/sec. The Factor of safety of piping is under the minimum of standard namely 3,

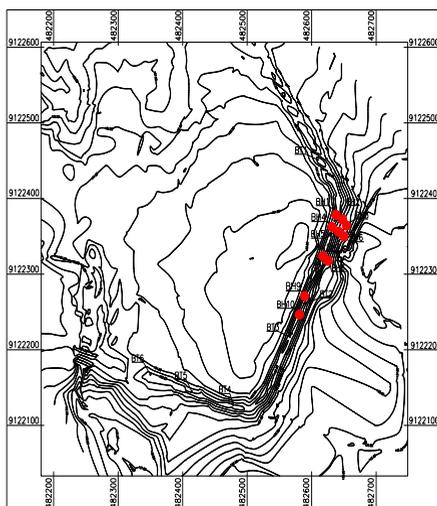
Fig 2. Core drilling location (dots are core drilling location).

conducted 25 meter from sliding location with four core drillings. Those locations can be seen in fig 2. The depth of core drillings have been done 15 meter, 12 meter and 10 meter in depth. Those drilling results have been used for laboratory analysis and for modeling of piping stability analysis. The modeling based on the log correlation of bore hole 1 through bore hole 10.

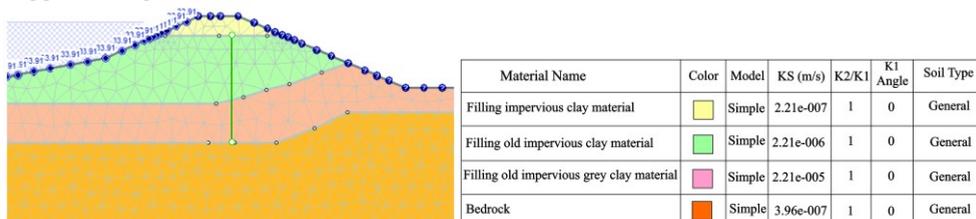
Fig 3. Permeability coefficient value for each materials

Piping curve is the direction of flow water coming out when the dam encounter seepage. This curve used for giving information where the leak happen. This curve was simulated by using slide 6.0. In this program, permeability value from each materials was set based on the laboratory analysis. Afterward, it was calculated to find where the flow of seepage takes place (fig 3). Seepage flow direction head to east of Kedung Uling dam and reach to the dam body (fig 4). This means the dam has vulnerable to piping because water flows to the area of dam body. Piping curve which pointing up possibly caused by soil critical hydrolic gradient. If the condition of piping pointing up, this means piping pressure same with density of soil. Therefore, effective pressure is zero. If the soil hydrolic gradient exceed critical hydrolic gradient, then possibly grains soil which is empty will pushed by seepage flow resulted in piping. Seepage curve headed to east of dam has total hidroulic gradient value is 0,190 (fig 4). By increasing higher value of total hydrolic gradient, the dam will not safe.
