High-temperature reaction of sodium vapour with quartz glass

Abstract. Heat pipes are one of the most efficient ways to transfer thermal energy hundred times more efficiently than copper. In this work, we present the investigation of sodium terminal velocity inside a glass pulsating heat pipe. Velocity measurements were conducted under operating conditions within the range of 500 – 1 100 °C. Since sodium is generally able to etch glass and ceramic materials, its presence resulted in glass reduction and sodium oxidation. From the XPS analysis of specimens extracted from a glass pipe after sodium explosion, it can be concluded that the reaction products are sodium oxide Na₂O and a thin layer of carbon, which is localized on the SiO₂ glass. The character of damage induced by chemical reactions is analysed in this manuscript.

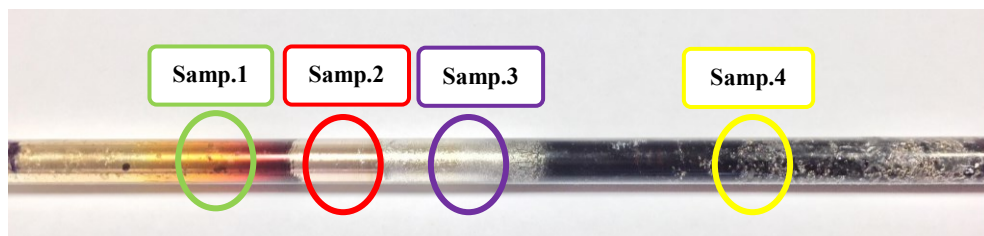
Fig. 2. Labelling of analysed areas of the exposed PHP.

Furthermore, the SEM analysis of the damaged PHP exposed to the molten sodium at four different temperatures were carried out (Figure 2).

Results from XPS and EDS analyses for samples 1 - 3 suggest formation of a sodium-enriched surface layer and broken silicon, oxygen stoichiometry. The structure of PHP is more fragile with increasing amount of sodium in the glass tube.

The sodium contamination of samples 1 and 2 was lower than 1 at.% and the sodium-exposed surface was smooth and free of deep cracks. The cracks observed were probably caused by excessive load at a time of explosion.

The sodium contamination of sample 3 is significantly higher and deeper compared to contamination of samples 1 and 2. The topmost sodium-exposed layer contains 21 at.% of sodium while the deepest region uncovered contains 1.2 at.% of sodium. As displayed in Figures 9-12, the sodium attack is highly localized by forming sodium-rich fibers (17-23 at.% Na) distributed in a silicon-rich (4-5 at.% Na) matrix. Such fibers form diffusion channels for further sodium contamination and act as vitrification and crack initiators.

Sample 4 exhibits the surface morphology completely different from samples 1 – 3. The sample is characterized by a rough surface full of deep cracks. (Note: Chemical analyses were not performed due to inappropriate sample sizes - the raised parts of the tube removed the signal for the EDS).

Based on the different temperatures in the PHP, it can be expected that samples 1 and 2 were particularly stressed by sodium vapour, which might explain the low sodium contamination of the pipe material. The colour transition from dim white to dark brown can be probably explained by an increasing contamination of the inner surface, where sodium replaced the silicon in the oxide structure. With an increasing distance from the molten sodium level, a lower temperature and lower sodium vapour pressure can be expected.

The pipe wall thinning can be expected due to the chemical reaction of molten sodium with the PHP's wall. The pipe was not resistant to further mechanical stress caused by operating pressure thermal gradients.
