Case study of negative impact of concave coal basin on long ribbon building development

*Beata Parkasiewicz**, and *Marian Kawulok*

Building Research Institute (ITB), Filtrowa 1 00-611 Warsaw, Poland

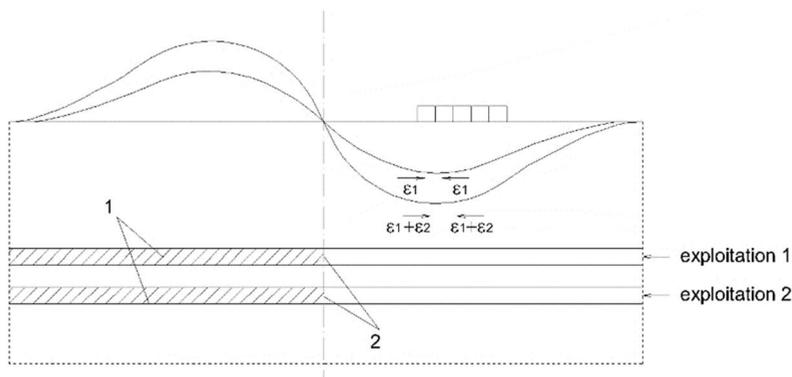
For longer ribbon buildings, correct structure of movement joints is crucial [3]. They need to have the ability to transfer mining influences along their full height. At the same time they should not be filled with any materials, in order to allow the units to move. It should also be pointed out that influences originating from different, subsequent mining operations may accumulate (fig. 15).

Fig. 15. Effects on the row building from two exploitations. Designations: 1 – carbon board, 2 – operating front, ε_1 – influence from exploitation 1, $\varepsilon_1 + \varepsilon_2$ – Total influences from exploitation 1 and exploitation 2. Source [6]

In the case of the buildings being analysed, in order to restore structural safety and safety of usage repairs need to be undertaken which will return them to their original state. Damaged construction elements should be erected anew. Tilted units should be straightened by levelling floors and walls, which may prove to be a very complicated exploitation, or by using hydraulic actuators. In the event of another mining operation, the movement joints

should be adjusted to allow them to transfer the influences, in accordance with recommendations given above.
