# The battery of silos for rapeseed - the impact of the building quality and exploitation conditions on the technical state of the object

*Krystyna Wróbel\**, and *Wiesław Kubiszyn*

**Abstract.** The subject of the paper is a battery of silos for rapeseed located in Oil Factory in Bodaczów. It consists of 24 cylindrical silos with capacity of 500 tons and 14 star-shaped chambers between them with a capacity of 100 tons each. The silos were supported on the supporting structure in the form of permeating ring beams and columns. The height of a single silo is 25 m, and the diameter about 6.0 m. Detailed macroscopic tests were performed on the battery of silos. Destructive and sclerometric in-situ quality tests and pull-off test were performed on the concrete, the degree of concrete carbonation was estimated. The position of the reinforcement in the concrete structure and the corrosion of the reinforcement steel were determined. Static and strength calculations were carried out. Based on the results the technical condition of the object was estimated as poor, locally due to the significant loss of concrete and structural reinforcement it was estimated as imminent failure. The article

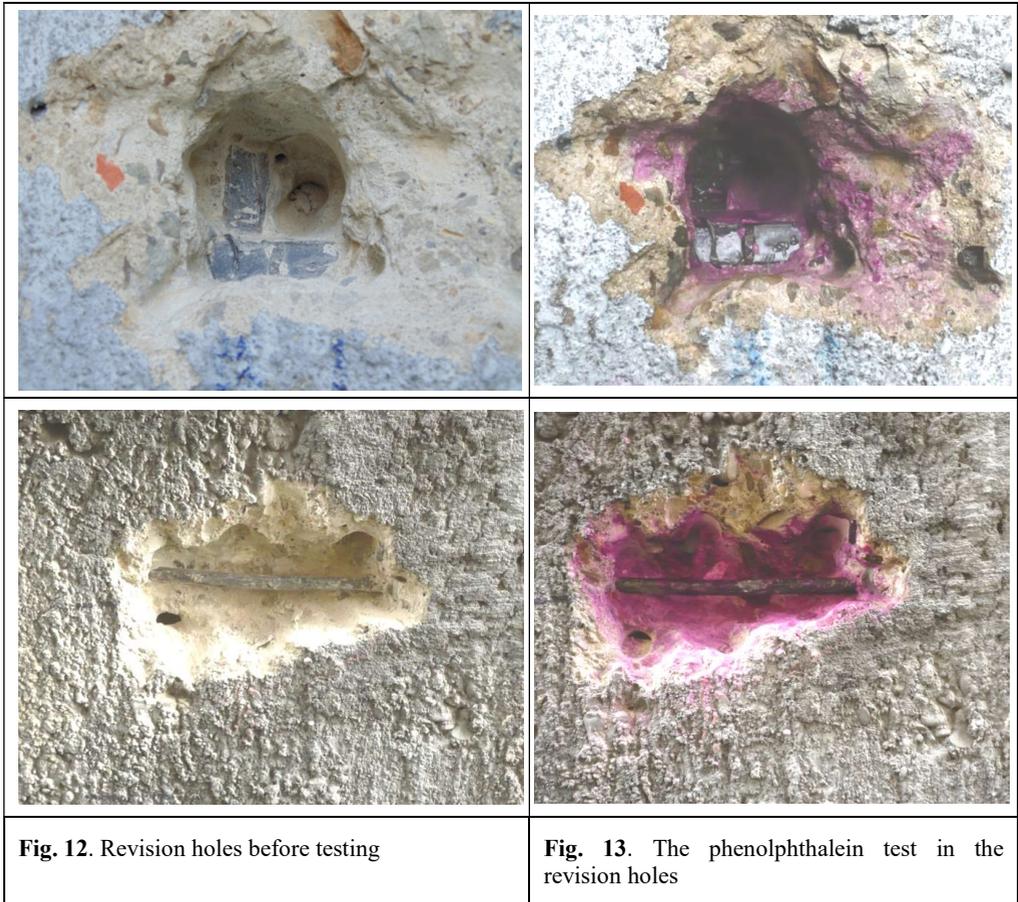
The location of the reinforcement in the external walls of the silos was determined in detail using the magnetic method using Proceq PROFEMET 5 device from the Swiss company Proceq in accordance with the manufacturer's instructions. Distances between horizontal and vertical reinforcement bars were determined. The place of revision holes were selected to directly examine the reinforcement, measure the thickness of the cover layer and determine the depth of carbonation of the concrete. The depth of neutralization (range of carbonation) in concrete was determined with a 1% solution of phenolphthalein in ethyl alcohol. This method is included in the standard [8]. The surface of the concrete was cleaned of dust and loose particles without the use of water and abrasion. Then the phenolphthalein solution was applied. The depth of the concrete neutralization was measured based on the color of the exposed surface. Below, in Fig. 12 and 13, two examples of revision holes (before and after the test) are shown, in areas outside the damages where the quality of the concrete was very good. In such areas, the depth of the concrete neutralization of  $5 \div 20$  mm was found. However, in the areas of defects and corrosion damage, the front of the carbonation went deep beyond the reinforcing bars.
