# Renovation of the historic building after damage connected with foundations subsidence – case study

**Abstract.** The paper delineates the study of a historic building renovation. It was built in 1900 and completed in 1939. Its both parts consist of different constructions. The old part was founded very deeply whereas the level of the younger part foundations was higher than the old one. After large floods, the walls started to crack, elements of the ceilings and roof under the extended part of the building slipped. It was expected that in the future a construction disaster would pose a serious probability of occurrence. In the study it was necessary to recognize the entire construction with a thorough investigation of the underground, old part of it and also the soil types density were examined. The main objective of the new research was to define the real reasons of the damage and to determine the possibility of repairing this building. The elaboration of the study results revealed a conception of supporting the walls of the building. The results indicated that the need to verify the reasons of the occurring damage in a complex and thorough way is tremendous, especially when a

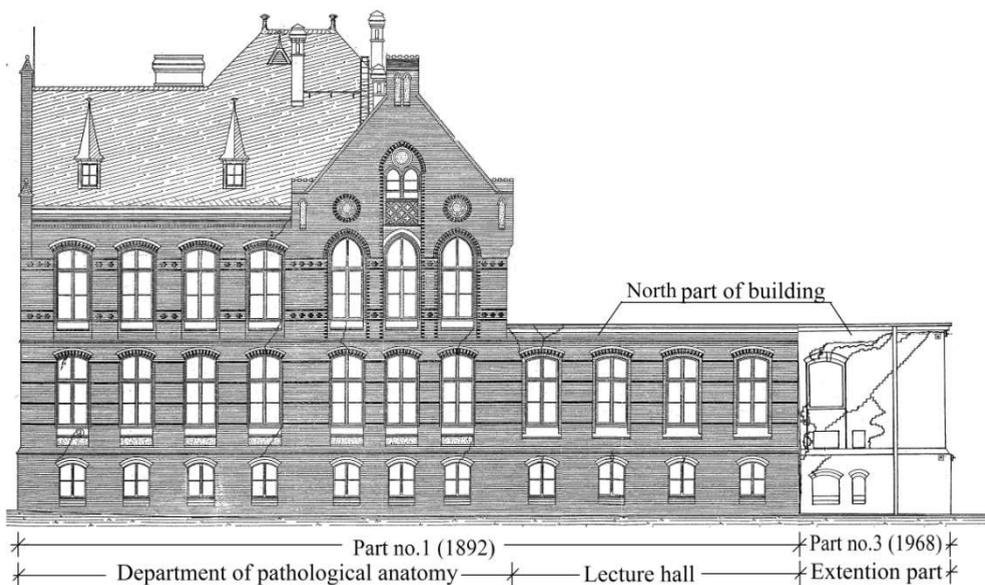
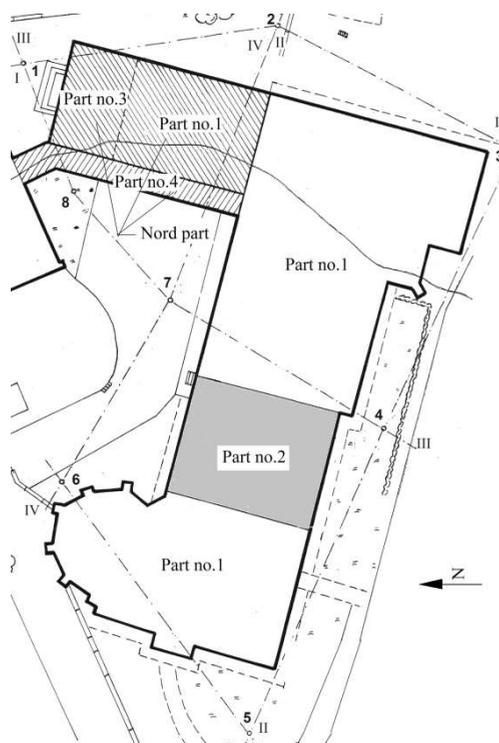
**Fig. 1.** Parts of the studied historical building (Part no.1– Division of general pathology (1898); Part no.2– the Connector building (1929); Part no. 3 – the Extension (1938); Part no. 4 – the Connector (1968); I-I ÷ IV-IV – geotechnical crosssection lines; 1÷8 – boreholes and research sensors sites).

It was assessed that the technical condition of the pathological anatomy building was generally stable as regards its foundations. The thin crack lines which emerged during over a hundred year old exploitation of that part of the building (Fig.1 and 4) did not constitute any hazardous implications for the construction. Nevertheless, they required to be eliminated with the submerged injection method under pressure for the sake of sustaining the continuity of walls.
