The Construction History and Assessment of Two Heritage Industrial Buildings in Wrocław

Piotr Berkowski*, Grzegorz Dmochowski, Jacek Barański, and Jerzy Szołomicki

In the following chapters, on the example of two old reinforced concrete industrial buildings, some results of the assessment of their technical condition are presented. The aim of the performed diagnostic procedure was to evaluate the possibility of adaptation of these buildings to new service functions.

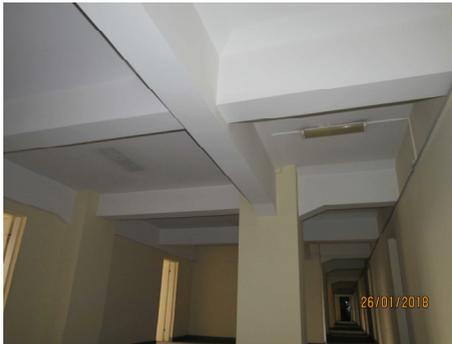
Fig. 3. The system of the RC beams and ribbed slab in the flour warehouse.

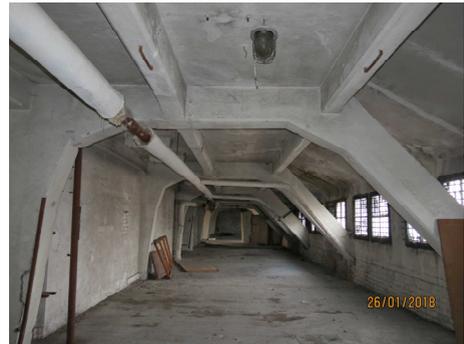
Fig. 4. The RC frame on the attic floors in the flour warehouse.

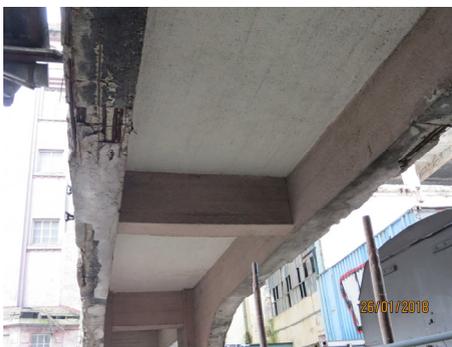
Fig. 7. The RC ground floor structure in the connecting building.

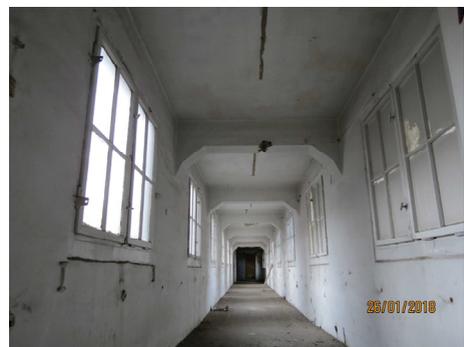
Fig. 8. The RC frames in the connecting building.

On the ground level the main supporting structure was made in the form of two double-span, arched reinforced concrete frames, which were based on the reinforced concrete pillars (Figs. 6, 7) due to the need to maintain an open communication space. Above the ground level, the structure of the building is one-bay and is also made of reinforced concrete with load-bearing longitudinal walls that are strengthened with pilasters that are connected to beams. They work as a stiffening structure (Fig. 8).

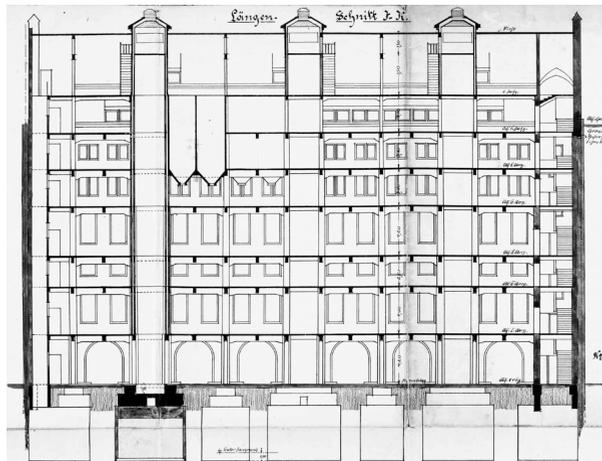
From the survey of the archived, historical documentation [12] and modern examination on site, it was identified that the foundation of the building was placed on 21 reinforced concrete wells (Figs. 9, 10) due to very difficult geotechnical conditions and a very high groundwater level. From the archival drawings, the authors concluded that the foundations of the wells were located 0.6 m above the ground water level at a depth of about 5.0 m below the terrain level. The wells are 4.0 m in height and the largest of them have a diameter of 6.4 m.

Fig. 9. The archival cross-section of the flour warehouse building [12].

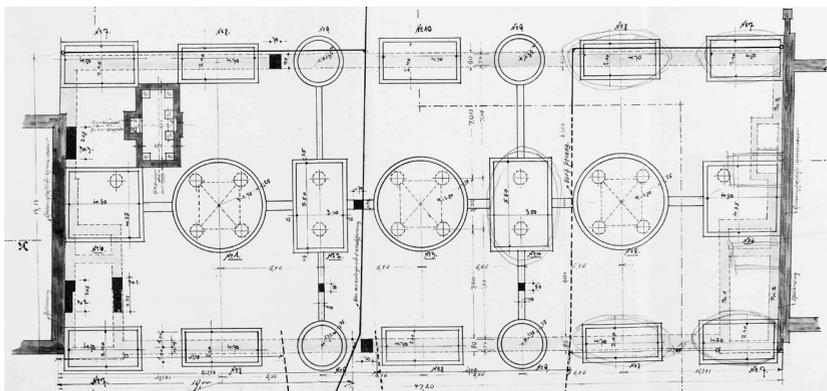
Fig. 10. The disposition of the foundation wells of the flour warehouse building [12].

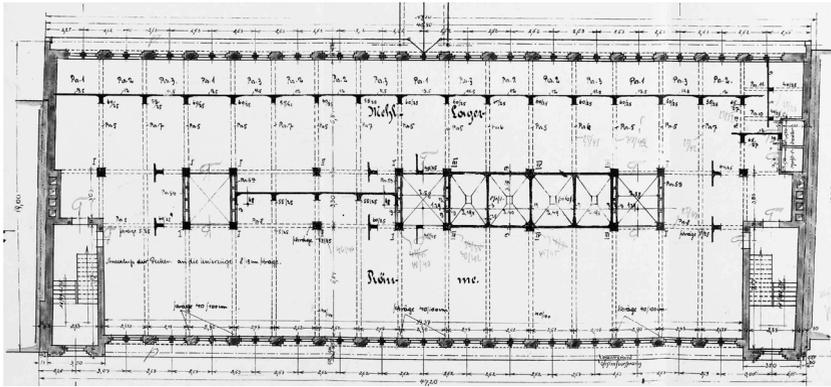
Fig. 11. The scheme of the RC slab on the 2nd floor of the flour warehouse building [12].

The main structure of the flour warehouse building is 3-bayed, with supporting brick longitudinal walls and two rows of reinforced concrete columns that define the central, narrower communication bay (Fig. 11). The floors are made of reinforced concrete, slab-ribbed and based on central columns and external walls. Between the 5th and 6th floors of the building, between the elevator shafts, was a battery of 6 concrete silos for flour. The bases of the silos were situated on the floors' main beams (Figs. 9, 11). Precise drawings of the reinforcement disposition in the slabs, beams, attic floor frames (Fig. 12) and also silos (Fig. 13) were found in the archival documentation. These were invaluable in attempts to identify the reinforcements when both making opencasts and using non-destructive testing.

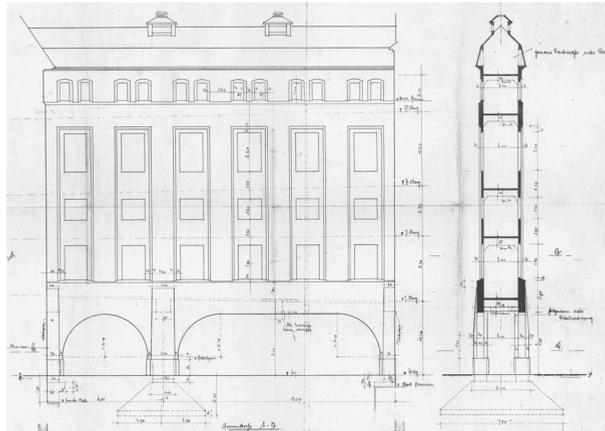
On the ground floor of the connecting building, the supporting structure consists of two two-span, arched reinforced concrete frames (Figs. 14, 15). The main structure above the ground floor is made out of thickened pilasters in the walls, which are connected to each other on the floors with slanted beams, and over the last floor of the building they create a system of reinforced concrete frames with spacing of approx. 3.3 m (Fig. 14).

Fig. 14. The archival cross-section of the connecting building [12].

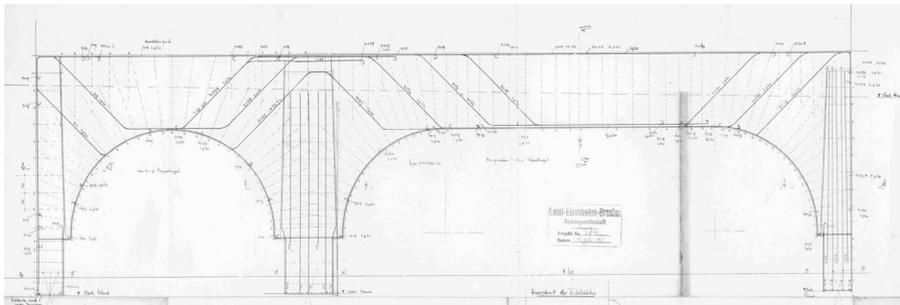
Fig. 15. The reinforcement of the main frame of the connecting building [12].

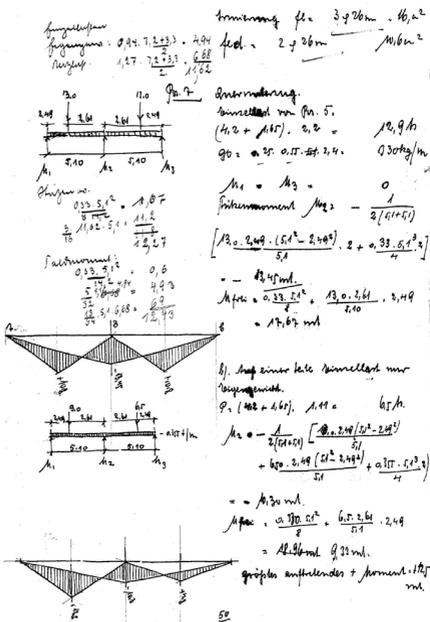
Fig. 23. The archival calculations of the beam in the slab of the floor warehouse [12].

During the assessment it was possible to analyze in the archival documentation the static calculations of the main structural elements of both buildings (Figs. 23, 24) [12]. All reinforced concrete elements were treated as the continuous ones. For this reason, such

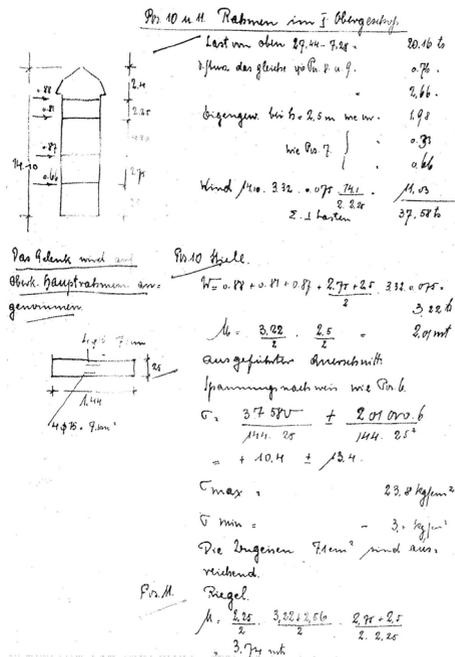
Fig. 24. The archival calculations of the bearing frame of the connecting building [12].

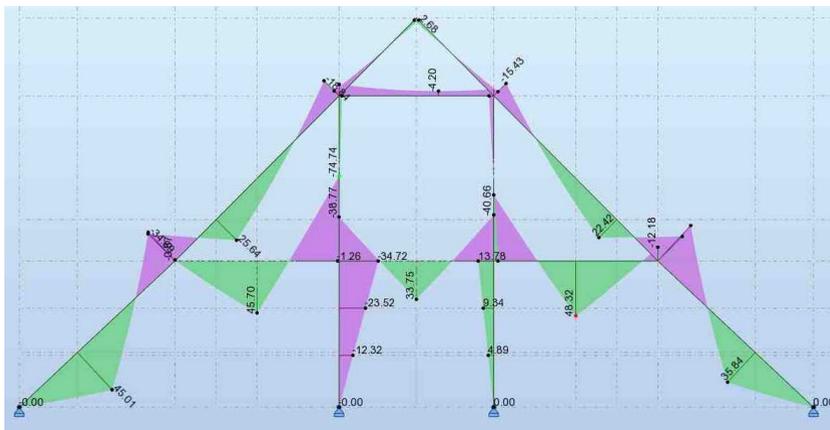
static schemes of the floor plates, the multi-span beams and the frames were used for verification calculations (Fig. 25).

Fig. 25. Exemplary diagram of bending moments for the attic frame of the floor building.
