Analysis of retaining wall stability in areas specified in register of objects of cultural heritage

Abstract. The case study of the assurance of retaining wall stability in densely urbanized conservation and cultural heritage areas are described in this paper. During The Second World War many of these historic buildings in Warsaw were completely or partially destroyed and until these days their remains constitute elements of the existing building development of the capital of Poland. This may be connected with a change in the nature of applied loads as well as current functions of these buildings. The results of expert opinions and investigations are presented, regarding the operational and technical state of two retaining walls submitted to an expert before the repair works. When designing the design concept, both the historic character of structures, the technical feasibility of performing construction works in the densely urbanized area, as well as determined water and ground conditions were considered. The first of the analysed cases concerns the retaining wall localised in the vicinity of the Ordynacka Street and the Tamka street. After analysing the historical aerial photogr

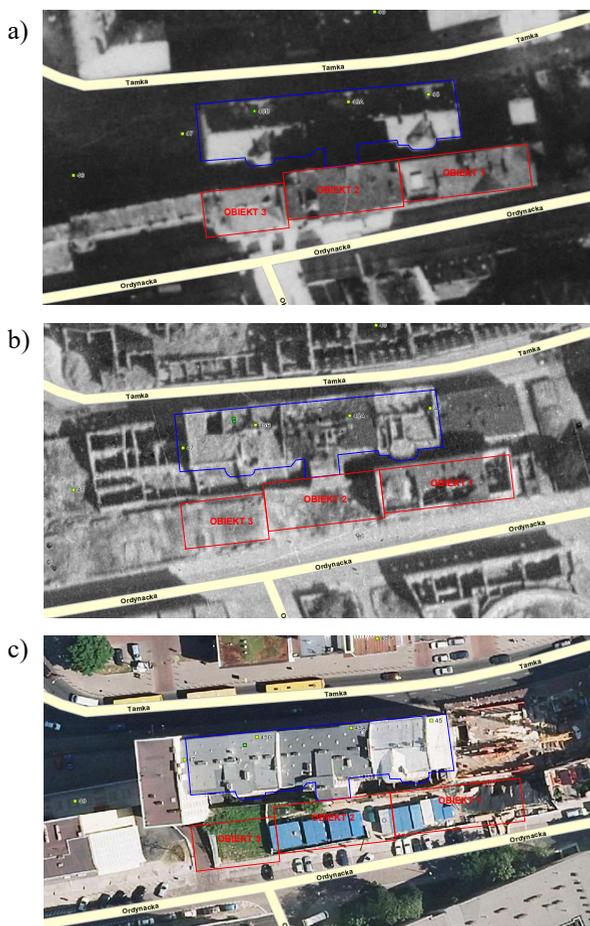
Fig. 1. Land development at the location of the analysed retaining wall: a) aerial photograph from 1935, b) aerial photograph from 1945 c) aerial photograph taken in 2008 [9].

The analysis of archival documentation, the assessment of the technical condition of the wall and inventory measurements allowed to conclude that the analysed object was a part of three tenement houses debris destroyed during The World War II - Fig. 1. The aerial photographs and diagrams show that there were three tenement houses in the area adjacent to the retaining wall – building objects marked with number 1 ÷ 3. Only one house remained in this location in 1945 - object 1. Presently, there are no facilities or buildings in this area. The remains of apartment house marked with No. 1 could be observed during conducting earthworks for the Chopin Centre built in 2009 - Fig. 2.

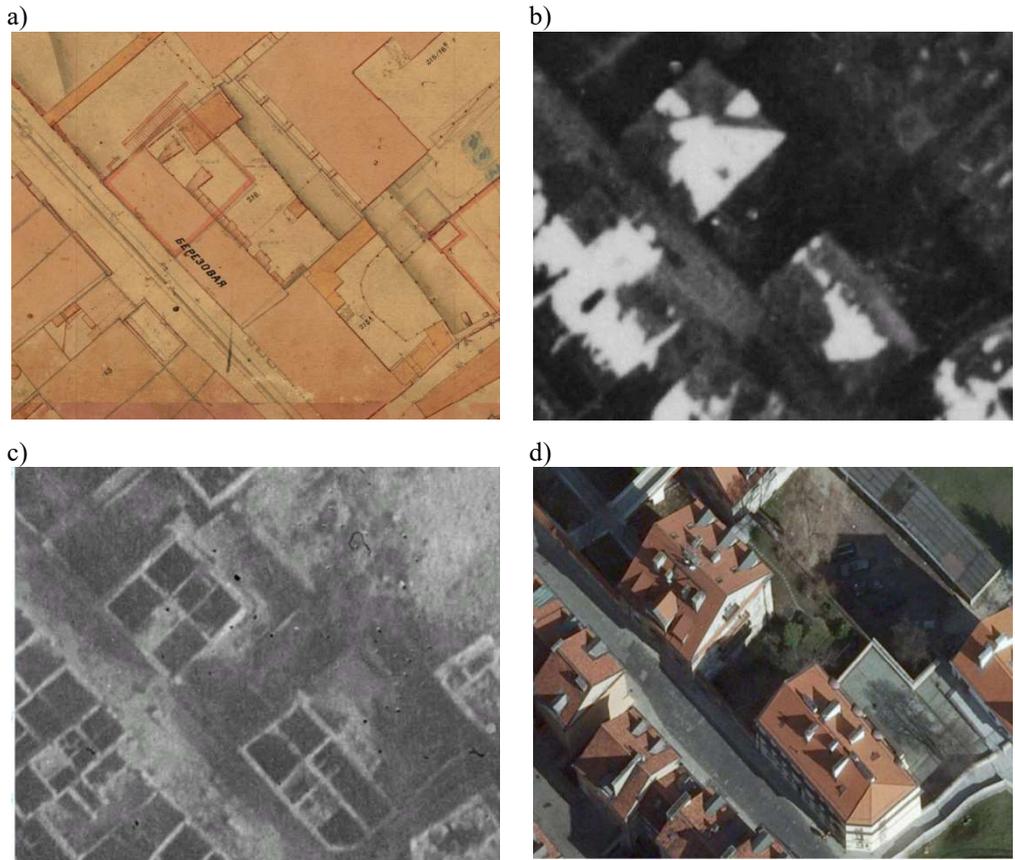
This conclusion resulted from a detailed analysis of archival documentation, assessment of the technical condition of the retaining wall and inventory measurements of the facility. Analysing aerial photographs, which present different stage of land development of this area in years 1891 - 2010 (Fig. 4), it can be concluded that building located at Brzozowa Street No.10 had been rebuilt and separated into two independent buildings. Currently undeveloped area between houses at Brzozowa 6/8 and 10 consisted with one compact tenement house in the past.

Fig. 4. Building development in the location at Brzozowa St.: a) years 1891-1908, b) year 1935, c) year 1945, d) year 2010 [2].
