Evaluation of tramway overhead line system in city of Osijek

Ivo Haladin^{1*}, Stjepan Lakušić¹, and Ivan Duvnjak²

Abstract. Overhead line system is a vital element of any electrified railway infrastructure. Its performance reflects to all vital parameters such as traction, reliability, availability and safety of railway infrastructure. Operator GPP Osijek runs a 27.5 km long tramway network which plays a key role in transit system of the city of Osijek, Croatia. In 2016 GPP Osijek applied to a tender for acquisition of new rolling stock with 85% EU investment. Mayor requirement prior to rolling stock acquisition was to document, analyse and upgrade current infrastructure (including track structure, electric substations and catenary) to an optimal level. Task of measurement and evaluation of tram track structure and catenary has been appointed to University of Zagreb Faculty of Civil Engineering. Overhead line analysis comprised from several measuring procedures, including supporting columns evaluation, catenary stagger, height, shocks and wear. Such extensive analysis included GPS positioning and on-site evaluation of 1214 supporting columns of overhead line, as well as overhead

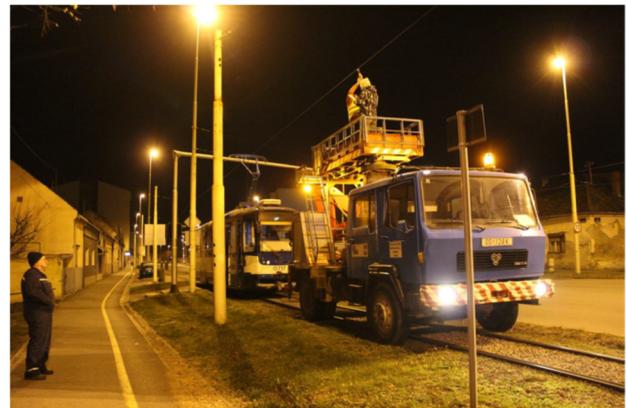
Fig. 3. Towing truck and tram T3 during overhead line measurements.

Overhead wire had to be checked along 18 km of track. On these sections, a tram T3 has been instrumented with measurement equipment and towed by a towing truck to conduct measurements off the power grid with a speed of around 10 km/h, Figure 3. Towing truck has also been used as an inspection vehicle for overhead wire wear assessment.

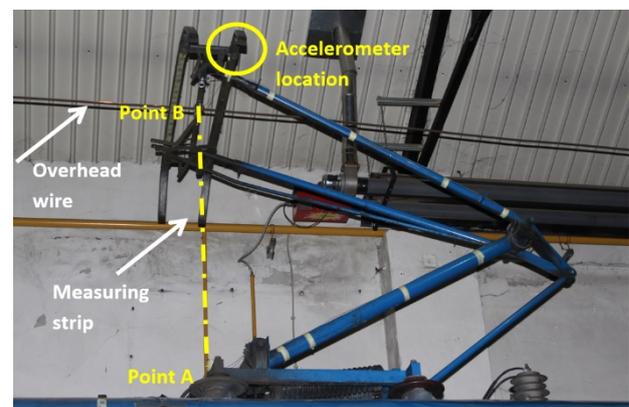
Fig. 4. Overhead wire height and shock measurement setup.

The overhead wire height has been measured using a digital measuring strip attached to pantograph base and pantograph top, recording the height variation, Figure 4. By adding the fixed value of top of rail to pantograph base height, total overhead wire height is calculated. Measurements are recorded continuously at 100 Hz. Such procedure allowed recording of overhead wire along the whole 18 km of tram track.

therefore important to measure and evaluate shocks and vibrations on the pantograph. To measure vibrations of the pantograph, accelerometers were attached to pantograph head and support rod (Figure 4) in vertical direction. Vibrations were recorded with a frequency of 100 Hz.

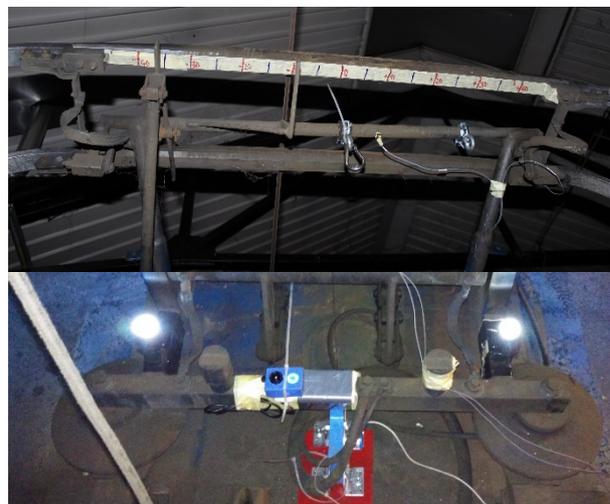
Fig. 7. Overhead wire stager measurements using camera and measuring strip on the head and camera in the base.

During a tram pass by over 18 km of track, a video camera was used to record the pantograph head with a measuring strip attached to it, to record the stagger of the overhead wire in lateral direction, Figure 7.

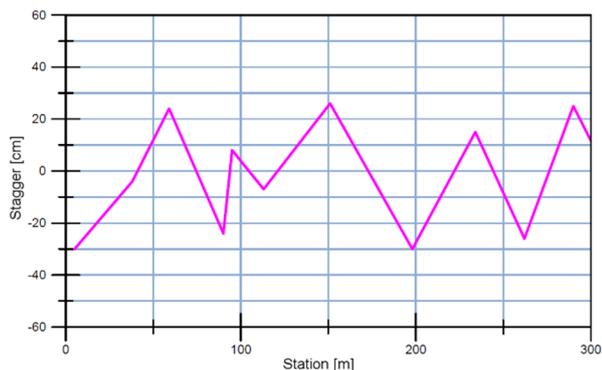
Fig. 8. Pantograph stagger recording.

This data has further been processed to create a polygonal curve based on the maximum values the wire has reached in lateral direction, traveling over the pantograph head, Figure 8. Using a GPS signal recorded simultaneously, such data could be geolocated to the tram network and track station.

Depending on pantograph specifications there is an optimal stagger width that leads to even wear of the photograph contact surface. In case of Osijek tram network, it is +/- 30 cm from pantograph centre line [4]. According to that, by histogram analysis, conclusions can be made on wear of pantograph contact surface. Analysis can also pinpoint locations of undesired wire placement (outside of +/- 30 cm range).
