Failure analysis of performance vehicle mechanical gear

Antonios D. Tsolakis, Konstantinos I. Giannakopoulos^{*} and Andreas S. Gkertsos

Department of Mechanical Engineering, Piraeus University of Applied Sciences, Greece

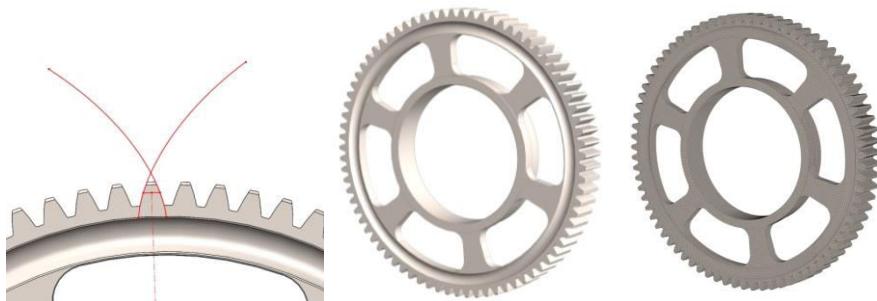
Fig. 5 (a) tooth profile equation driven curves, (b) 3D Mathematical model of the gear under investigation. (c) Mesh model of the gear.

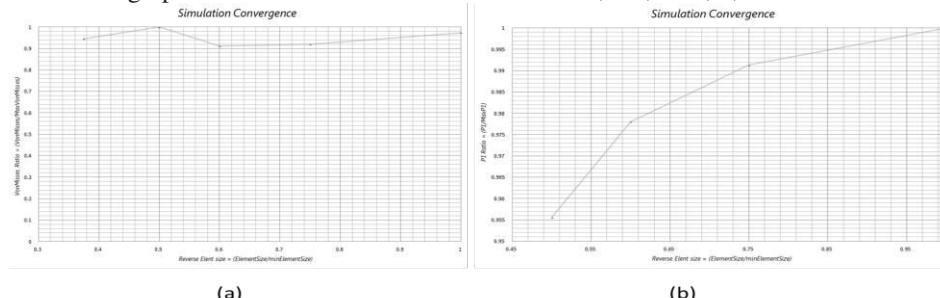
Following the Von Misses stress calculation, the 1st Principle stress is calculated and the results are listed in Figures 16, 17 and 18. The case studies were simulated for a given element size of the mesh. For this reason, the results cannot be validated unless multiple simulations are run for different sizes of elements during meshing. This process is called results convergence. Unless all stresses converge after a specific size of element, the simulation cannot be validated. The convergence graph for the 1st case study, max Von Misses stress as well as 1st Principle stress can be seen at Fig.8a and Fig.8b. The above mentioned graphs were extracted for element sizes of 2, 1.5, 1.25, 1, 0.75mm.

Fig. 8 (a) Convergence graph of max Von misses stress and (b) convergence graph of 1st Principle stress.
