Analysis of the Constructive Features of the Earth Dam

Abstract. The article considers the earth dam of the run-of-river unit – Kuibyshev hydroelectric power station on the Volga river (Russia). The main parameters of the earth dam, peculiarities of its erection and operation are described. The article notes the importance of ensuring a high degree of reliability of water structures constructed near major cities. It is especially important to monitor the condition of retaining structures with long service life. The factors influencing the change of the initial design conditions of operation of the Kuibyshev run-of-river unit dam are discussed. The results of examination of the geometric parameters of the body of the dam, performed at different periods of its maintenance, are analyzed. Examination results revealed significant deviations of the elevation marks of the earth dam surface on the upstream side from the design values. Possible causes of the discrepancy between these parameters and the design solutions are considered. The conclusion is drawn that the most likely reason for these features of the dam design lies in the initial incompleteness of construction. The measures for

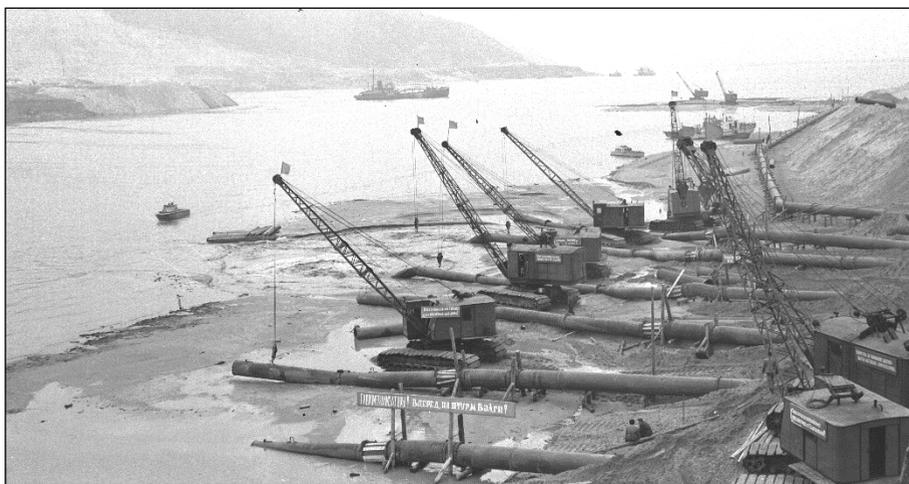
The earth dam of the Kuibyshev hydroelectric complex deserves to be called one of the unique hydrotechnical objects of that time. It has a considerable length of about 2800 m and a large height of 50 m within the channel part, and 27 m - in the floodplain [3]. The dam was erected by hydromechanization means, without anti-filtration devices, by filling with fine-grained sands (figure 2), so its body is homogeneous.

Fig. 2. Construction of an earth dam [6].
