Non-invasive tests of precast cantilever balcony in OWT-67 system

Abstract. This article presents a non-invasive tests report of precast cantilever balcony support in OWT-67 large-panel system. During field testing, the balcony's reinforced concrete structure was subjected to radiometric analysis in the context of thermal energy distribution as well as from the point of view of mycology - to the possible presence of spores of domestic fungi. The temperature distribution tests carried out by means of the electromagnetic wave detection in the infrared spectrum clearly confirmed the significant losses of thermal energy caused by the effect of the thermal constructional bridge located in the balcony. Mycological diagnosis was carried out using the rapid test of the Mycometer bacterial meter, which allows fluorimetric evaluation of the presence of the enzyme presence in filamentous fungi. In the conducted study, no spores of the house mushroom were found on the inside surface of the Z-type balcony supporting beam as a place where condensation of water vapor may occur. The summary also presents a design solution that allows to eliminate this physical problem.

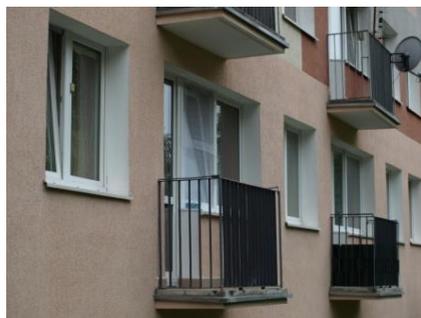
Fig. 5. OWT-67 system (author`s archive)

The results of in-situ thermovision tests - a linear thermal bridge, which is located in the structural system of the balcony of the large-panel system OWT-67, are shown below (Figures 6, 8 and 10).

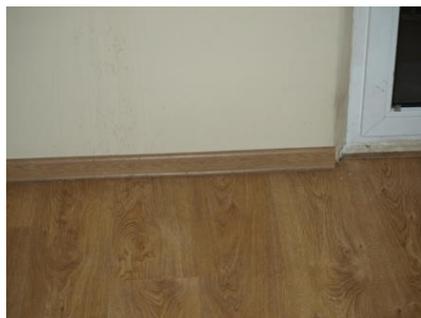
Fig. 7. The floor of the 1ST floor (author`s archive)

It is worth emphasizing at this point how important are the acceptance of window joinery with the use of thermovision diagnostics. The lack of this type of thermal technical analysis results in insufficiently good assembly and unnecessary losses of heating energy (Figure 8).

It is also recommended to wider the implementation of thermovision diagnostics to receive assembly of window frames in buildings.

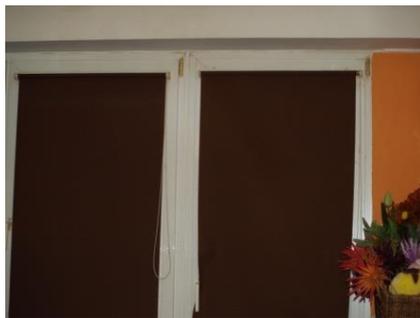
Fig. 9. Lintel „Z” (author`s archive)

The conducted tests with the help of wave detection in the infrared spectrum confirmed the significant losses of thermal energy within the linear power bridge. On the external plane of the building envelope, the average temperature difference $\Delta\theta_e = 4$ K was found - within the interactions and outside the thermal impact area of the thermal bridge (Figure 6). In the aspect of the internal surface of the external wall, the difference was on average $\Delta\theta_{e1} = 8$ K on the longitudinal wall in the level of the floor (Figure 8) and $\Delta\theta_{e2} = 3$ K within the prefabricated "Z" lintel beam (Figure 10) - in the level of the roof slab over ground floor.

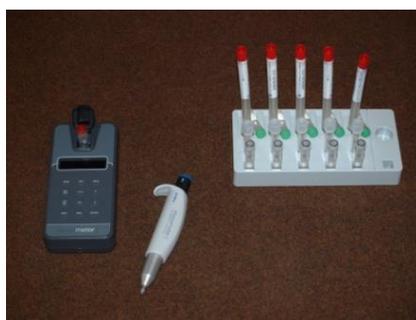
Fig. 12. MycoMeter

Examination of the fungus potential was done in a large room (Figure 11), for rooms in a small room and kitchen. The results were obtained at the level of category A, which clearly means no spores. The method has three levels of results A, B and C.

In terms of the tests provided for in the scope of mycology for the possible presence of spores - their presence was not found. However, in many other cases, this type of place, where there is a decrease in surface temperature, condensation of water vapor, favors the development of fungal spores, especially when these places are covered with curtains, curtains.
