# Investigation of transformer failure in Indonesia

Brian Bramantyo S.D.A. Harsono<sup>1,\*</sup>, Aristo Adi Kusuma<sup>1</sup>, Buyung Sofiarto Munir<sup>1</sup> and Nur Widi Priambodo<sup>1</sup>

<sup>1</sup>PLN Research Institute, Transmission and Distribution Department, Jakarta

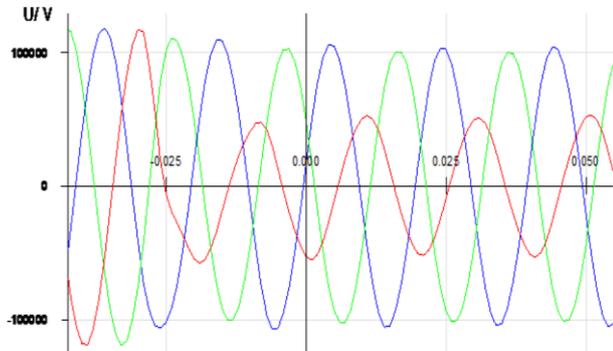
The voltage and current waveform on the primary side of the transformer during the fault were shown in Fig. 8 and Fig. 9.

**Fig. 8.** Voltage waveform record during fault (Phase R=red, phase S=green and phase T=blue).

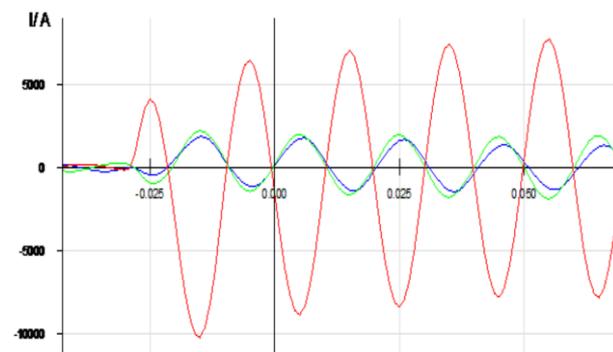
**Fig. 9.** Current waveform record during fault (Phase R=red, phase S=green and phase T=blue).

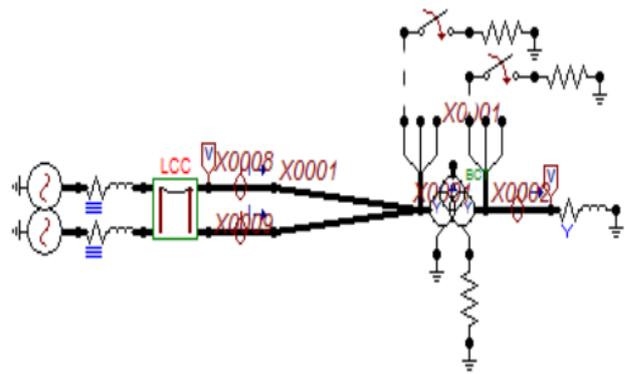
**Fig. 10.** Simulation model for phase to ground fault on transformer winding.

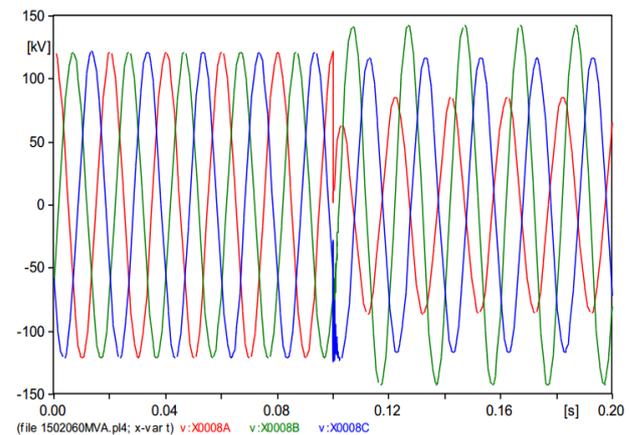
The voltage and current waveform for phase to ground fault simulation on primary winding (phase R) was shown in Fig. 11 and Fig. 12, while the voltage and current waveform for phase to ground fault simulation on low voltage winding (phase R) was shown in Fig. 13 and Fig. 14. Based on the simulation result, ground fault on primary winding gave identical voltage and current waveform with the recorded waveform data of DFR.

**Fig. 11.** Voltage waveform for phase to ground fault on primary winding (Phase R=red, phase S=green and phase T=blue).

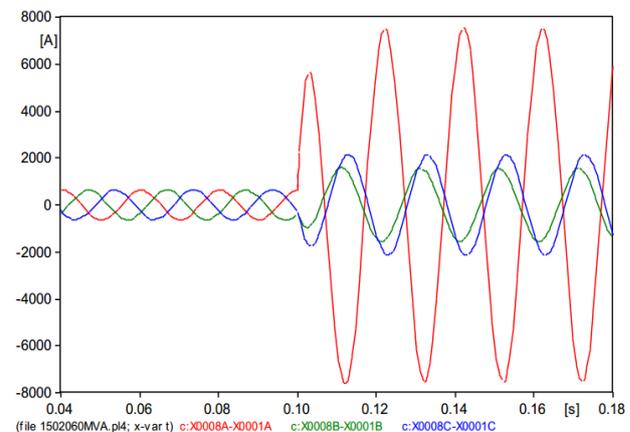
**Fig. 12.** Current waveform for phase to ground fault on primary winding (Phase R=red, phase S=green and phase T=blue).

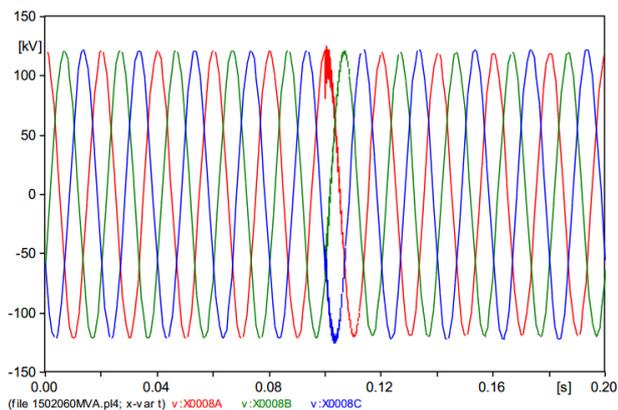
**Fig. 13.** Voltage waveform for phase to ground fault on secondary winding (Phase R=red, phase S=green and phase T=blue).

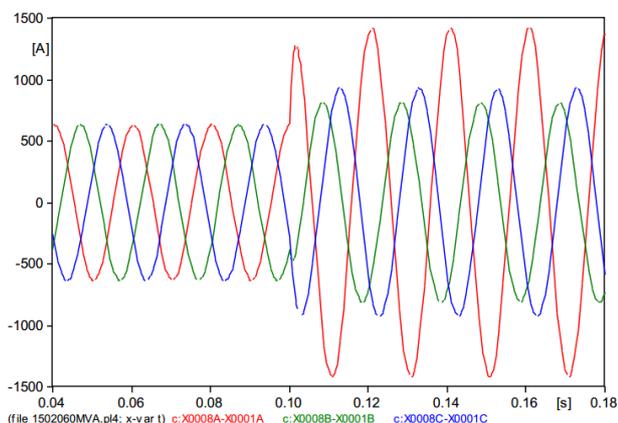
**Fig. 14.** Current waveform for phase to ground fault on secondary winding (Phase R=red, phase S=green and phase T=blue).
