Demolition of Old Oak Bridge B4113: Condition of a 54-year old prestressed concrete bridge

Abstract. The extension of the 3rd lane on Trunk Road 9 Section 1 (N1) at Bellville in the Western Cape necessitated the demolition and replacement of the Old Oak Road Underpass Bridge B4113. This bridge had insufficient vertical clearance as well as insufficient horizontal clearance for the widening of the road. Furthermore, the existing precast beam and slab deck has suffered from repeated vehicular impact damage over the years, resulting in continued costly repairs. This paper describes the condition of this bridge after a 54-year service life. The primary objective is to report and comment on the condition of this bridge in order for other engineers who have to rehabilitate, raise or widen similar bridges built at the same time, to have an indication of the quality of materials, workmanship, condition and behaviour. During and after the demolition operation, a visual inspection of the rubble was undertaken to evaluate the condition of this bridge which was constructed in 1963. Concrete cores taken before the demolition revealed higher concrete strengths of 50% and more. Carbonation and d

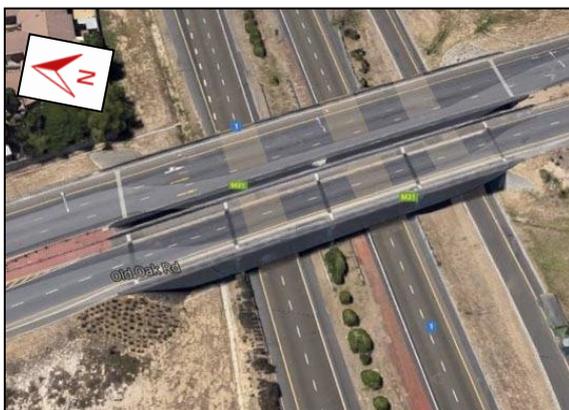
Fig. 2. Aerial view of Old Oak Interchange before demolition (B4113 is the lower bridge in the photo).

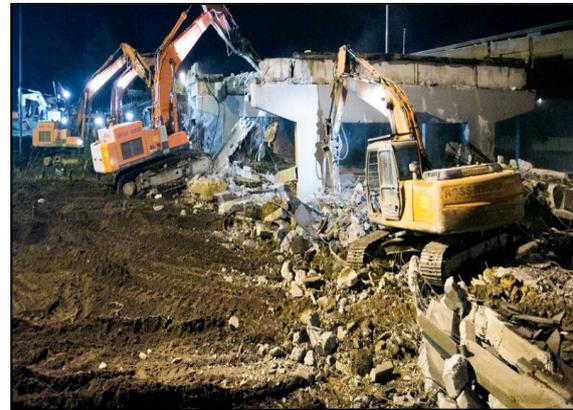
Fig. 3. During the demolition operation.

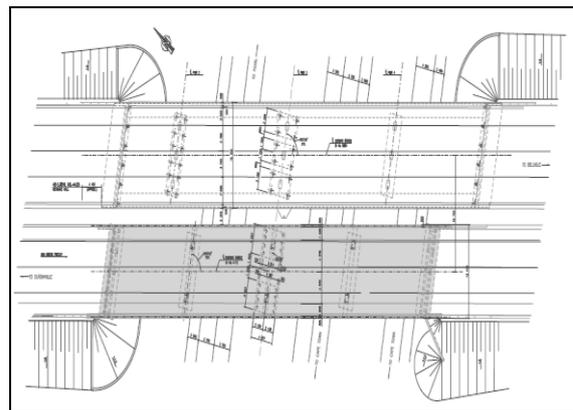
Old Oak Interchange's layout in Fig. 4 clearly shows the proximity of the 2 bridges. It also illustrates the difference in bridge B4113's pier 2 and 4 position relative to bridge B5884.

Fig. 4. Layout of Old Oak Interchange.

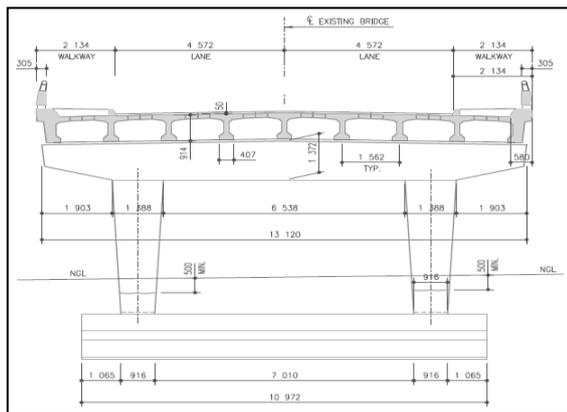
The piers comprised 2 columns each with a pier-head which supported the 9 precast prestressed beams (Fig. 5).

Fig. 5. Cross section through pier 2.
