Flood-induced Bridge Failures in Papua New Guinea

Gibson Ali HOLEMBA^{1*}, and Takashi MATSUMOTO²

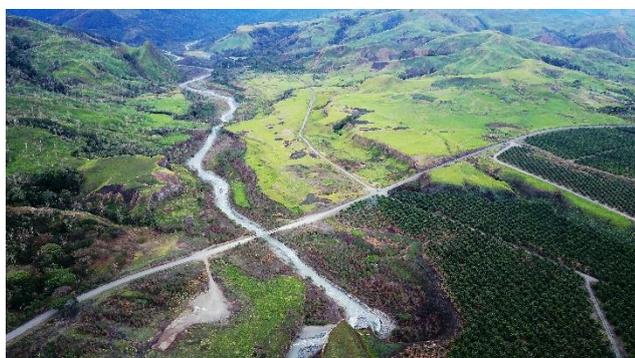
Figure 4. Mavic Pro DJI Drone image of Surinam Bridge, Ramu Highway, Madang Province, PNG. Photo Credit: Jeremy Mark (2017).
