# Measurement of RC slab surface shape and investigation of local water stagnation

**Abstract** In a road bridge, drainage facilities are installed to discharge the water on the bridge surface. For each drainage facility, installation spacings are exemplified by waterproof manuals and others, but the quantitative sharing and drainage capacity of each facility and bridge surface have not been clarified. Also, it is thought that water will be stagnant due to bridge surface irregularities generated during construction or during service. However, no regulations on the concavities and convexities about the slab surface are clearly shown in construction standards. Therefore, in this study, surface shape measurement and water sprinkling test on unpaved actual bridge slab were carried out. From the results, we confirmed the possibility that irregularities on the slab surface affect the tendency of local water stagnation. Since only one bridge was studied in the current study, we have not confirmed the influence of gradient magnitude on the drainage capacity of uneven slab surface. It is a future task to clarify the relation between surface gradient and allowable irregularity size and to d

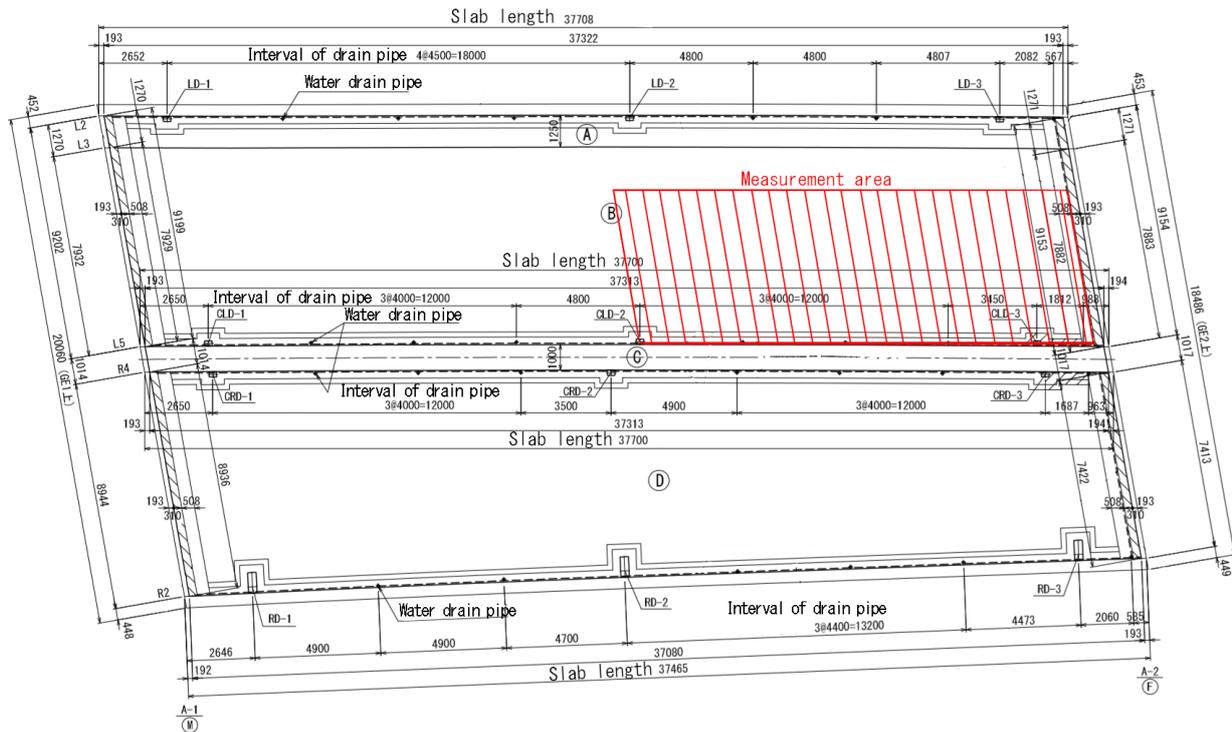
Fig. 1. Bridge plan view

This bridge was before opening its service, and measurements were made before construction of the waterproof layer and pavement. Fig. 1 is the plan view of a target bridge. The measurement area is indicated by red hatching in the figure.

The measurement area is indicated by hatching in Fig.1. The area is about a quarter of the L side lane and is 5 m by 15.47 m. The surface shape of this slab area was measured. Also, water was sprinkled in the same area, and the temporal change of the surface water content was measured.

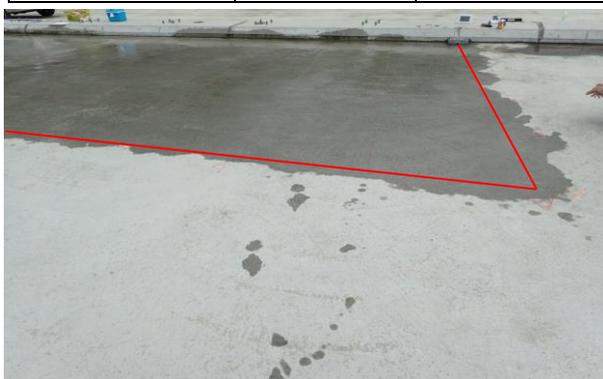
**Fig. 6.** Water sprinkled area

First, at 12:00, we sprinkled water, a total volume of 40 litres, over the entire measurement area (Fig. 6). The first measurement was carried out at 14:00 which is two hours later after the sprinkling.
