# Flaking of PEEK under one-point rolling contact fatigue using Al<sub>2</sub>O<sub>3</sub> ball

**Abstract.** The growth of flaking as tribological fatigue failure in PEEK was investigated through the one-point type rolling contact fatigue test between a machined PEEK polymer shaft and an alumina bearing's ball. Due to Hertzian contact of cyclic compressive stress, the subsurface fatigue cracks in the PEEK shaft propagated in rolling and axial directions. When the rolling fatigue life of the PEEK shaft reached 10<sup>6</sup> fatigue cycles, many narrow angled cracks occurred in the near-surface of the rolling track without flaking. On the other hand, when the flaking occurred on the PEEK shaft before 10<sup>6</sup> fatigue cycles, semicircular surface and subsurface crack propagations were observed. From these observations, it was found that micro-flaking occurred due to the linkages between subsurface and surface cracks. Flaking developed due to the accumulation of these micro-flakings.

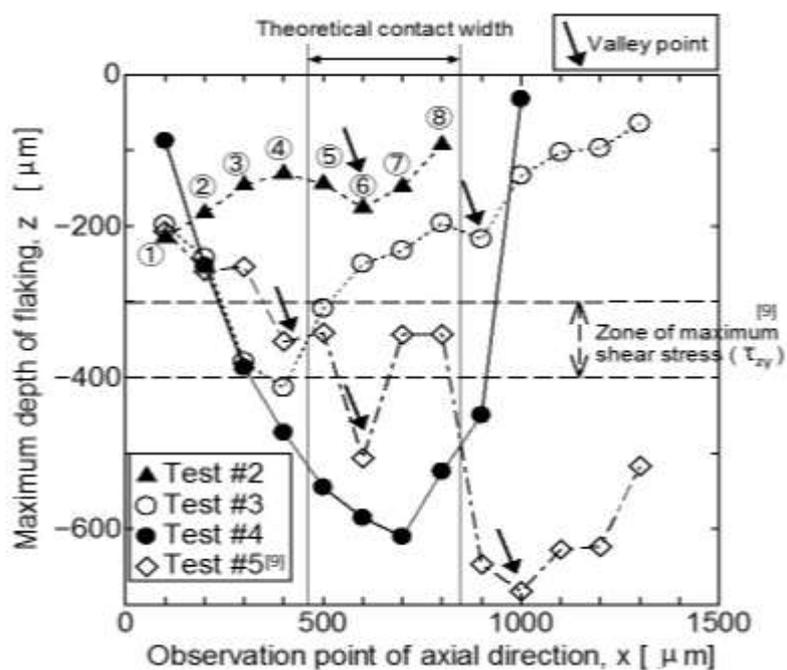
Fig. 7. Maximum depth of flaking of the PEEK shaft at 120 N.

Figure 7 shows the profiles of the maximum depths of the flakings at 120 N. Test #2 corresponds to the flaking in Figure 4. In the profiles, valley points were observed at flaking bottoms. This means that the flaking gradually grows due to the accumulation of small (micro) flakings.

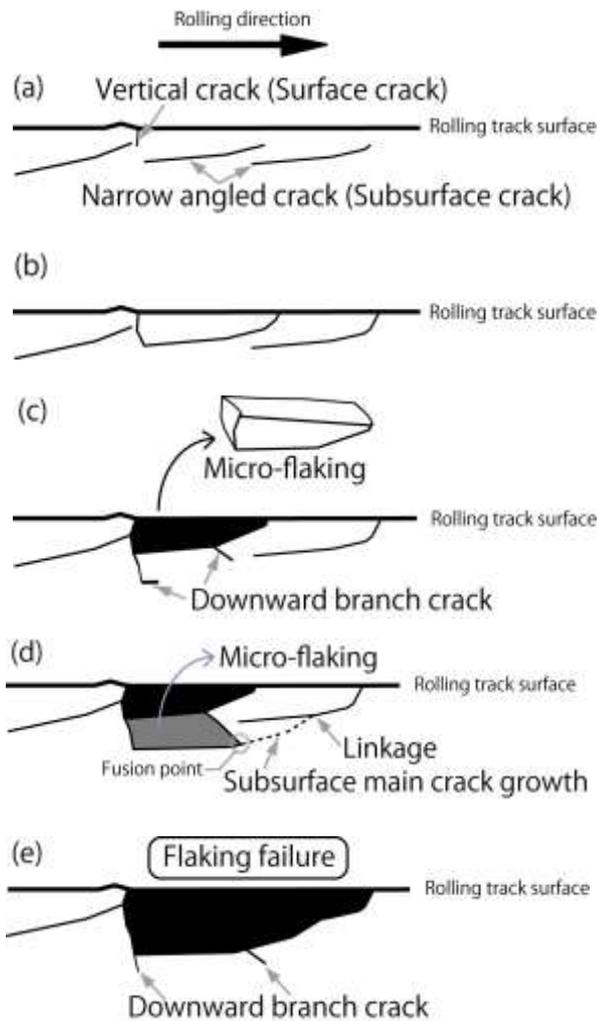
**Fig. 9.** Illustration of the flaking growth of PEEK shaft under one-point rolling contact fatigue.

Figure 9 shows the flaking process near PEEK shaft surface. The flaking process is as follows:
