# Analysis of technical condition of footbridges over the railways in danger of collapse

Ryszard Chmielewski<sup>1,\*</sup>, and Aleksandra Bąk<sup>1</sup>

<sup>1</sup>Military University of Technology, Faculty of Civil Engineering and Geodesy, Warszawa, Polska

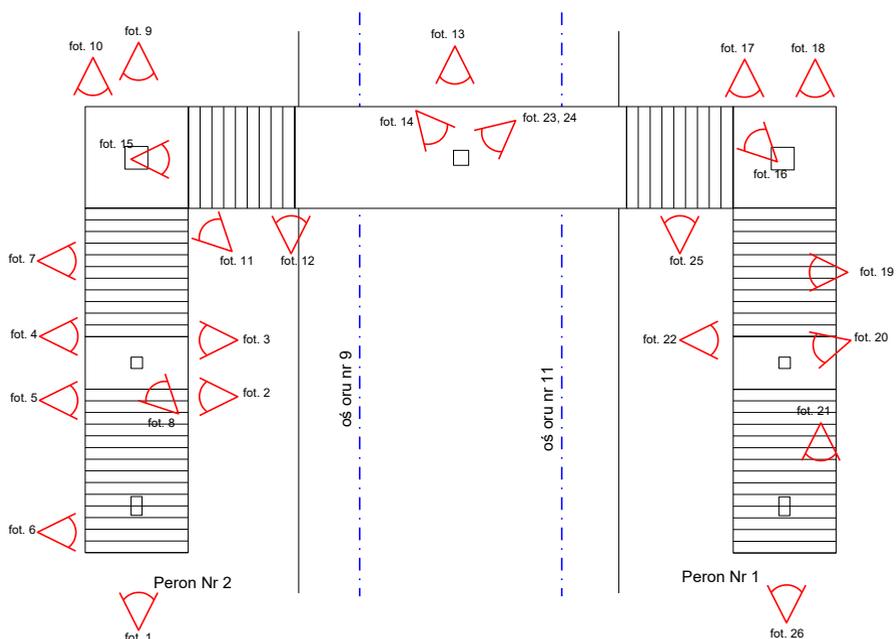
**Fig. 1.** Scheme of photo shots of photographic documentation [12].

The design flaws were compounded by construction errors, for example dragging caused by the use of formwork made of poorly connected planks. In the Figure 1 the footbridge scheme with the directions of the photographic documentation is presented.
