Impact of improper storage and installation of glazed fire rated walls on their performance

Jacek Kinowski¹, Paweł Sulik^{1,}, and Bartłomiej Sędlak¹*

¹Institut Techniki Budowlanej, Zakład Badań Ogniwych, 00-611 Warszawa, ul. Filtrowa 1, Polska

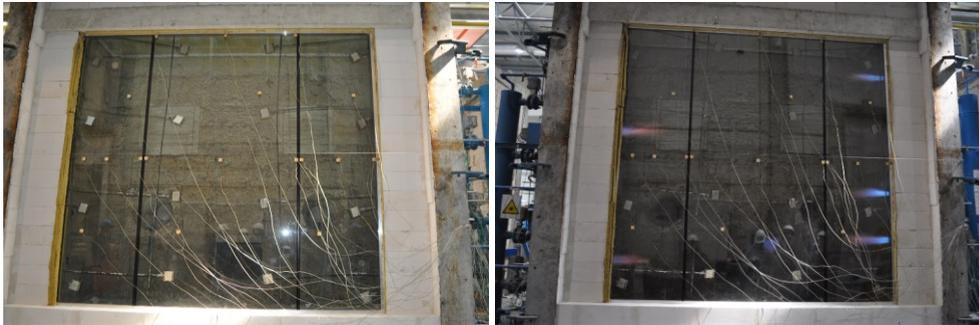
A scenario where glazing is stored incorrectly is particularly dangerous, as the chemical changes which occur when glass intended to be used indoors is exposed to sunlight (and temperature) are frequently impossible to see with the naked eye. Fig. 5 shows photographs taken during a fire resistance test of a mullion-free glazed partition wall and progressing loss of insulation on the element’s surface. The same test specimen before the test is shown in Fig. 4. Incorrect behaviour of the gel in this area, according to a later “investigation” was most likely caused by the glazing being stored for (only) 5 days without cover outside the test building in sunny, warm July weather.

Fig. 4. Mullion-free glazed wall test specimen before a fire resistance test. Building Research Institute's archive.

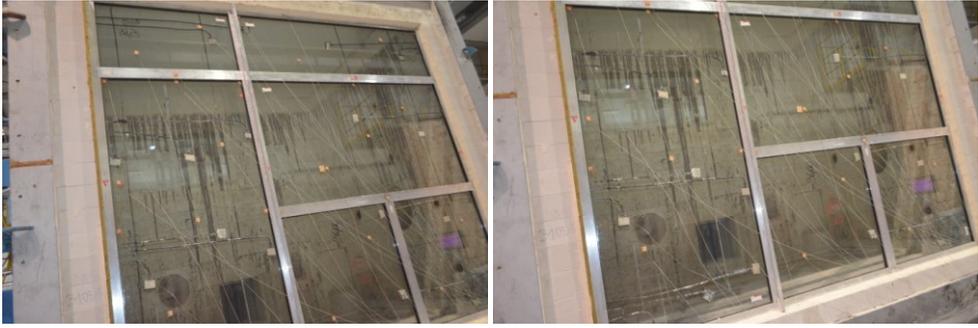
Fig. 11. Photographs of unexposed surface of a partition wall before fire resistance test. Building Research Institute's archive.

The graph above presents a very similar situation to that shown for a test on a mullion-free wall – regular increase and moderate values. However, due to problems with improper mounting of the glazing the test failed. Details of the test specimen – non-load-bearing glazed wall with profiles – aluminum; the analysed area is shown in Fig. 14.
