The analysis of the causes of the collapse of two timber sheds during the construction

Abstract. The paper describes collapses of two timber sheds located in Cieszyn and Zebrzydowice, Poland. The collapses took place during the construction process. The structures of the sheds are described, the construction works are analysed, the causes of the collapses are determined and the recommendations and technical solutions regarding their repair are presented.

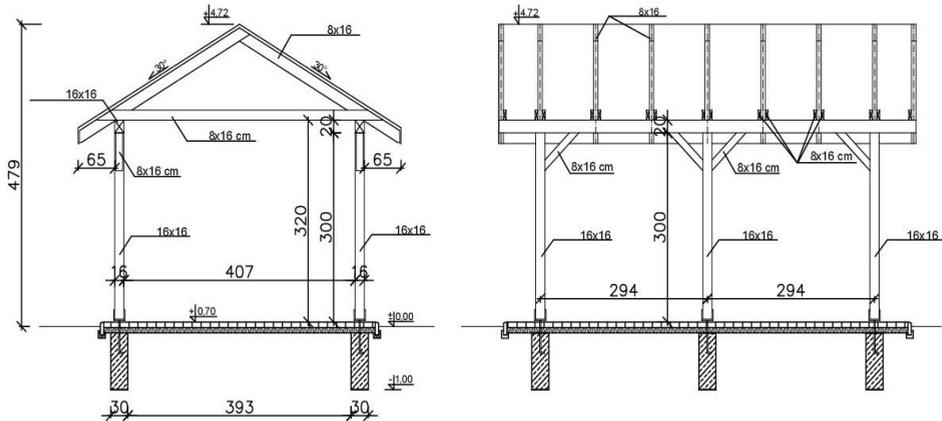
Fig. 1. The diagrams of the sheds.

the wall plates only longitudinally and not transversally. The anchors connecting the foundations with the posts were small and should not have been used in such structures. Although the roofing material was different (the shed in Cieszyn was covered with concrete rooftiles and the one in Zebrzydowice with sheet metal), both contractors used the same sizes of the parts. The diagrams of the sheds are shown in Fig. 1.
