Change in groundwater conditions as a cause of structural failure – selected case studies

Tomasz Godlewski^{1,*}, *Witold Bogusz*¹ and *Lukasz Kaczyński*¹

¹Institut Techniki Budowlanej, ul. Ksawerów 21, 02-775 Warszawa, Polska

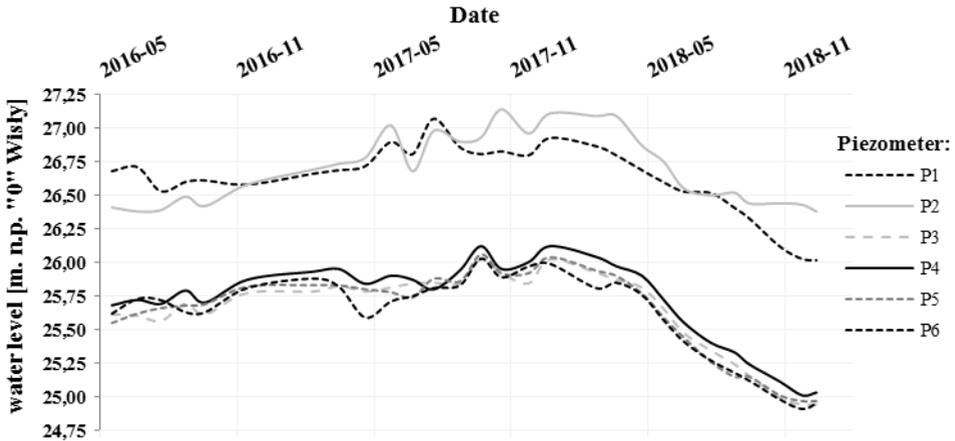
Fig. 1. An example of groundwater lowering in Wola district area in Warsaw, as registered in piezometers.

In such a case, long-term dry periods can lead to lowering of groundwater table, resulting in volumetric changes in the subsoil, as well as the increase of effective stresses. The experiences of ITB show that lowering of 1 m can result in 1-3 mm of additional settlements in the case of permeable cohesionless soils. In the case of fine-grained (cohesive) soils, this effect can be more pronounced and reactivate consolidation processes. This often results in additional settlements after a period of stabilisation. Their exact values are dependent on the type of the soil and its susceptibility to water content change. The largest settlements are usually observed in the case of organic soils and can reach few centimetres. The reactivated consolidation process usually has the characteristic of long term settlement, which may be similar to settlement caused by creep, as it may show similar trend. As presented case studies show, in the case of expansive soils, the shrinkage and expansion of the soil may play important role in influencing foundation movements. All those phenomena are strongly interrelated as groundwater lowering, in the case of shallowly occurring expansive soils, lead to the change in water content as well [2]. Neogene clays (tertiary Pliocene clays), in the Warsaw area, may exhibit linear shrinkage of up to 10-15%. When water-content change occurs in upper part of those strata (e.g. approx. 0,5 m), this may lead to a settlement of more than 5 cm. For typical structures, such values are significant for both serviceability and ultimate limit state consideration.
