Geotechnical failure of a slope featuring site development with industrial facilities caused by irresponsible leveling in the neighboring area

Maciej Kordian Kumor^{1,*}, and Lukasz Aleksander Kumor¹

¹University of Technology and Life Sciences, 7 Kaliskiego Street, PL 85-386 Bydgoszcz, Poland

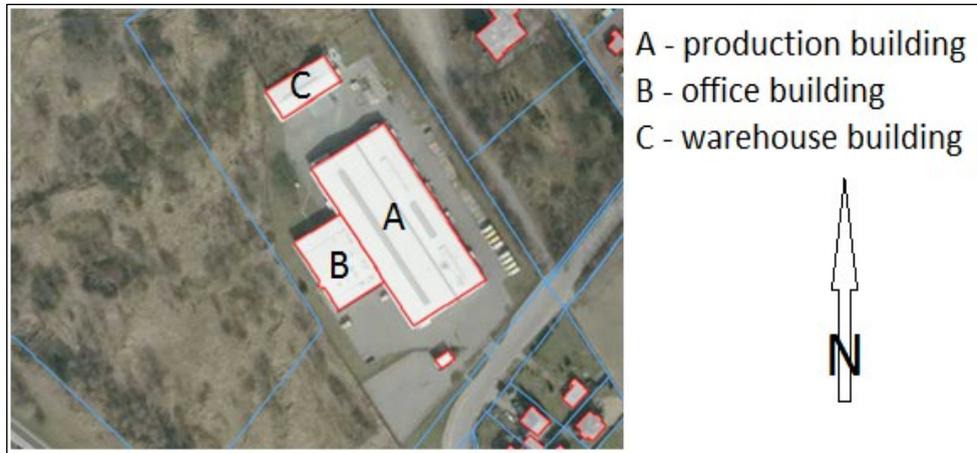
The analyzed geotechnical failure was reported on the lot with reference number 15/10, developed with industrial facilities, Fig. 1.

Fig. 1. View of the industrial facility along with the lot boundaries (marked in blue).

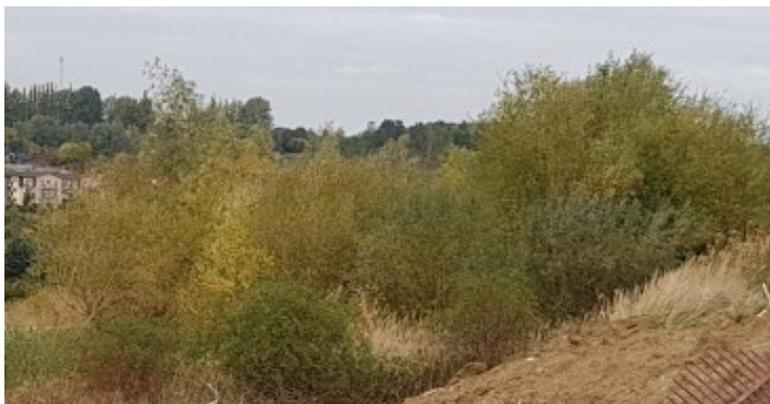
Over a period of some thirty years, the slopes of the storage site have been overgrown with self-sown deciduous trees, Fig. 2.

Fig. 2. Spontaneous reclamation of the slope with deciduous trees, after twenty years.

In June 2017, the owner of the neighboring western building lot, i.e. lot no. xx/11, started – without any arrangements [6] - earthworks, preparing the land for its own investment project. Cleaning works included initially tree clearing, Fig. 2, expanded successively by extensive levelling of terrain, including entries and operation of heavy equipment on the lot no. 15/10, increasing the angle of inclination of the slope and undercutting the base of the slopes, Fig. 6 and 7.

The owner of the lot no. 15/10 notified the Office on unauthorized tree removal by third parties on its lot. An on-site visit with representatives of the Office was performed along with photographic documentation after clearing trees by third parties on the slope within the limits of the lot no. 15/10, Fig. 2, 6.

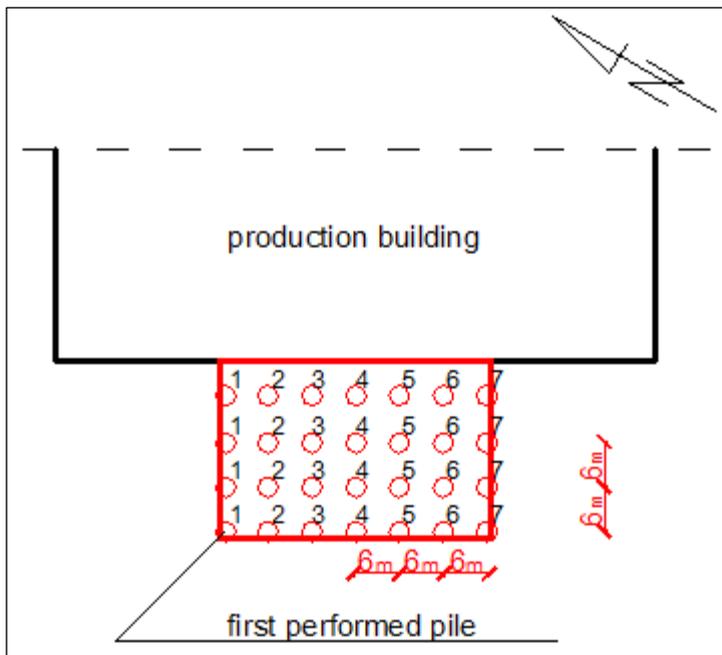
On part of the lot that was not disturbed and partially reclaimed, construction of production facilities of a big enterprise started in 1999. The production building was founded in the area not disturbed directly on continuous footings. The office building, located closer to the slope edge, was designed indirectly on reinforced concrete slab supported on Wolfsholz driven piles with 508 mm in diameter, [2] Fig. 3.

In 1998, the solution for founding the office building on Wolfsholz piles was a well thought out answer to stabilization of the subsoil and a slope for development of production facilities.

Fig. 3. Drawing with a layout of piles under the building according to [2].
