Causes of failure of a four-storey building and the reconstruction concept

Abstract. The article presents causes of failure of a four-storey building of a complex structure. It reviews the causes related to soil features, foundation works and construction design of the facility. The article rationalizes the concept of soil improvement using the jet-grouting technology and suggests eliminating the process of flooding and damping basements of the building.

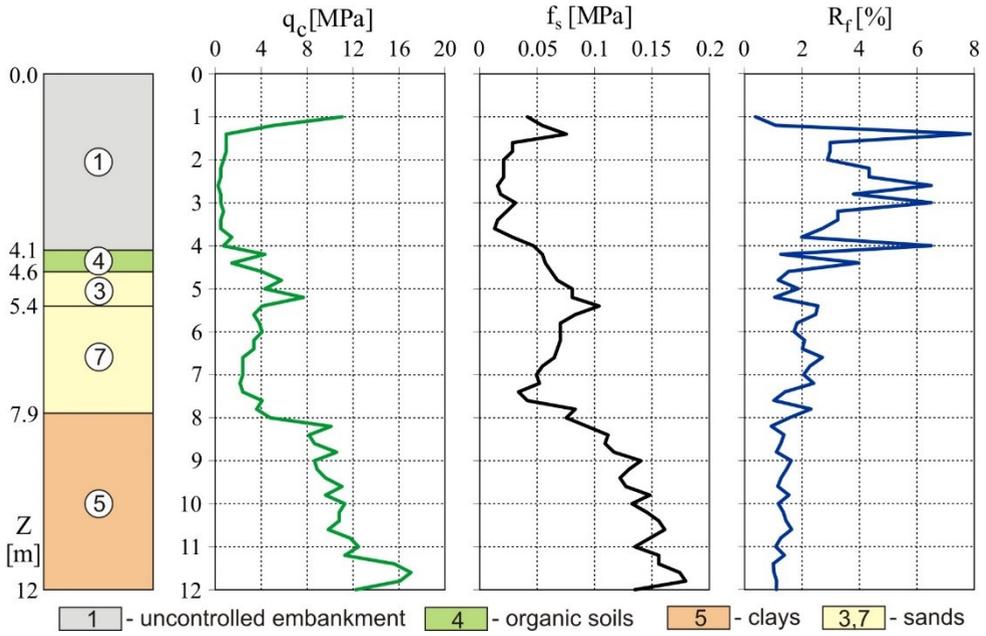
Fig. 4. Characteristics of the CPT test.

Factor α for loamy sands of layer 5, which contained significant amounts of fine and silty fraction adopted 3. For a section of loamy sands mixed with humus sands, probably organic silt (assessment based on the values of R_f – Fig. 4) the factor value of $\alpha = 2$ was adopted. In order to determine the compressibility modulus for mineral fine and silty sands, the formula by Lunne [8], which, depending on the cone resistance value (normally consolidated soil), was applied and is as follows:

For the silty sands found in the soil, in layer 4 with an admixture of organic soils, the s_u values were calculated with the $N_k = 19$ factor (Fig. 5). The determined values of s_u in layer 4 classify it as soils of low shear strength according to PN-EN ISO 14688-2, whereas loamy sands of layer 5 can be classified as soils of high or medium shear strength.
