The delayed effects of flooding a residential building – case study

Abstract. The work describes the case of a single-family residential building, which suffered a breakdown due to flooding. Flooded water in the nearby watercourse, did not reach the building directly, but in its vicinity, but raised to a very high level the local groundwater table, which reached locally, even above ground level. This condition was maintained over a longer period of time, causing the soil moisture to rise, and thus its geotechnical parameters deteriorated. The consequence of this, the building underwent an uncontrolled and uneven settlement, which was accompanied by the formation of cracks on the walls. The effects of failure were presented and an attempt was made to identify possible causes of failure. Own study of the substrate was carried out in "in situ" conditions and verification of laboratory tests, and their results are presented on relevant charts and tables.

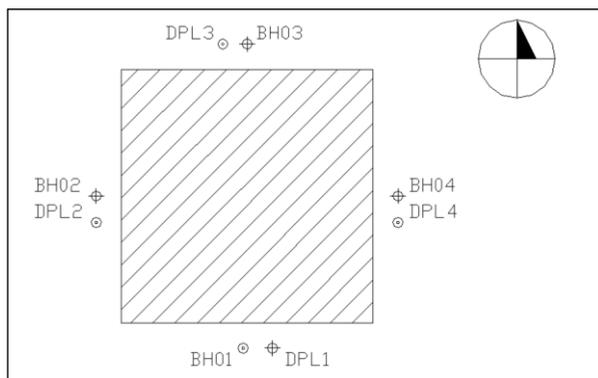
Fig. 4. The scheme of locations of Boreholes and DPL tests points at study case.

Assessment of subsoil was made on the basis of laboratory and in situ tests. In the immediate vicinity of the building which was damaged, four boreholes were drilled up to approx. 6 m depth, from which soil samples with undisturbed structure were collected for selected laboratory tests. At the same time, next to the boreholes, a soil test was carried out using a dynamic penetrometer DPL (Dynamic Probing Penetrometer) [4]. The ground conditions and soil index properties soil was determined on base results of lab researches samples collection from Boreholes. Samples with undisturbed end disturbed structure were obtained and used to identification, macroscopic analysis and laboratory tests. The orientation of the building, the location of research Boreholes and dynamic sounding points shows Figure 4.
