Causes of damage and methods of repairing floor made on polystyrene concrete

Abstract. The paper describes damages, tests and repair of the floor made on existing ceiling and expanded polystyrene concrete underlay. The floor was built on a reinforced concrete ceiling with an area of about 1050 m². Significant damage in the form of cracks, detachments and unevenness was found in the floor. In order to determine the causes of damage, in situ tests and laboratory tests were carried out. It was found that the damage was caused by numerous performance errors. A test repair of the damage (4.7x6.0 m) was carried out, and then the repair method was applied on the entire floor surface.

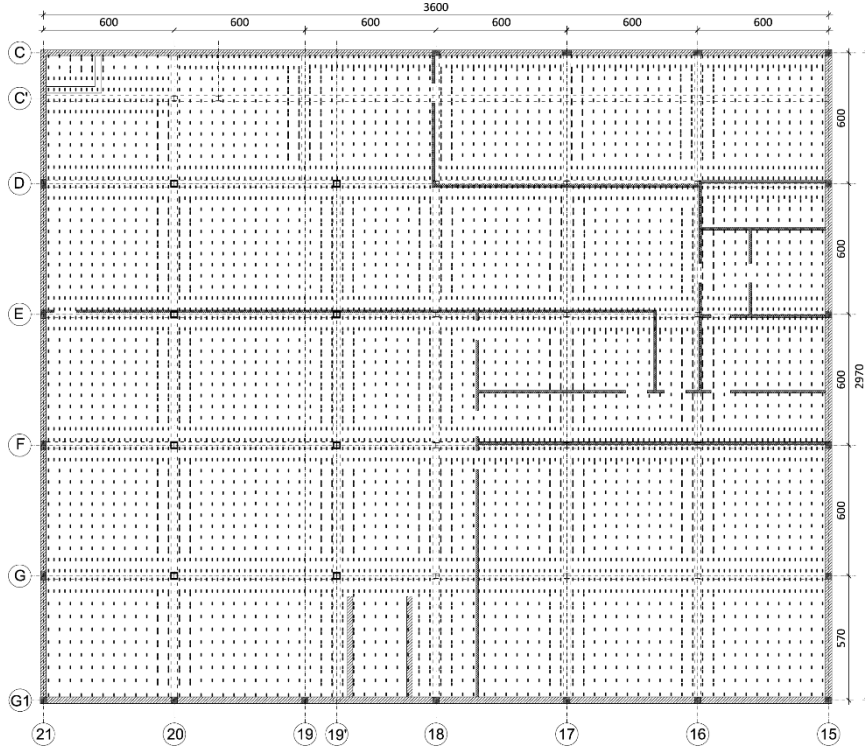
Fig. 1. Beam system and the location of reinforcement pins (connecting the existing ceiling, top layer and EPS concrete).

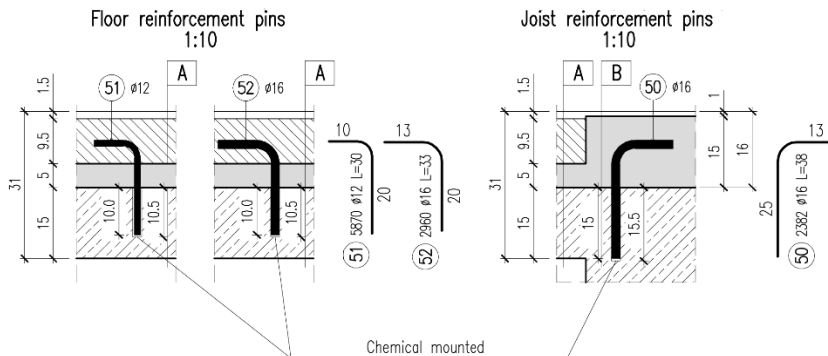
Fig. 2. Cross section of reinforced slab and reinforced joist.

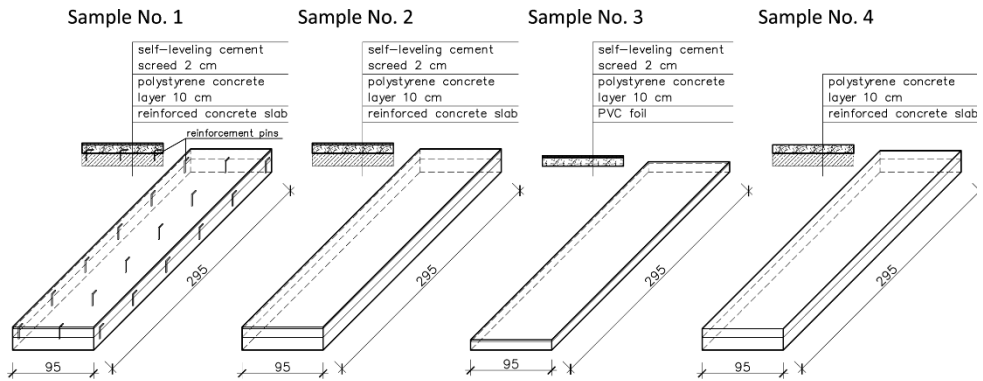
In order to determine the possible interaction between individual layers of the floor, four test specimen were prepared. Three of them were made on a 95x295 cm reinforced concrete slab, the last one on a PVC foil (Fig. 7). The first sample was reinforced with steel 12 mm pins, with 10 cm of a 30/50 EPSC overlay and 2 cm of self-leveling screed. The model reflected the existing floor. Sample no. 2, was identical to the first one with exclusion of reinforcement pins which were not installed. The model, in comparison to the first one, was used to determine the effect of the pins. In sample no. 3, a 30/50 EPSC was cast on a PVC foil and finished with a 2 cm layer of self-levelling screed. The model was used to determine the possible influence of slip membrane laid under the EPSC. The last sample, a 10 cm layer of 30/50 EPSC cast over a reinforced concrete slab. was made in order to determine the possible shrinkage. The specimen was left uncured and uncovered, untypically to standard practices. The samples are shown in Fig. 8 and Fig. 9.

Fig. 7. Comparative test samples.

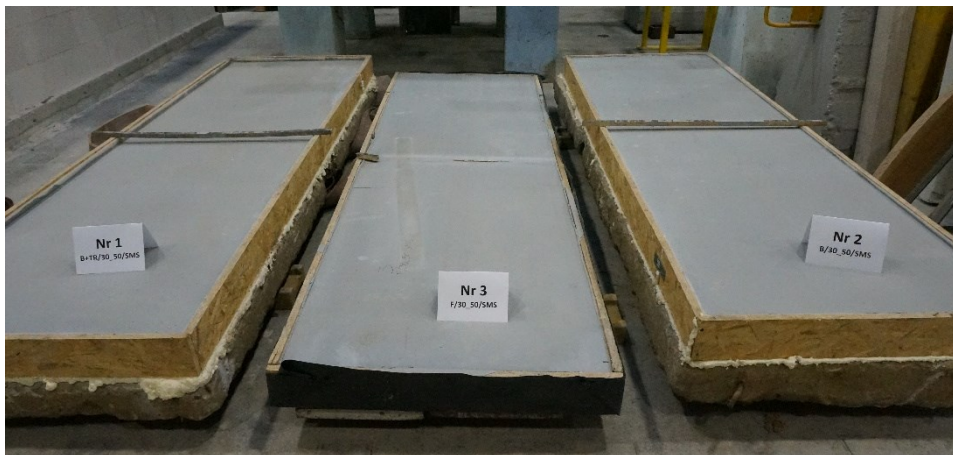
Fig. 8. Samples no. 1, 2 and 3.

The visual evaluation of the samples was being conducted for over 2 months. The observations lasted over 2,5 times longer than the time in which the cracks occurred in analyzed floor. After 49 days first three samples did not exhibit any signs of cracking. The last sample exhibited small shrinkage cracks. Local width of the crack reached between $0.1 \div 0.5$ mm. The cracks on the surface of the EPSC occurred after two weeks due to lack of curing. The cracks are shown in Fig. 10.

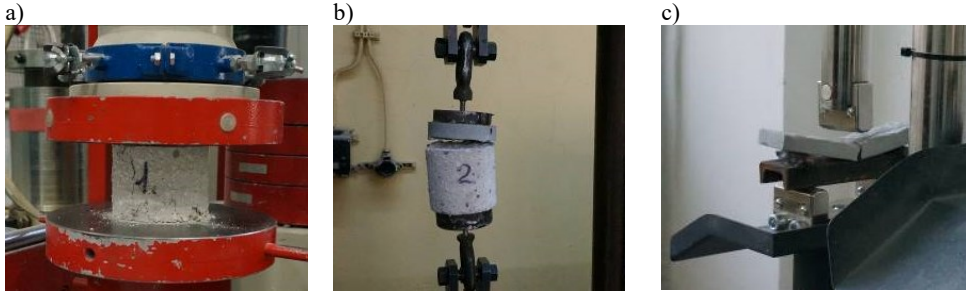
Conducted tests have determined that the materials used (p. 4.1) in the comparative laboratory tests meet the manufacturers recommendations in terms of compressive and flexural strength. Core samples from the damaged floor in majority also exhibited required

compressive and tensile strength. A single sample exhibited significantly lower flexural strength, while the other did not meet the tensile strength requirements.

Fig. 12. Laboratory tests: a) compressive strength test of the EPS concrete, b) tensile strength test of the EPSC+screed samples, c) flexural strength test of the screed.
