# Commercial building flooring failure caused by swelling of the foundation layers

**Abstract.** The work describes the damage, testing and method of repairing the flooring. The flooring formed part of a commercial pavilion covering an area of approx. 1200 m<sup>2</sup>. Significant damage in the form of cracks and elevations of up to a height of almost 80 mm were detected in the flooring. Geodetic, laboratory and geotechnical tests were carried out to determine the causes of the damage. The cause was found to be swelling of the floor base course layers, consisting of embankments made of unburnt colliery shale mixed with ashes. The swelling processes ceased about 5 years after the structure was commissioned.

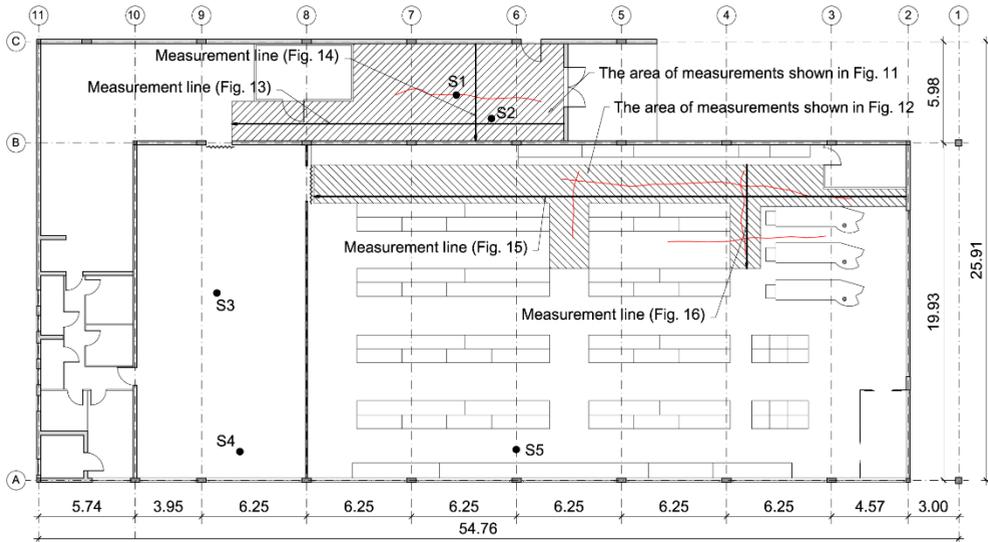
**Fig. 10.** Locations for geodetic measurements, boreholes and geotechnical tests.

The flooring levels were tested to show the deformation. The tests were carried out in the storage room and the sales room in the areas of the largest deformations (Fig. 10). The test was carried out using a self-levelling level and a levelling rod with millimetre graduation. The measurement accuracy was estimated at  $\pm 1.0$  mm. In the storage room, the test was carried out over a length of 18 m and a measuring grid of 1.2x1.2 m was used. In the sales room, the tests were carried out in the western part over almost the entire length of the room, with a measuring grid of 0.4x0.4 m, this being additionally reduced by half in those areas with the largest deformations. Based on the measurements it was found that the maximum flooring displacement in the night storage room was 5.5 cm, and occurred in the middle of the flooring, while the maximum flooring displacement in the sales room was 7.6 cm (at the corner of the store manager's room). Graphs with the results are shown in Figs. 11 and 12.

The first test was carried out in July 2015, i.e. 21 months after the commissioning of the structure. Subsequently, the tests were continued at intervals of approx. six-months, until no new impact was found (June 2018). Fig. 13-16 show the changes in flooring deformation recorded during subsequent measurements. These were carried out as linear measurements along the lines shown in Fig. 10.

A total of 5 core boreholes, marked S1-S5, were made in the flooring (fig. 10). It was found that the flooring layers were consistent with the design (Fig. 17a). In S1 it was possible to bore through the crack, and it was found that the crack was located in the screed and the upper part of the concrete slab, and was enclosed in the area of half of the sample (Fig. 17b). This indicates the occurrence of a bending condition in the flooring. The strength tests of concrete samples S2-S5 were carried out in accordance with the recommendations [10] and it was found that the concrete grade was consistent with the design.
