# The method of strengthening the church building in terms of the planned mining exploitation

**Abstract** This article describes the method of strengthening a church building in Ruda Śląska against predicted effects of mining exploitation. The building had been already exposed to effects of 22 mining incidents which significantly damaged walls and vaults. Therefore, it was decided to strengthen the building before new exploitation works. Strengthening works included longitudinal walls support with the tendon system built over the vault support. Additionally, ribs were strengthened by suspending them to new reinforced concrete ribs placed over the existing ones. And precast concrete cube elements were used in new ribs.

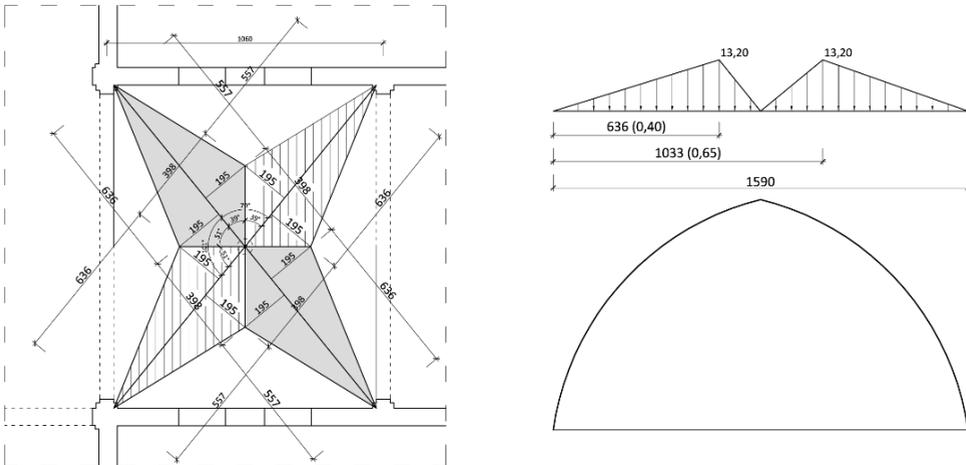
**Fig. 6.** Load distribution from squinch to ribs: the plan and the cross-section.

Computational analysis of the planned strengthening of ribs was performed. Ribs of the church vaults were modelled in the FEM software. The analysis was made for existing conditions with the load exerted by self-weight and displacement resulting from the predicted impact of exploitation and conditions with additional strengthening in the form reinforced concrete ribs, for which self-weight load and displacement resulting from the predicted impact of exploitation were assumed. Constant load to the rib was distributed in accordance with geometry principles of load division (Fig. 6). Thus, non-uniform loading became necessary (Fig. 7). Loading with displacement was uniformly distributed to vaults due to executed tie rods (Fig. 8).
