# Analysis of removal method of a 19<sup>th</sup> church's deflection

Krzysztof Gromysz<sup>1,\*</sup>

**Abstract.** A historic mid-19<sup>th</sup> C. church building is located on the area affected by the impact of underground coal mining. In the past, the building was secured many times against an adverse effect of the mining area deformation by providing massive reinforced-concrete reinforcements. As uneven depressions have emerged, caused by underground coal mining, the structure has become vertically deflected by 39 mm/m in the eastern direction. With the building length of 51 m, the corners have been vertically displaced in relation to each other by 1.99 m. The existing deflection impedes the structure's usage, decreases its value and threatens the stability of its furnishings. The deflection should therefore be removed. Due to the building's historic character and the presence of massive reinforcements installed already during its operation, three scenarios of deflection rectification were assessed. After the assessment, a scenario was chosen where the building is detached with the use of hydraulic jacks in the floor level, and then straightened by uneven raising. The lift

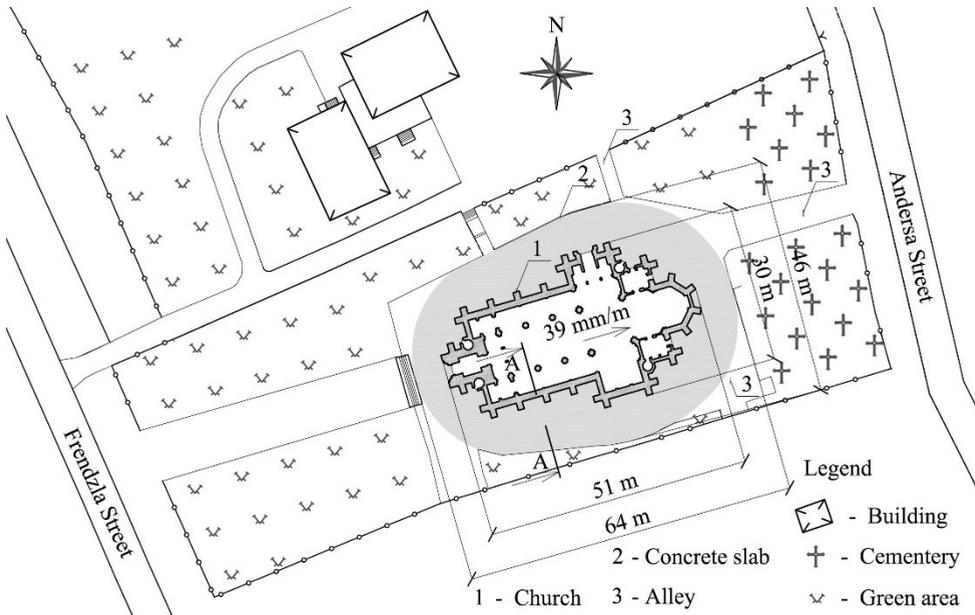
**Fig. 1.** The church building is positioned in relation to alleys, cemetery and green area; the section A-A is in Fig. 2

A cemetery is located in the eastern part of the building, 7 m from the presbytery. It is very important - due to the adopted method of removing the building deflection - that a reinforced-concrete slab attached to the building is situated in the cemetery limits from the church side (Fig. 1). Alleys used by pedestrians are situated between the cemetery and the presbytery and around the church, directly by its walls (Fig. 1). Vehicles move along the alleys during bigger events or during funerals.
