Cracking of the Vault in a Church Building and Activities Undertaken in the View of the Further Mining Exploitation

Abstract. The paper concerns a church building, where as a result of mining exploitation a number of damages have been observed, including cracking of the nave. The method of repairing the damage was presented. Taking into consideration the further planned mining exploitation, a concept was put forward to reinforce the church with steel tie rods at the level of the vaults over the nave, which will provide for its protection against adverse impact of the tilt of the land surface.

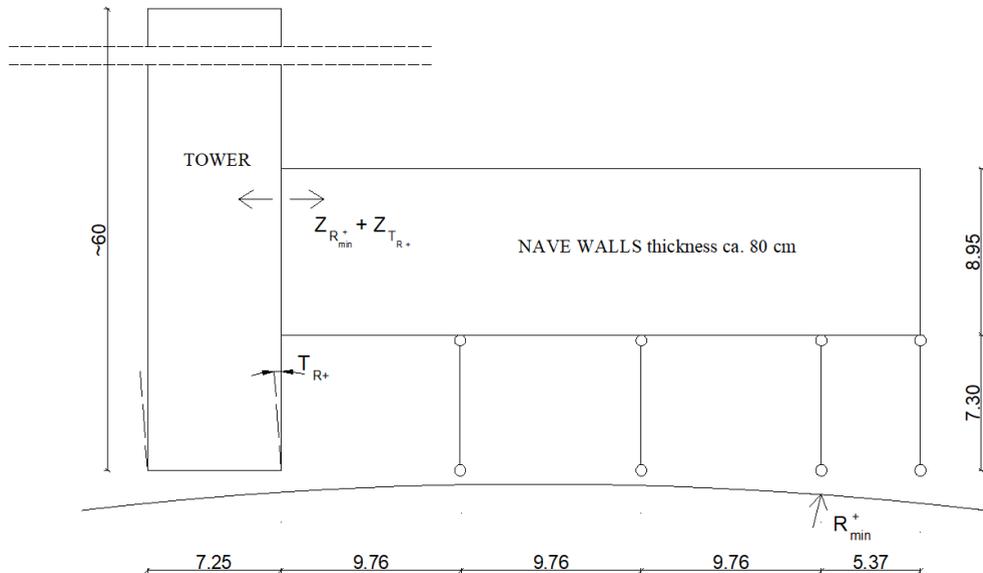
Fig. 10. The calculation scheme resulting from the simultaneous impact of R^+_{min} and T_{R^+} (dimensions in m)

- the impact of the slab encompassing the outer walls of the church,
- reduction of the tensile stress in the lower parts of the walls by the influence of the curvature.

In such circumstances, the structure loading diagram should be assumed in a simplified manner as in Fig. 10.
