About problems with cast iron columns of the revitalized post-industrial buildings

Tadeusz Urban¹, and Michał Goldyn^{1,*}

¹Lodz University of Technology, Department of Concrete Structures, al. Politechniki 6, Łódź, Poland

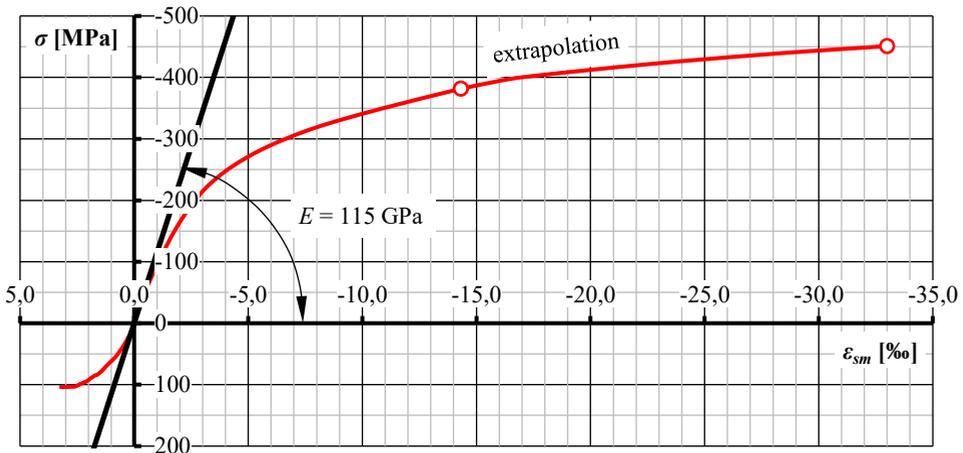
The obtained ratio of compressive to tensile strength $R_c/R_t = 4.34$ was characteristic for a brittle material. This value is slightly lower than the ratio $R_c/R_t = 6$ conventionally assumed for typical 19th century cast iron. Based on the strain measurements, a stress-strain diagram was made for the entire stress range – see Fig. 3. Due to the maximal measuring range of strain gauges, only measurements below 15‰ could be considered as reliable. However, by extrapolation, the maximum shortening at fracture $\varepsilon_{s,c} = 33\text{‰}$ was estimated. Considering only the range of elastic deformations, the secant modulus of elasticity was set equal to 115 GPa.

Fig. 3. Stress – strain relationship determined according to destructive tests.

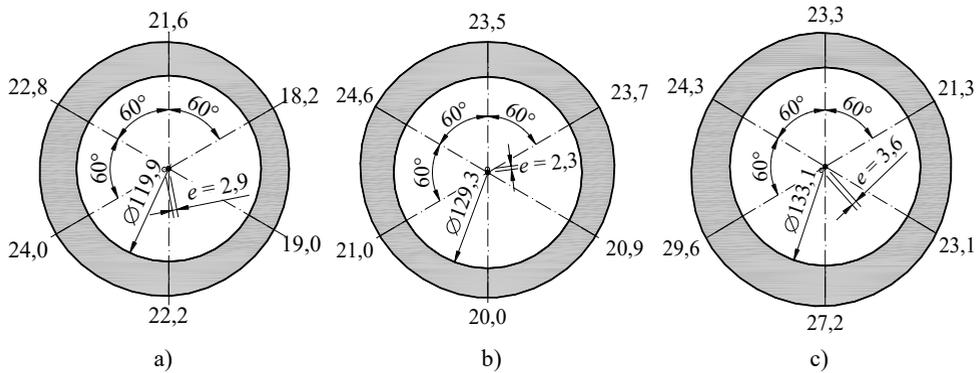
The subject of the main study was a cast iron column with a height of about 3,1 m and a non-prismatic section, gradually decreasing from the base towards the head. Due to the method of casting the element, the wall thickness was not constant around the perimeter. The extent of the actual diameter deviates from the idealized ring as evidenced by the measurements of the column wall thickness shown in Fig. 4. In the vicinity of the column head, it varied from $18.2 \div 24.0$ mm, while at the base it was $21.3 \div 29.6$ mm. The inner diameter was 119.9 mm and 133.1 mm at the head and at the column base respectively. Asymmetry of the cross-section resulted in low geometric eccentricities, accounting about $e = 2.3 \div 3.5$ mm.

Fig. 4. Cross section of the column at the distance of: a) 0.10 m, b) 1.80 m, c) 2.80 m from the base.

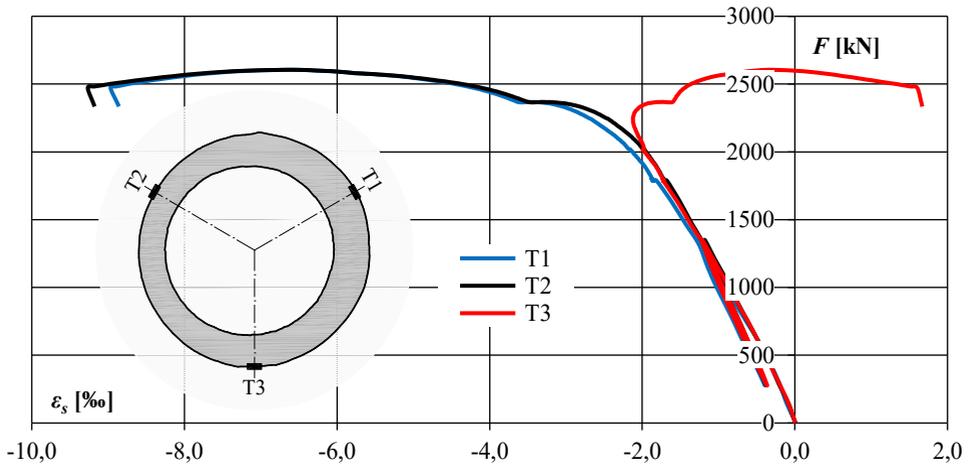
During the test, deformations at half of the column height at three points spaced evenly around the perimeter were recorded – see Fig. 7. As a result of the column unloading in the first phase of the test, by a load of about 1400 kN, a permanent deformation of approximately $\Delta\varepsilon = 0.20\text{‰}$ occurred. Increasing the column load resulted in an even increase in deformation on all of the surfaces. At a load of about 2000 kN (accounting for about $\sim 77\%$ of the ultimate force), the average strain of the cross section was about $\varepsilon_{sm} = 2.0\text{‰}$ ("- means compression). As the load was increased, a gradual decrease and then a change in the nature of the strains measured in the measuring base T3 was recorded. At the maximum load $F_{max} = 2605$ kN, the deformations at the aforementioned place were close to zero ($\varepsilon_{s3} = -0.3\text{‰}$), while at the moment preceding failure they amounted to $\varepsilon_{s3} = 1.65\text{‰}$ (tension). This deformation was therefore about twice lower than the strain at rupture by tension test. The change in stress (from compression to tension) occurred only in the vicinity of the T3 base. In the other two measurement points, during the tests only compressive stresses were recorded. The maximum measured strains were about -9.0‰ – much lower than the ultimate strains at fracture of the cylindrical samples ($\varepsilon_{sm} = -33\text{‰}$). The failure of the column was therefore a consequence of exceeding of the material strength on the tensioned side, due to deflection resulting from buckling and not from fracture of the iron in the compressed side of the cross section.

Fig. 7. The results of measurements at the half of the column height.

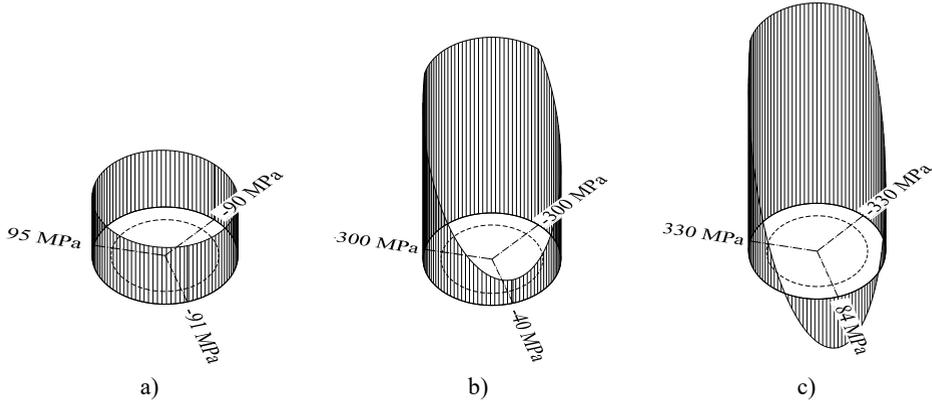
In the Figure 8 the distribution of stresses in the column cross section, according to the load level, was shown. At the ultimate load F_{max} , the maximum tensile stresses were 7.5 times lower than the maximum compressive stresses in the cross section. Right before failure the maximum compressive stress was 330 MPa while tensile stress 84 MPa, which constituted respectively: 73% of compressive strength and 81% of tensile strength.

Fig. 8. Distribution of the stress in the column cross section (at the half of the height) according to load level: a) $0.4 F_{max}$, b) F_{max} , c) at the moment preceding failure.
