The analysis on causes of failure and strengthening of foundation slab with pre-tensioned CFRP stripes

Abstract. The paper presents an example of failure of the foundation slab of a complex of multi-storey buildings and an analysis of the complex reasons of its origin. In addition, the method and technology of the repair was presented in conditions of continuous, though limited operation of the facility, taking into account the existing limitations. The repair involved the necessity of performing specialized preparatory works, proper assembly and protection of the designed strengthening.

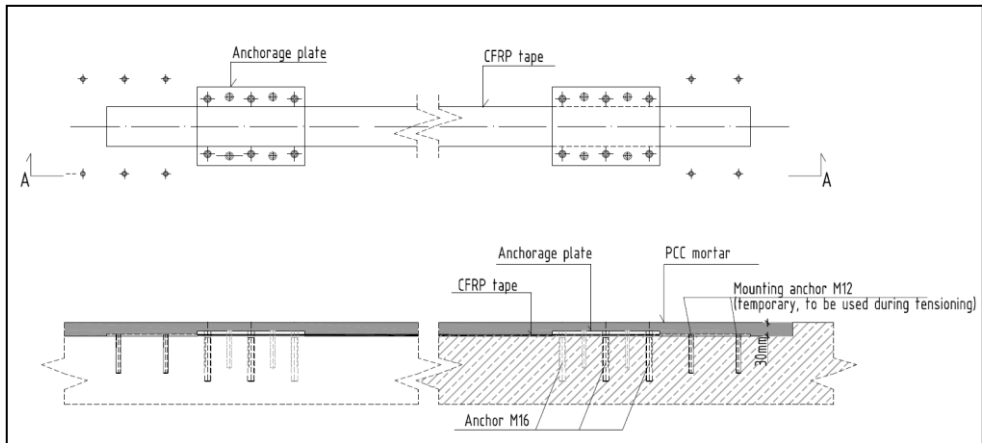
In particular zones, by means of subsequent iterations, the required composite reinforcement was determined to obtain the expected capacity for the strengthened slab and that the crack size does not exceed 0.30 mm. Strengthening stripes with a minimum elastic modulus of 170 GPa and a cross-section of 140 mm² (Fig. 5) were assumed to be assembled.

Fig. 6. Scheme of a pre-tensioned stripe with anchorages.

After installing the drainage system and performing the injection to pre-protect the strengthening zone against flooding, prestressing was started. Since the entire facility was operated during the repair, all loud works were carried out at night. The assembly of stripes was planned in the spans of a 0.40 m thick slab perpendicular to the existing cracks. In order to place the pre-tensioned stripes in the slab's structure, narrow cuts were first made in the top concrete cover to a depth of approximately 30 mm (Fig. 6). Then the anchoring elements were prepared and the stripes were assembled using prestressing force in the range up to 120 kN. Initial prestressing was achieved by hydraulic jack (Fig. 7, 8), and the level of prestressing was controlled by means of a manometer on the jack and by controlling the deformation of the stripe. The tension control was carried out on the base section between passive and active anchorage. The beginning of the base section at the passive anchorage was the place where the stripe was clamped in the clamping jaws, while the end of the section and the point of strain measurement was the area in the direct vicinity of the active anchorage. Due to the local occurrence of leaks, the epoxy resins binding in a moist environment were used during assembly of the stripes.
