Analysis of stabilisation method of gable walls of a barrack located at the section BI of the former KL Auschwitz II-Birkenau

Abstract. The subject of the article is an analysis of the stabilisation method of the western gable walls of a barrack with the inventory number B-123, situated at the section BI of the former German Nazi concentration and extermination camp Auschwitz II-Birkenau. The barracks of the former Birkenau have a documentary and historical value and are subject to protective conservation. A barrack with inv. no. B-123 had been erected in the last months of 1941 as a residential barrack, then it was used as a hospital facility. The barrack walls are characterised by low stiffness, because with the building's plan of 36.17 m × 11.39 m, the walls are only 0.12 m thick. Gable walls have been greatly deformed, as a result they have detached from longitudinal walls and their deflection is up to 120 mm. The construction of the walls is at risk, because a bad-quality wall is loaded with horizontal and vertical forces transmitted from the roof, on the eccentricity reaching 120 mm. Deformations are progressing as a consequence of such forces and the walls must be stabilise

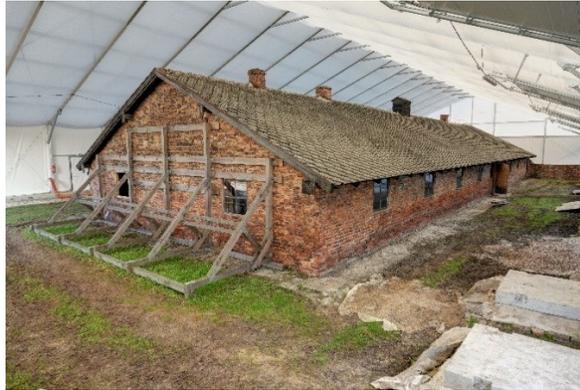
The barrack, with a current inventory number B -123 (camp number, Fig. 1), was built in the last months of 1941. Initially, it had been a residential barrack, and then, in the second phase of the camp's existence, it was used as a camp hospital. Some of the internal walls are covered with original plasterwork of high historical importance. The barrack's gable walls have been largely deformed, by being detached from the inner stiffening wall, with the deflection of up to 120 mm. The deflection has been constantly growing, hence it is necessary to stabilise the walls.

Fig. 1. View from the west of residential barrack with a current inventory number B -123.
