Anatomy of Failures: Stability Requirements in All Stages of Operations

Piotr Moncarz^{1*} and Cliff Bishop²

1 The KTVO Tower Collapse

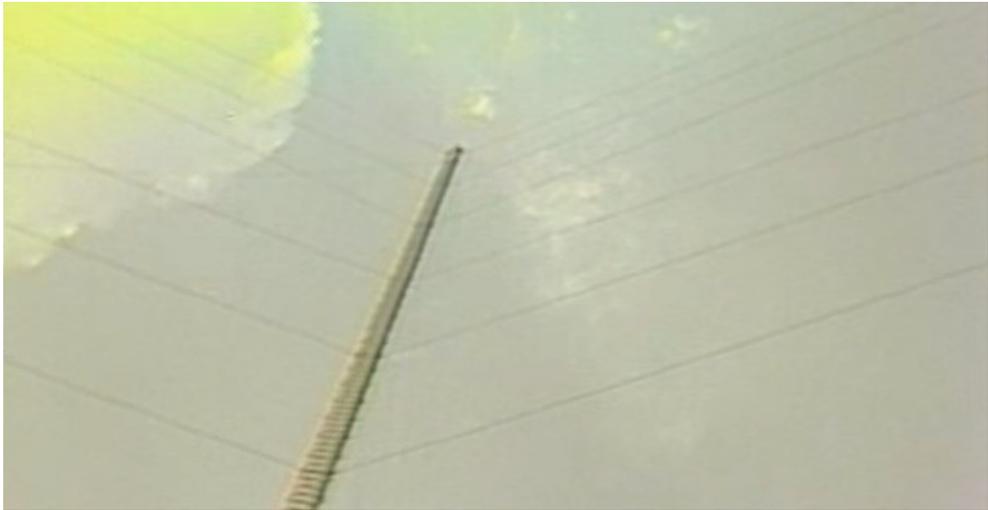
Fig. 1. KTVO-TV Tower. [Image Source: KTVO-TV (ABC)].

The 581 m (1905 feet) tall (or 610 m tall including the top mast) KTVO Tower (Tower) was erected in Colony, Missouri, United States of America, in September of 1987. The tower was completed in September of 1987 with a total price tag of \$2.5 million USD (equivalent to \$5.6M USD in 2019). At the time of erection, this was one of the tallest towers in America – over twice the height of the Eiffel Tower. The Tower consisted of one central spire supported by guy wires (Fig. 1).

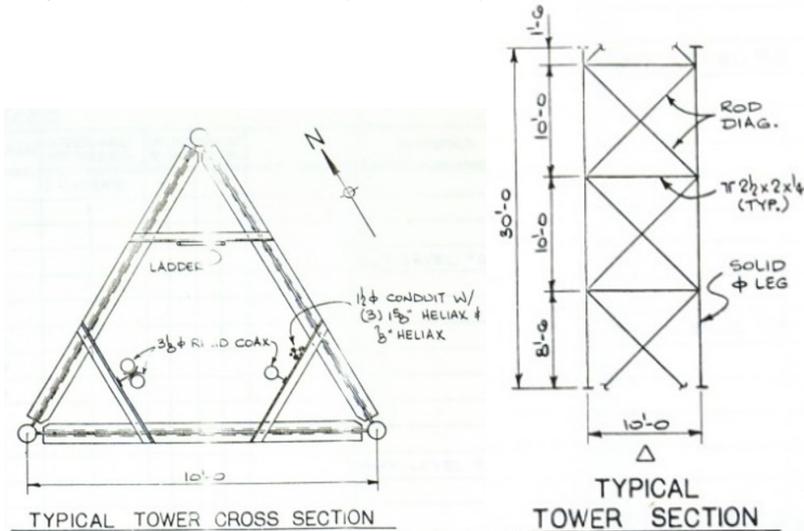
Fig. 4. Tower layout (plan at left, elevation at right).

The tower was triangular shaped in plan and had diagonal x-bracing between corner columns (Fig. 4). The steel member type by component is as follows:

- Three main columns – solid round steel ranging in diameter from 159 mm (6-1/4 inch) at the bottom of the structure to 102 mm (4 inch) at the top. The columns came in length of 9.1 m (30 feet) with bolted splice plates welded at the end of the column. Three tiers of diagonally braces were attached to the column segment as shown in Fig. 4;

- Horizontal truss members – steel double-angles;
- Internal diagonal bracing – round steel bars. The bar diameters were 25 mm (1 inch), 21 mm (7/8 inch), 19 mm (3/4 inch), and 16 mm (5/8 inch). At the ends of the bars, connecting plates were welded to provide a bolting connection to joint tabs welded to the legs of the tower. To avoid net compression in the diagonals they were fabricated shorter and mounted under tension (potentially up to the yield level) in their final configuration; and

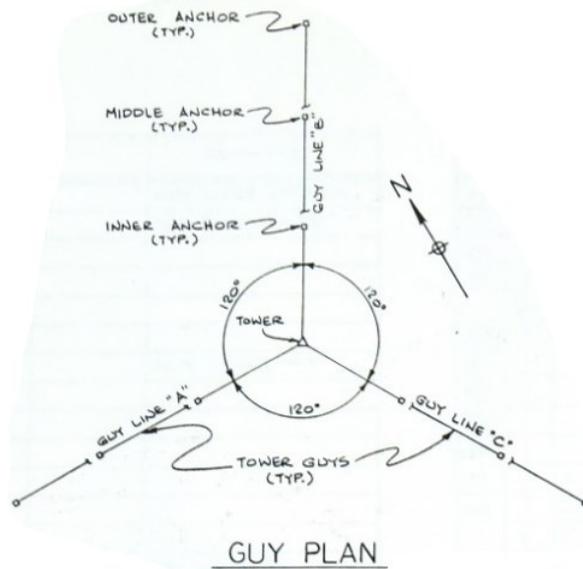
Fig. 5. Guy wire configuration in plan.

There were a total of thirty guy wires installed over the height of the Tower; ten sets of three, radially positioned at 120 degrees from the Tower's center (Fig. 5). The guy wires were anchored to the ground at three anchor points at each azimuth: 3 lowest elevation lines were anchored at 145 m from the center of the base of the tower, 3 higher elevation lines were anchored at 290 m from the center, and the 4 top elevation lines were anchored 411 m from the center.

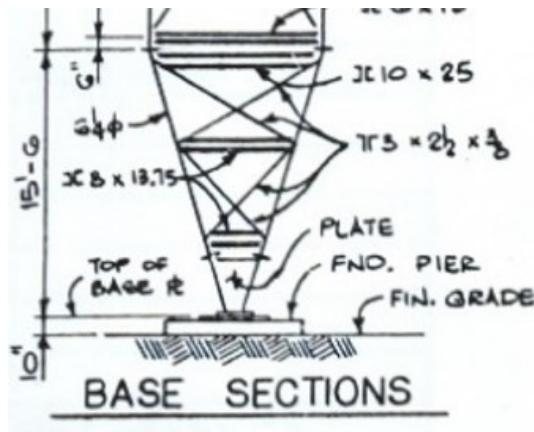
Fig. 6. Tower tapered into a single point at the bottom elevation.

The bottom 15 feet of the Tower tapered as a pyramid to a single point (Fig. 6). The base of the tower was anchored to a 250 mm (10 inch) thick steel base plate which was then anchored with bolts into the concrete foundation.

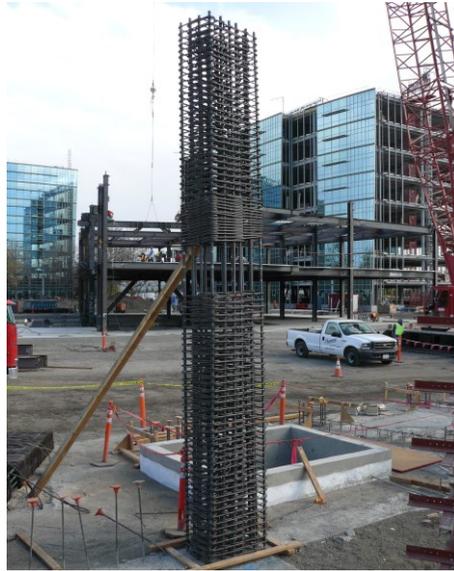
Fig. 10. Reinforcing cage with temporary bracing.

Another common occurrence where an engineer does not often contemplate a work plan is in the erection of column reinforcing cages. In the United States, the erection of structures is often left to the contractors' means and methods; therefore, there is rarely a comprehensive plan to address stability concerns before the structure is completed. For the case of concrete construction, the reinforcing cage is often tied together on the ground, lifted into place using

a crane or hoist, and then secured in place using temporary bracing (**Fig. 10**). The location, quantity, and type of bracing installed is often based on the wisdom and experience of the iron worker.
