# Corrosion as a cause of the failure of the pipeline steel supporting structure

**Abstract.** The article describes the failure of the steel supporting structure of the pipeline caused by corrosion. The structure in question is a three-span steel bridge with truss girders. The structure was erected in the 1960s and is located above the railway track. Due to the specific shape of the hinges, which join the middle span with the rest of the structure one of them was damaged by corrosion, which caused it to break off. That led to situation where the middle span was retained by only three joints. To achieve proper safety of the structure it was additionally supported and strengthened. Due to the necessity of quick repair (there was a real threat of a collapse), some of the works performed had a provisional character. The article presents a description, detailed causes for failure and all the works, which were carried out in order to protect and repair the structure. The analysis of this case showed that, despite adequate protection of structural elements against corrosion, improper design resulting in retaining water led to serious failure.

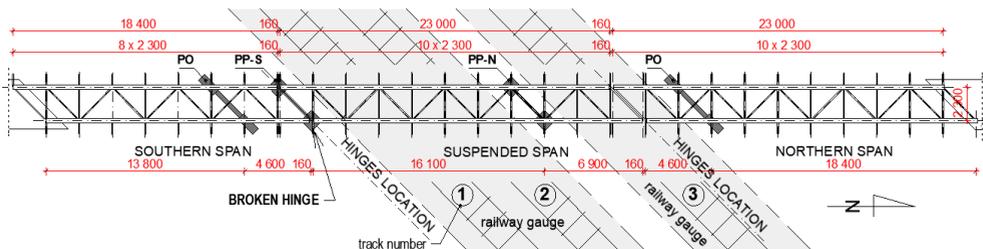
The steel supporting structure of the water supply system 2Ø600 is located above the dual-track of electrified national railway line and the electrified railway line running beyond national borders. The construction diagram is shown in Fig. 1.

**Fig. 1.** Plan of the supporting structure (PO – structural supports, PP-S – southern temporary supports, PP-N – northern temporary supports).

Initial, most crucial task was to support the middle span at the location of the broken hinge. The temporary support, considering available materials, was erected in the form of two columns consisting of  $\text{Ø}244.5 \times 8$  steel pipes with height of 5.62 m (PP-S support in Fig. 1 and Fig. 7 b)). The column heads were placed at the level of the lower chords of the middle span. The top of the eastern column was thus at the level of the chord, after it had been torn off. The base of the columns were made of 500x500 mm base plates with a thickness of  $t = 20$  mm and stiffened with four ribs ( $h = 450$  mm,  $a = 190$  mm,  $t = 10$  mm). The column bases were placed on five 14 cm thick reinforced concrete slabs. The slabs are enclosed in C140 frames. The column heads were permanently welded to the structure of the supported span. The column bases were not fixed to the concrete slabs. Instead, the slabs were covered with railway gravel from three sides. Temporary supports were installed directly to the east, outside the railway clearance gauge of track no. 1 (Fig. 1). Installed columns provided protection from span collapse, however the span was not in a safe distance from catenary wire.

- suspending the middle span to the side spans at the location of all hinges (Fig. 8), while leaving three original hinges with an uncertain degree of reduction of load-bearing capacity,
- use of temporary supports supporting the middle span in the southern hinges of both main girders and installing additional support at a distance of 6.90 m from the northern hinges of both main girders (PP-N and PP-S in Fig. 1 and Fig. 7 b)).

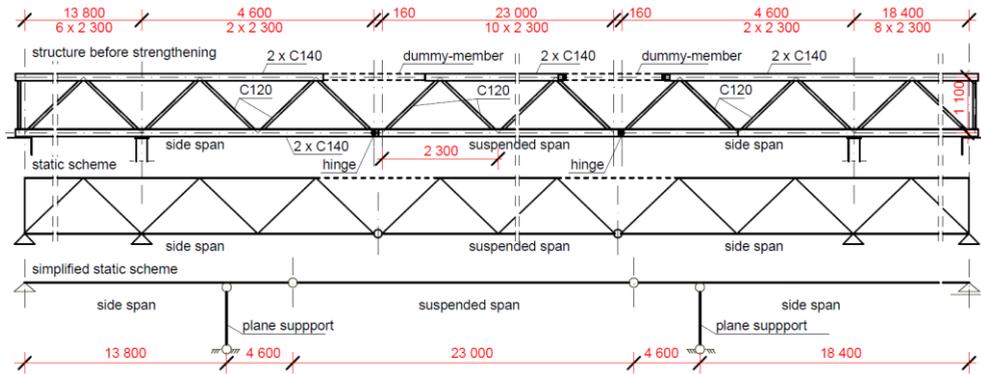
The original steel supporting structure is made as a three spans Gerber beam with truss girders and two plane vertical supports. Abutments and foundations of plane supports are made as reinforced concrete elements and are not the subject of that analysis. The structure was erected in the 1960s before the electrification of the railway line.

**Fig. 2.** Side view of structure and statical scheme.

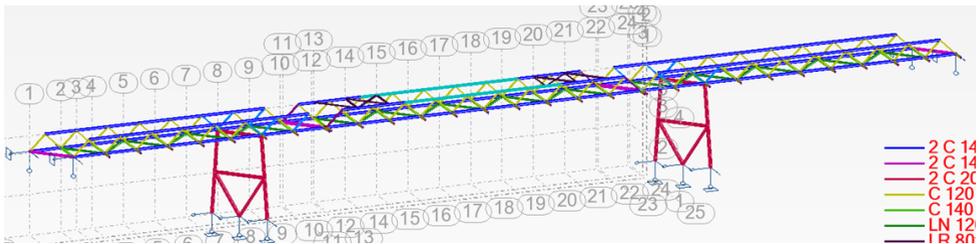
a) MODEL 1

**Fig. 10.** Numerical model of the structure.

- 1) original structure after water mains replacement under full service load in 2015- marked MODEL 1 (Fig. 10 a));
- 2) original structure under full service load at the moment of failure after breaking of the S-E hinge - marked as MODEL 1a;
- 3) structure under full service load after introduction of hangers, assuming that all hinges have been removed and the middle span is attached to hangers only - marked as MODEL 2;
- 4) structure under full service load, assuming that the middle span is supported only by the temporary supports - marked as MODEL 3a;

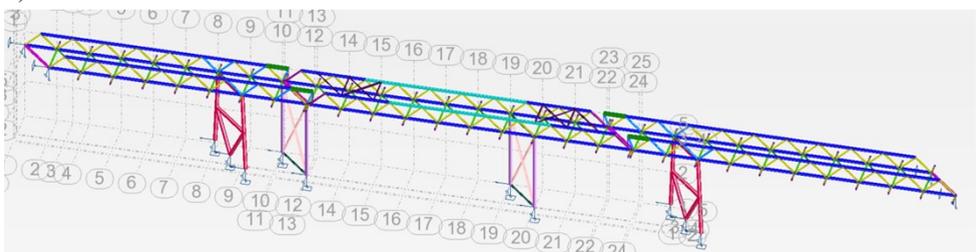
b) MODEL 3

5) structure under full service load in the final system of hangers and temporary supports - marked as MODEL 3 (Fig. 10 b).
