# Failure of a steel boiler chimney caused by corrosion of the structural shell plate

**Abstract.** The article presents issues concerning the corrosion of sheets of the guyed steel chimney with boiler house in an industrial plant. The subject of considerations is a steel chimney with a height of 46.5 m and a diameter of 1.25 m. The chimney was used for seventeen years and did not show any significant corrosion losses. After the change of the way of usage and the fuel used for feeding boilers, the corrosion rate has dramatically increased. The paper presents issues concerning corrosion types and mechanisms of corrosion degradation of the steel. The reasons for the increase of corrosion velocity within the chimney base were given. The method of chimney renovation and the results of this renovation, detailing the order of works is presented too. Attention was also paid to the proper maintenance of construction works, as periodic inspections themselves may be insufficient to ensure safe operation.

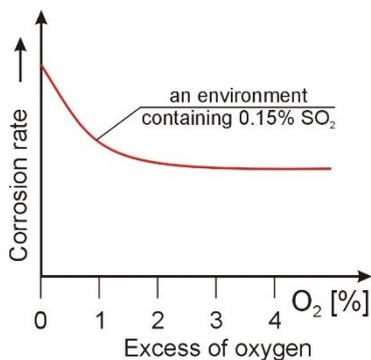
The precipitation water diluted the sulfuric acid concentration, which also caused acceleration of corrosion (Fig. 7), as well as reduced the access of air, which also increased the speed of corrosion (Fig.8) [4]. In addition, the prevailing tensile stresses from wind forces in this part of the chimney, initiated stress corrosion.

**Fig. 7.** Corrosion rate of low carbon steel in the atmosphere of exhaust gases.

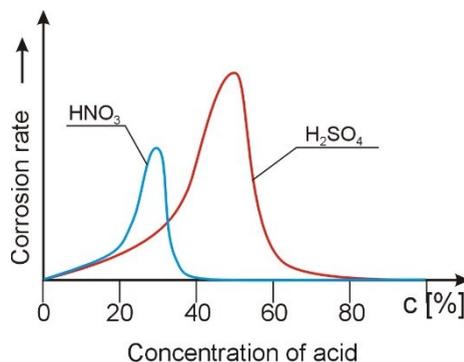
**Fig. 8.** Dependence of the corrosion rate of steel on the concentration of acid.
