Condition assessment and service life prediction of a marine concrete structure: an interesting case study

Joost Gulikers*

*Ministry of Infrastructure and Water Management, Rijkswaterstaat GPO, P.O. Box 2232, 3500 GE Utrecht, Netherlands

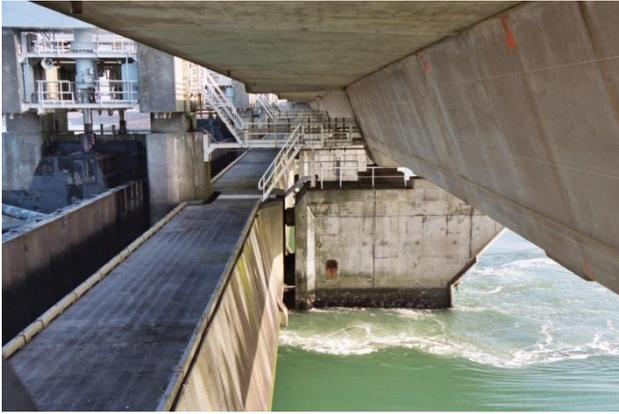
Fig. 1. View of the location and exposure conditions of the walls of the box girder bridge.

The lowest part of the bridge is located at a level of +6m above MWL whereas the bridge deck is at a height of +11.75m above MWL. All elements of the box girder bridge are T-shaped which implies that the concrete faces on the underside are sheltered from rain and other precipitation. In addition, the presence of sliding doors located in front at the North Sea side will shield a significant part of the concrete surfaces. Consequently, the environment can be described as predominantly atmospheric with exposure to chlorides contained in aerosol, and occasionally seawater spray and incidentally splash (during periods of storm when the sliding doors are lowered).

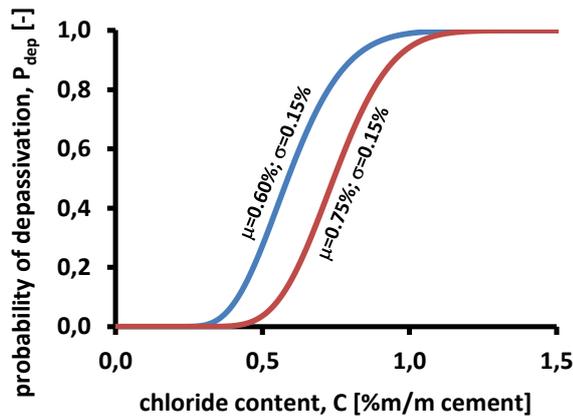
For the ageing factor a beta distribution was used with a mean of $\mu n = 0.75$ and a standard deviation, $\sigma n = 0.05$. For the lower and upper boundaries, a minimum $a = 0.0$ and a maximum $b = 1.0$ were chosen. For the critical chloride content, a beta distribution was applied with $\mu C_{crit} = 0.75$; $\sigma C_{crit} = 0.15$; $a = 0.20\%$ and $b = 2.00\%$, see Fig. 7.

Fig. 7. Distribution of the probability of depassivation for the critical chloride content as adopted in the probabilistic calculations.
