ASR: Practical investigative techniques and field monitoring systems used to assess ASR for service life modeling.

Irene Matteini^{1,*}, Paul Noyce², Gina Crevello³

¹ Echem Consultants, Technical Operation Manager, New York, USA

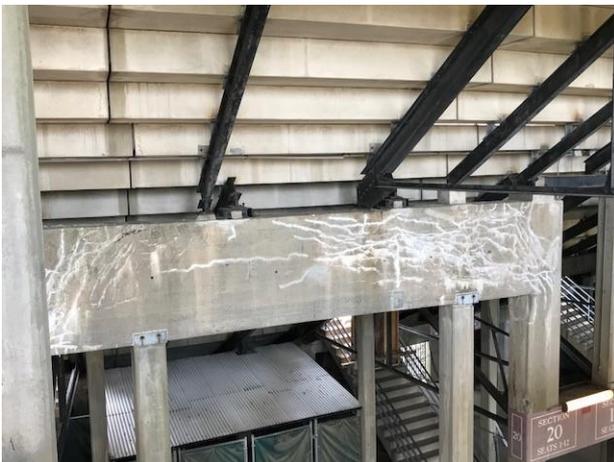
This swelling has the potential to induce tensile stresses within the concrete and can lead to the appearance of cracking with a pattern that depends on the geometry of the structure, and the layout of the reinforcement. [4] The typical cracking pattern is so called “map-cracking” which consists of a network of cracks randomly distributed from which a whitish gel will leach out of the concrete as illustrated in Fig. 3.

Fig. 3 Typical ASR Crack Mapping. Courtesy of Echem Consultants.

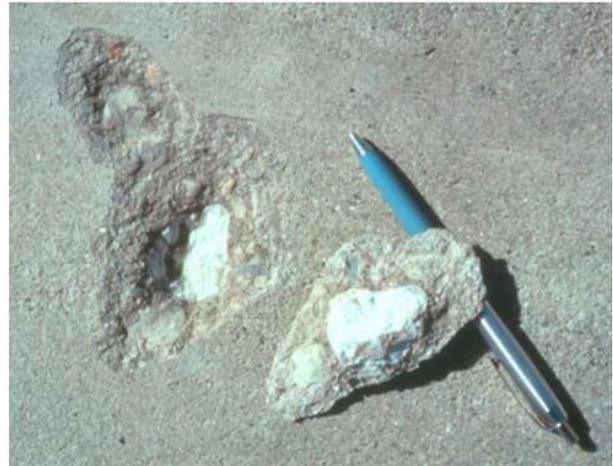
Besides the typical crack mapping of ASR, another typical ASR form of deterioration is referred to as “Pop-outs”. This consists of a reactive aggregate undergoing expansion causing the concrete to detach leaving the reactive aggregate behind. [5] This is generally a localized phenomenon as shown in Fig. 4.

Fig. 4 “Pop-out” effect of ASR deterioration. [4]

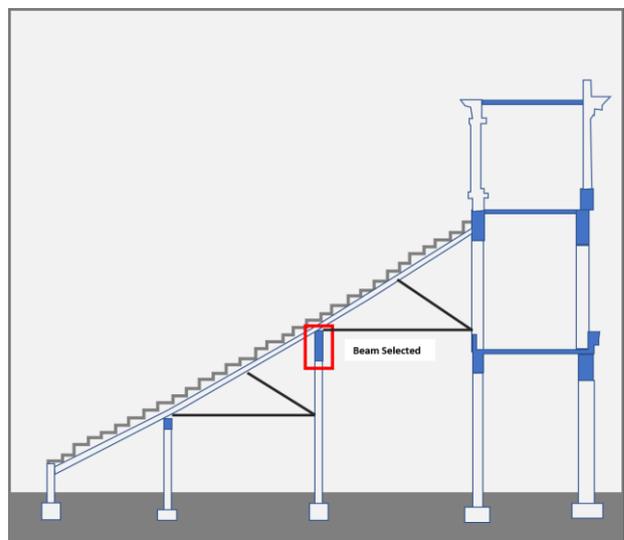
Due to limited time and budget, one beam was selected for extensive monitoring. This beam represents a main component of the structure as shown on the drawing below.

Fig. 12 Diagram representing the main cross section of the stadium. One beam was selected for this monitoring program. Courtesy of Echem Consultants.

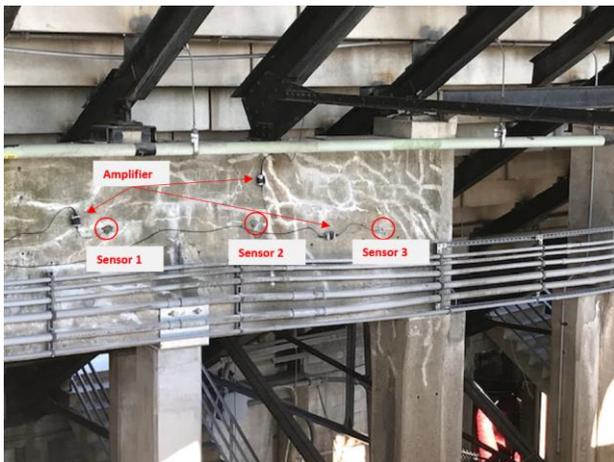
A sample of a recorded ultrasonic signal is shown in Fig. 17. For each transducer, a 25 mm diameter hole was drilled to the middle of the beam and properly grouted, as shown in Fig. 18. Each transducer is connected to a pre-amplifier (Vallen AEP4) located close to the transducer. The transducers were embedded in one beam located 1.5 meter (5 ft) apart, acting both as transmitter and receivers, as shown in Fig. 19.

Fig. 19 Photo showing the installation locations of the three transducers at the beam. Courtesy of Echem Consultants.

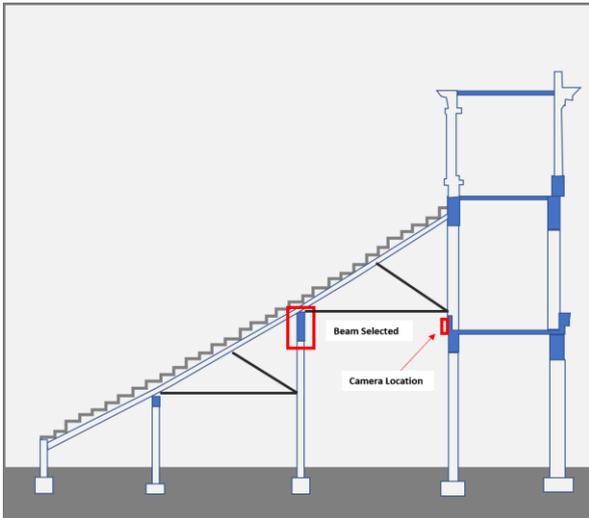
Fig. 20 Diagram showing the location of the camera in relation to the beam. Courtesy of Echem Consultants.

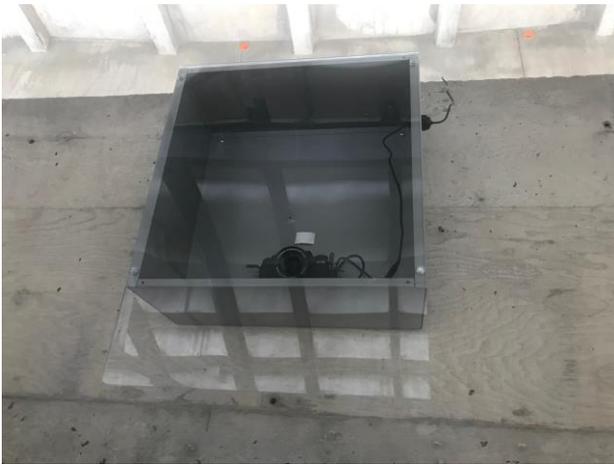
At the stadium, a camera has been installed twenty-five feet (7.6m) from the beam in order to obtain an image representing the component in its entirety as shown in Fig. 21. A Fujifilm X-T2 mirrorless camera has been used to collect one picture every four hours. After collection, the pictures are processed by using Matlab. The software overlaps pictures and elaborates the pixels to determine changes in the component.

Fig. 21 Picture of the Camera Box installed at the stadium. Courtesy of Echem Consultants.
