# Structural condition assessment of a reinforced concrete driveway

**Abstract.** The reinforced concrete structure of a driveway built in the eighties of the 20<sup>th</sup> century is under consideration. It is a single-storey structure with a length of approx. 66.00 m, made in the form of a reinforced concrete skeletal structure, consisting of 7 frames with cantilevers, spaced at 9.00 m: 3 frames in the horizontal part of the driveway are three-span ones, and 4 in the sloping part are single-span frames. The driveway frame main beams have a rectangular cross-section and are based on pillars that have been placed on the spread footing - these elements form a monolithic structure. Prefabricated reinforced concrete hollow floor plates were laid on them in the central part of the driveway, and in the outer parts the driveway floor was made of hollow clay slab blocks (Ackerman type). At the time of investigation, the upper layers of the driveway consisted of a surface waterproofing layer, a concrete slab of approx. 10 cm thickness made on a 1 cm sand layer. However, no internal waterproofing layer was found as was in the original design. The paper describes the process of determinin

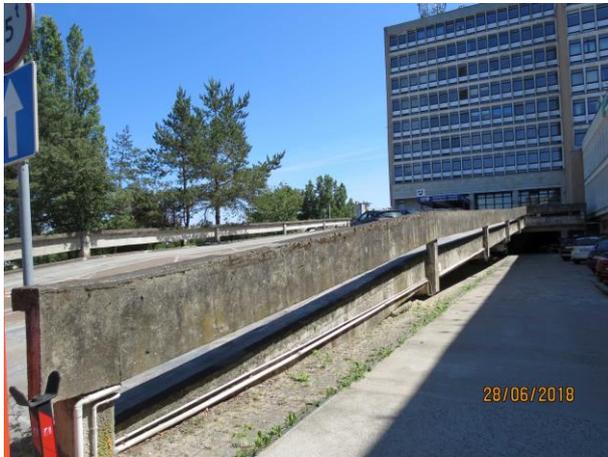
**Fig. 5.** General view of the driveway in 2018.

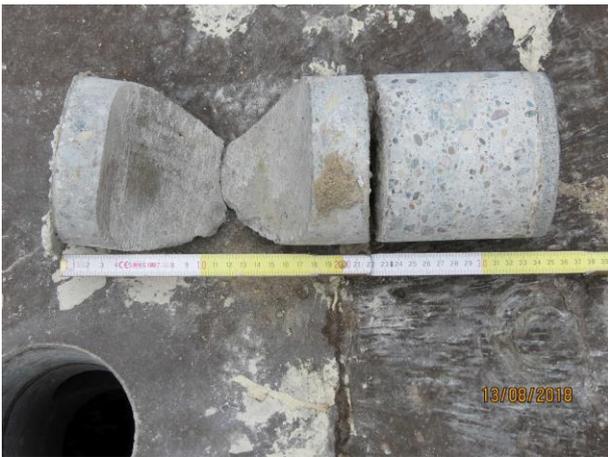
The following layers of driveway floor were found on the basis of the core drillings made in the places where the prefabricated hollow plates constitute the slab - from the top of the slab (Fig. 9):

- coating of waterproofing material on the leveling layer – 1.0-1.5 cm;
- main concrete layer – 10 cm;
- sand and cement bedding – 1 cm;
- prefabricated hollow slab – 24 cm;
- plasterboard – 0.5 cm.

**Fig. 9.** Core drilling through the driveway slab.
