Structural failure of old reinforced concrete river wharf

Abstract. According to the archival documentation the river harbour wharf was constructed around 1912. The quay was divided into 6 separated segments with a length of 32.0 m each. The structure of the wharf consists of the reinforced concrete frames situated perpendicularly to the riverbed. At ground level, the frames are connected by a reinforced concrete deck and longitudinal beams, located along the side of the river and the quay. The frames are also connected along the riverside by the concrete cap situated at the top of the retaining wall made of prefabricated panels and embedded in the bottom of the river. That wall constitutes a direct strengthening and protection of the embankment against the influence of the flowing river water. Basing on the performed inventory inspections, material examination, structural calculations and hydro-geotechnical analyses, the main reasons for the failure of the reinforced concrete wharf of the Odra River were defined. They were: very poor technical condition of the structure, lack of stabilizing anchors at the level of the wharf structure frames, and sudden fluctuations in water level

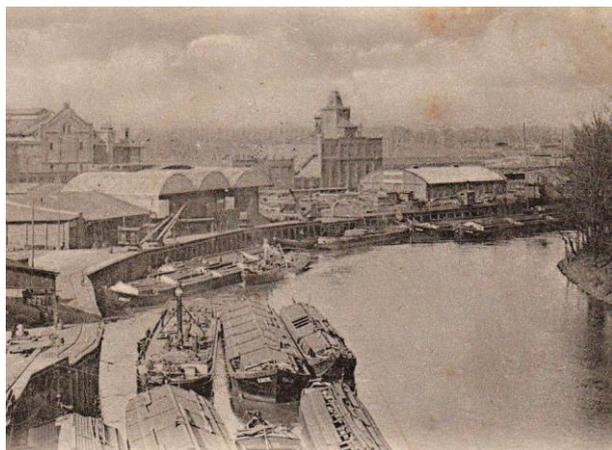
The discussed wharf which, according to the archival documentation, was constructed around 1912 (Fig. 1), is situated on the left bank of the Odra's southern channel in Wrocław. The wharf was designed and erected by the Schlesische Betonbau Gesellschaft for the Schlesische Dampfer Compagnie founded in 1887. In the following years, the company took on a special position in German inland shipping. It was a shipping and warehouse company and owned two shipyards. Its shipping was operated on the Oder, Elbe and the connecting channels.

Fig. 1. Historical view of the wharf.

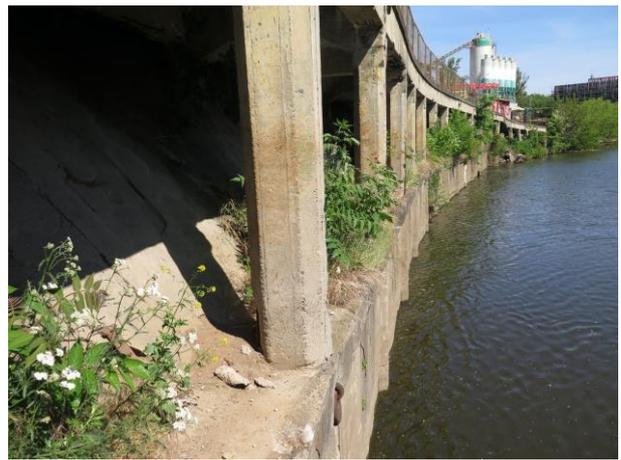
At present, the following elements of the reinforced concrete wharf structure can be distinguished (Fig. 7):

with a thickness of 0.40 m; in the upper part (3.30 m high), from the river side, the frame is made of a vertical pillar with an octagonal cross section of 0.35x0.40 m and an oblique pillar with a width of 0.35 m and variable height from 0.50 to 0.90 m; both pillars are connected at the top by a beam with a cross-section of 0.35 x 0.55 m with slants;

- longitudinal beams, based on pillars of the upper girder of the supporting frames, with a cross section of 0.40x0.55 m; in the segment no. V beams from the river side have a cross-section of 0.30x0.75 m, and from the land side - 0.80x0.75 m;
- the upper slab (deck) of the wharf with a thickness of 0.20 m and width 3.80 m, based on the longitudinal beams, situated along the river and with cantilever of 0.90 m along the line of the land.

Fig. 7. Current view of the wharf structure.

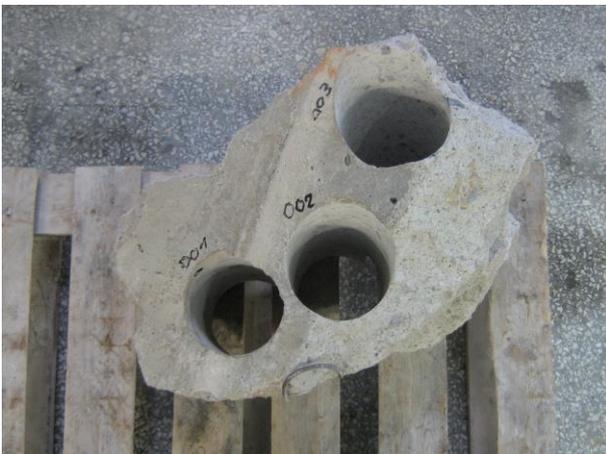
In order to determine the strength of reinforcing steel and concrete, several concrete blocks were removed and a number of reinforcing bars cut from the construction (Figs 16 & 18). Results of those tests (Figs 17 & 19) were used to define the wharf structure material models for structural calculations.

Fig. 16. Concrete probes.

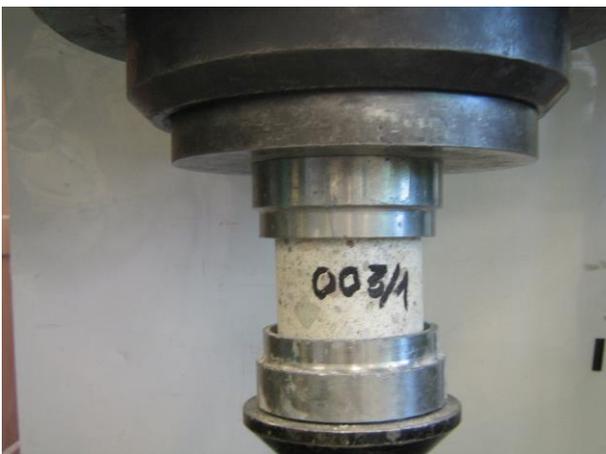
Fig. 17. Concrete testing.

A number of cylindrical samples were prepared and destroyed in accordance with the applicable standard (PN-EN 12390-3:2011) in order to determine the concrete class. The final test results and the strength value determined on the basis of a simple statistical analysis are presented below:

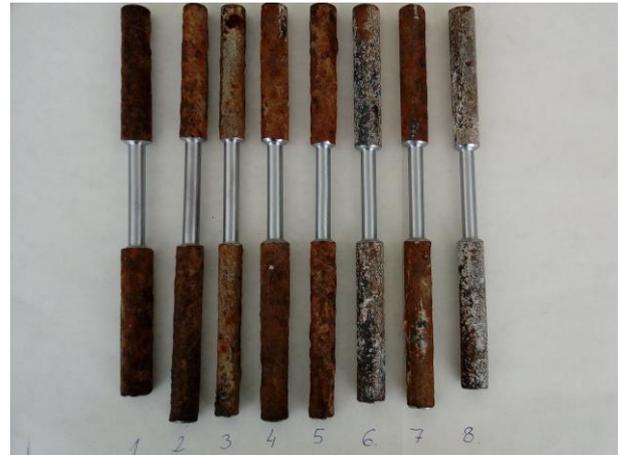
Fig. 18. Rebar probes.

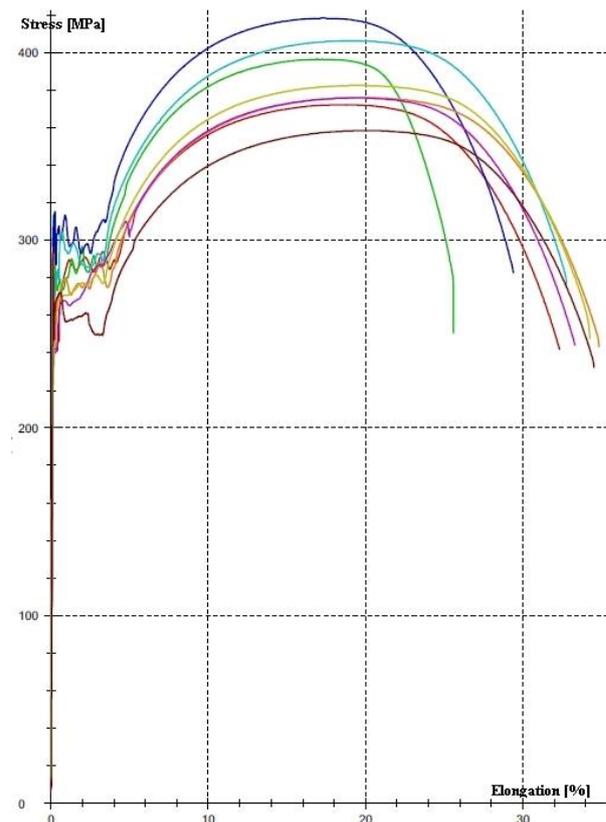
Fig. 19. Rebar test results.
