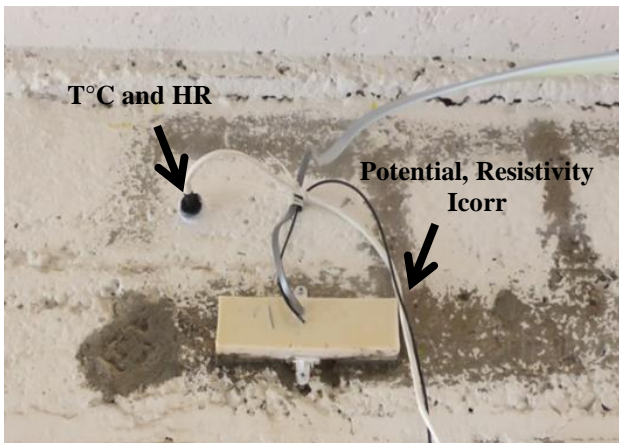
- Temperature and relative humidity in the air (weather station, Fig. 4),
- Temperature and relative humidity in the concrete (Vaisala[®] sensors, Fig. 3),
- Resistance, potential and polarization resistance (dedicated sensor designed by the Spanish company Sensecorr, Fig. 3) equipped with manganese/manganese oxide reference electrodes.

Fig. 3. Temperature, relative humidity and corrosion sensors.

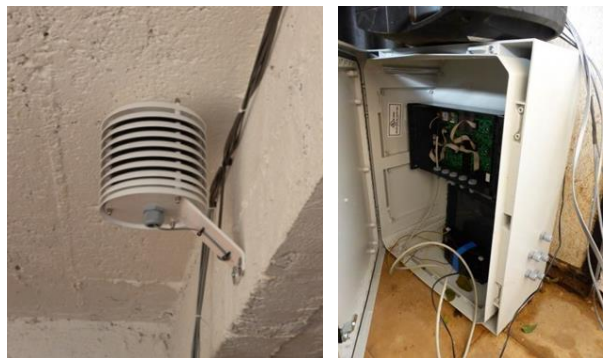
All the sensors were connected to a data acquisition system remotely interrogated by cell phone (Fig. 4).

Fig. 4. Weather station (left) and data acquisition system remotely accessible (right).

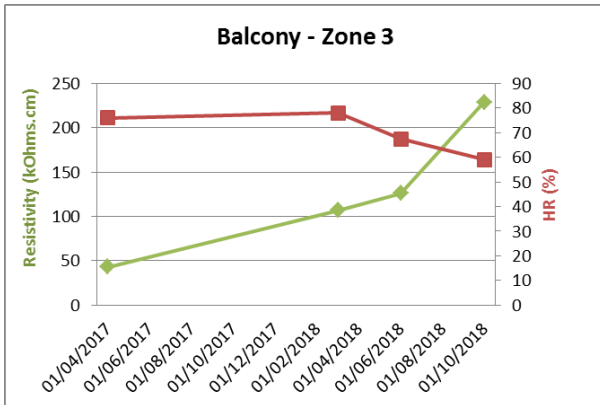
On the following three series of measurements performed in March, June and October 2018, almost similar resistivity and potential maps were observed, with nevertheless an increase of corrosion risk on the lower part of the beam (Fig. 7). A clear correlation could be observed between the evolution of the relative humidity in the air and the resistivity and potential values. Thus, when the relative humidity decreases, the resistivity increases and the potentials tend to less electronegative values (Fig. 8 and 9).

Fig. 8. Evolution of the average resistivity in zone 3 and of the relative humidity in the air.

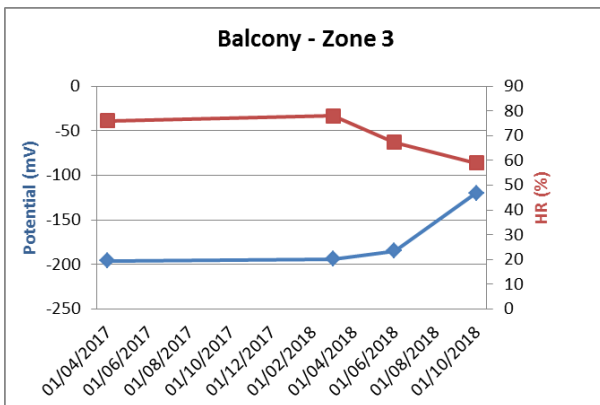
Fig. 9. Evolution of the average potential in zone 3 and of the relative humidity in the air.

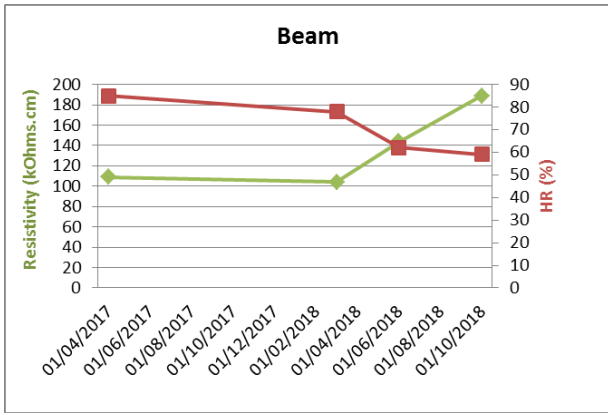
As for the balcony area, similar results were observed on the three following three series of measurements, with again a clear correlation between the evolution of the relative humidity in the air and that of the resistivity and potential (Fig. 13 and 14). If the corrosion currents measured at point B12 were also well correlated (Fig. 15) and indicative of a negligible level of corrosion, at point B23 a continuous increase of the corrosion current could be noticed, in correlation with the opening of a crack (Fig. 16).

Fig. 13. Evolution of the average resistivity in the beam and of the relative humidity in the air.

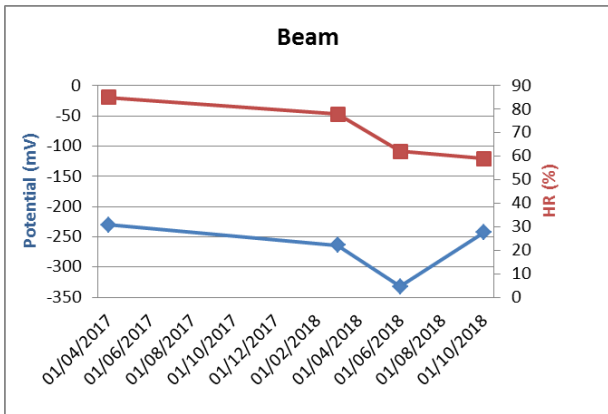
Fig. 14. Evolution of the average potential on the beam and of the relative humidity in the air.

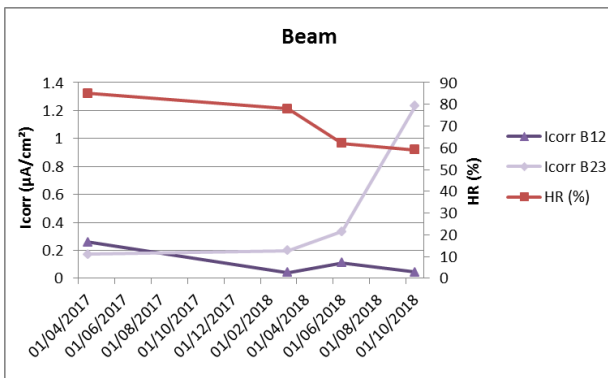
Fig. 15. Evolution of the average corrosion current on the beam and of the relative humidity in the air.

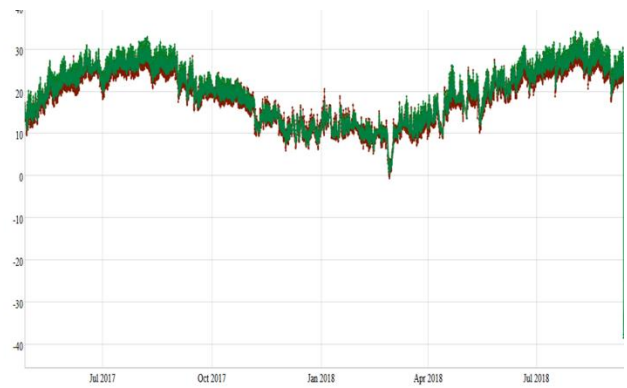
As can be observed on Fig. 17, the temperature measured in the concrete either under the balcony or in the beam, are very similar but also very close to that measured in the air. The three curves are overlapping. During the monitoring period, temperatures in the concrete ranged between 0.5 and 33°C, with a maximum daily amplitude of 5°C.

Fig. 17. Temperature (°C) in the air (brown curve) and in the concrete in the balcony and in the beam (green curve).

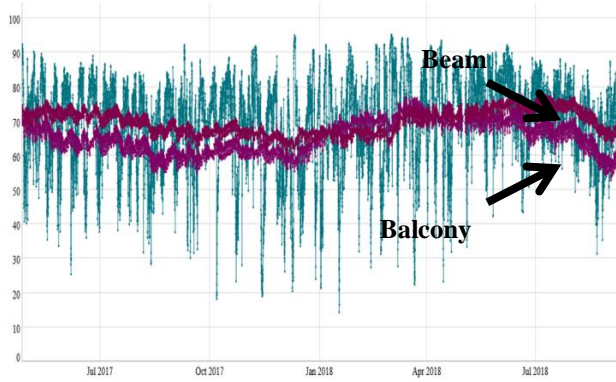
Contrary to the temperature, relative humidity in the air and in the concrete was clearly distinct. Thus it fluctuated a lot in the air, while it was much more stable in the concrete (Fig. 18), which was already observed by several authors [13]. When comparing the results obtained in the 2 zones monitored, it appears that the relative humidity was slightly higher but also less fluctuating in the beam (average: 68%) than in the balcony (average: 63%). Globally, the relative humidity in the concrete was lower in winter and higher in spring. Thus, in the beam, the maximum was reached the 13rd of June 2018 (78%) and the minimum in December 2017 (60%). On the Balcony, the maximum was observed on the 21st of June 2018 (77%) and the minimum in December 2017 (53%).

Fig. 18. Relative humidity (%) in the air (blue curve) and in the concrete in the balcony and in the beam (purple curve).

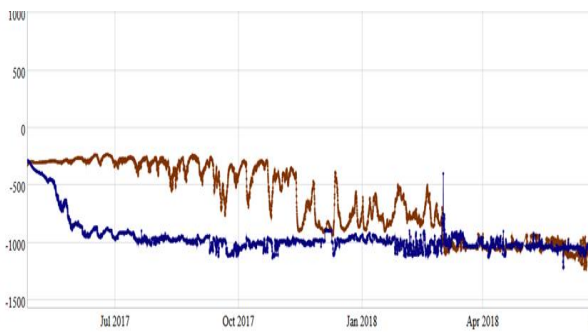
As the two zones monitored were protected from the rain, electrochemical monitoring was an issue. Effectively, the contact mortar used between the sensors and the concrete gradually dried and the measurements became impossible, quite rapidly for the beam and soon after for the balcony (Fig. 19). Nevertheless, the first data were consistent with the non-destructive testing, with corrosion current values lower in the beam than in the balcony (Fig. 20).

Fig. 19. Potential (mV) on the balcony (ochre curve) and on the beam (blue curve).

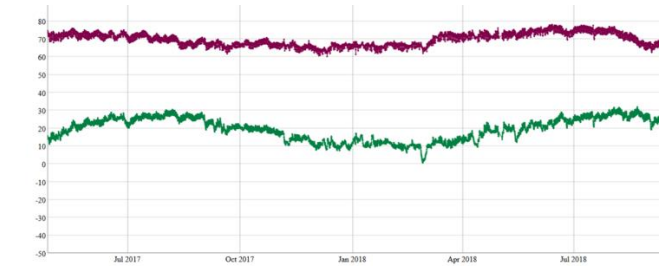
As the testing zones were sheltered from the rain, the relative humidity in the concrete was quite low (yearly

average between 63 and 68%). Several studies evidenced a critical threshold of relative humidity between 60% and 70%, below which corrosion is supposed to be negligible [14] [15]. On this basis, the corrosion currents observed on the 2 tested zones of the villa could be surprising. But other authors evidenced that this threshold can vary depending on the exposure of the concrete (rain and temperature...) [13], and the carbonation and/or chloride pollution of the concrete [3]. Thus for a carbonated concrete, depending on the chloride content the relative humidity below which corrosion is negligible, can decrease to 40% [3]. This could be linked to both the hygroscopicity of the chloride salts and to the aggressiveness of the combined carbonation and chloride pollution for the corrosion of reinforcing bars.

Fig. 21 Temperature ($^{\circ}\text{C}$, green curve) and relative humidity (%) in the beam (purple curve).
