Corrosion at low moisture content in both carbonated and chloride polluted concrete – Villa E-1027, a case study

Elisabeth Marie-Victoire^{1,*}, Myriam Bouichou²

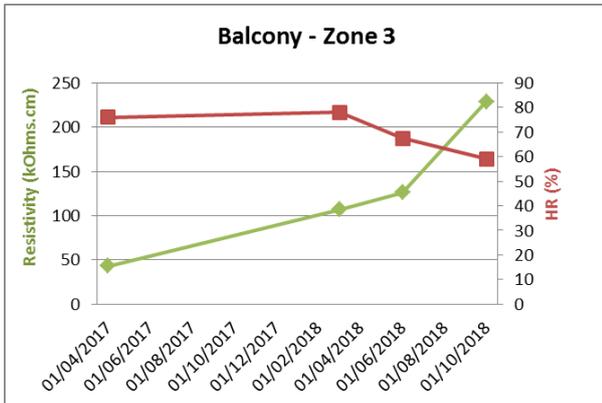
Fig. 8. Evolution of the average resistivity in zone 3 and of the relative humidity in the air.

On the following three series of measurements performed in March, June and October 2018, almost similar resistivity and potential maps were observed, with nevertheless an increase of corrosion risk on the lower part of the beam (Fig. 7). A clear correlation could be observed between the evolution of the relative humidity in the air and the resistivity and potential values. Thus, when the relative humidity decreases, the resistivity increases and the potentials tend to less electronegative values (Fig. 8 and 9).

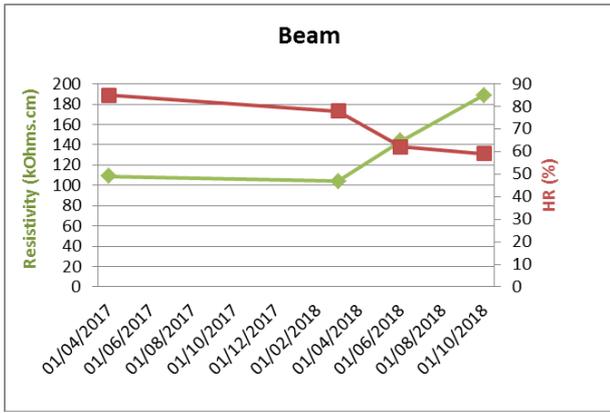
Fig. 13. Evolution of the average resistivity in the beam and of the relative humidity in the air.

As for the balcony area, similar results were observed on the three following three series of measurements, with again a clear correlation between the evolution of the relative humidity in the air and that of the resistivity and potential (Fig. 13 and 14). If the corrosion currents measured at point B12 were also well correlated (Fig. 15) and indicative of a negligible level of corrosion, at point B23 a continuous increase of the corrosion current could be noticed, in correlation with the opening of a crack (Fig. 16).

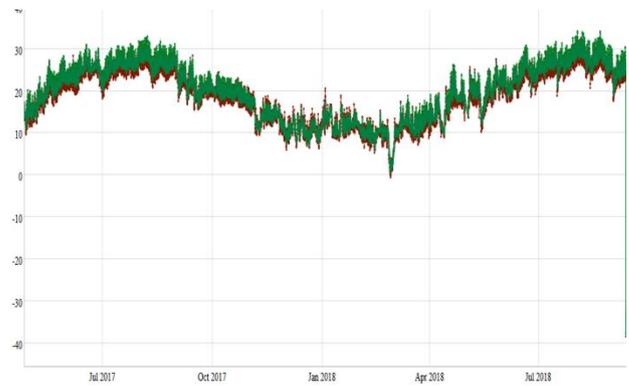
Fig. 17. Temperature (°C) in the air (brown curve) and in the concrete in the balcony and in the beam (green curve).

As can be observed on Fig. 17, the temperature measured in the concrete either under the balcony or in the beam, are very similar but also very close to that measured in the air. The three curves are overlapping. During the monitoring period, temperatures in the concrete ranged between 0.5 and 33°C, with a maximum daily amplitude of 5°C.

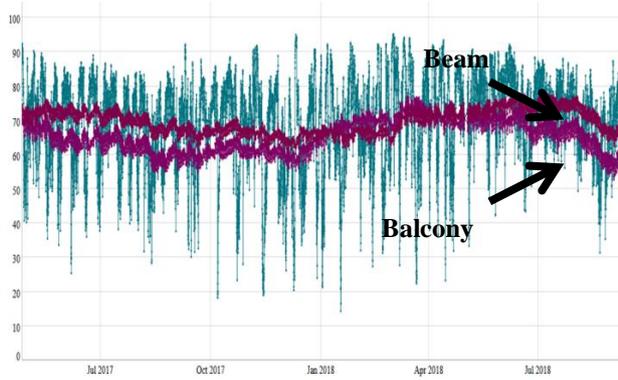
Fig. 18. Relative humidity (%) in the air (blue curve) and in the concrete in the balcony and in the beam (purple curve).

Contrary to the temperature, relative humidity in the air and in the concrete was clearly distinct. Thus it fluctuated a lot in the air, while it was much more stable in the concrete (Fig. 18), which was already observed by several authors [13]. When comparing the results obtained in the 2 zones monitored, it appears that the relative humidity was slightly higher but also less fluctuating in the beam (average: 68%) than in the balcony (average: 63%). Globally, the relative humidity in the concrete was lower in winter and higher in spring. Thus, in the beam, the maximum was reached the 13rd of June 2018 (78%) and the minimum in December 2017 (60%). On the Balcony, the maximum was observed on the 21st of June 2018 (77%) and the minimum in December 2017 (53%).

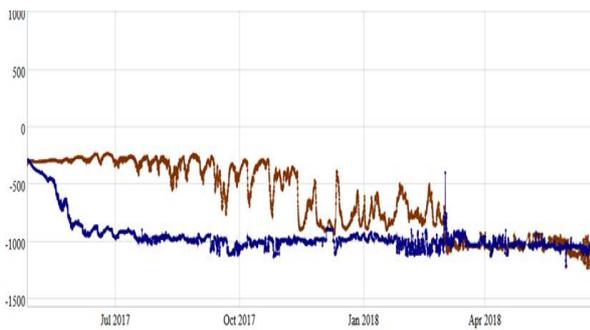
Fig. 19. Potential (mV) on the balcony (ochre curve) and on the beam (blue curve).

As the two zones monitored were protected from the rain, electrochemical monitoring was an issue. Effectively, the contact mortar used between the sensors and the concrete gradually dried and the measurements became impossible, quite rapidly for the beam and soon after for the balcony (Fig. 19). Nevertheless, the first data were consistent with the non-destructive testing, with corrosion current values lower in the beam than in the balcony (Fig. 20).

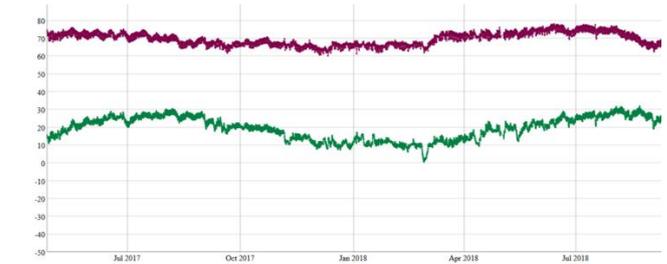
Fig. 21 Temperature ($^{\circ}\text{C}$, green curve) and relative humidity (%) in the beam (purple curve).

As the testing zones were sheltered from the rain, the relative humidity in the concrete was quite low (yearly

average between 63 and 68%). Several studies evidenced a critical threshold of relative humidity between 60% and 70%, below which corrosion is supposed to be negligible [14] [15]. On this basis, the corrosion currents observed on the 2 tested zones of the villa could be surprising. But other authors evidenced that this threshold can vary depending on the exposure of the concrete (rain and temperature...) [13], and the carbonation and/or chloride pollution of the concrete [3]. Thus for a carbonated concrete, depending on the chloride content the relative humidity below which corrosion is negligible, can decrease to 40% [3]. This could be linked to both the hygroscopicity of the chloride salts and to the aggressiveness of the combined carbonation and chloride pollution for the corrosion of reinforcing bars.
