Field repair of a severely damaged FG/epoxy fuselage

Abstract. The paper presents development of a repair procedure for a severely damaged primary laminate structure of a light aircraft, certified in accordance with CS22. The procedure was developed with the assumption that it would be a field repair carried out by people of average manual skills, who have not been trained in repairs of composite structures. To develop the procedure, a typical FG/epoxy laminate glider fuselage was used. The primary objective of the repair was to restore the original fuselage stiffness, while maintaining possibly low stress concentrations resulting from the repairs. To facilitate development of the repair, an FE model was developed. It was parametrized to be useful for design of similar repairs of similar structures. The experimental work done with the use of a real structure allowed the authors to verify numerical simulations, which were found to be correct.

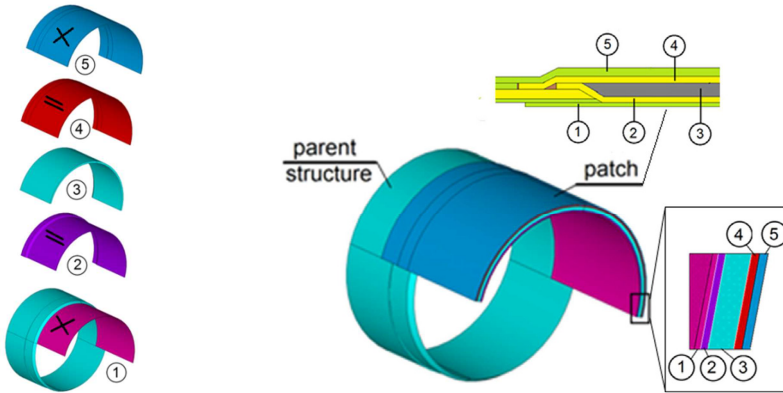
Fig. 5. Flowchart of patch fabrication. The numbers indicate the sequence of actions.

A stepped repair was chosen since it is simpler than a scarf one and at the same time offers similar strength [2]. Soft patch technology was chosen for the repair. As recommended [3], restoration of structural continuity in terms of reinforcement directions was attempted wherever possible. To achieve this, the lay-up of the fabric constituting the patch was chosen as shown in Fig. 4a. Sanding was used to prepare the parent structure for gluing. For this purpose, a 50 mm wide strip of the most outer reinforcement layer (92125 fabric) and 40 mm wide strip of UD reinforcement (92145 fabrics) of the parent structure were exposed along the cut-out perimeter, Fig. 4b. Also, sanding was applied for surface preparation of the most inner layer of the fuselage shell. The flowchart of the repair procedure ensuring merger of the fabrics with the same reinforcement arrangement is shown in Fig. 5. First, one layer of 92125 fabric was impregnated at the top surface of an 0.5 mm thick backing plywood plate. Next, with the help of this plate the impregnated but not cured fabric was pressed against the inner surface of the fuselage. For this purpose, a set of bands was used. It was noticed that the band tension affected the camber of the backing plate; thus to minimize possible gaps between the fuselage inner surface and the patch layer, the band tension had to be adjusted. This problem was analyzed with FEM and will be discussed further in the paper. After curing had been completed, the bands were removed and the remaining parts of the patch were formed. It involved placement and

impregnation of 3 layers of UD 92145 fabric (step#2), 3 layers of mat forming filling (step#3), 3 layers of UD 92145 fabric (step#4) and 2 layers of 92125 fabric (step#5).

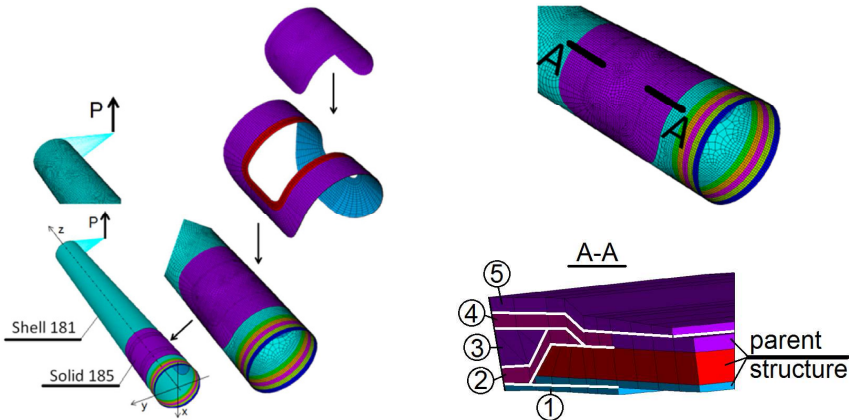
The considered bound lines are shown in white in Fig. 6. Load P was applied at the distance of 380mm from the xz plane with the MPC181 element. The opposite end of the fuselage was fixed (all freedom degrees at the nodes in the plane $z=0$ were removed). The failure of the bound line was defined in terms of the debonding parameter d .

Fig. 6. FE representation of the repaired structure, The white lines (cross-section A-A) indicated the locations of the bound lines simulated with pairs of Conta174-Target170 contact elements

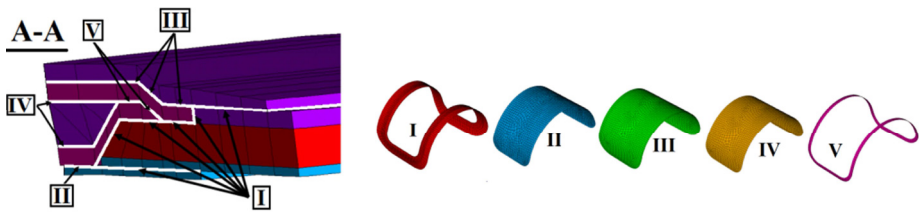
Fig. 7. Areas I-V represent the interfaces between the parent structure and the patch, and between the patch sub laminates themselves. The numbers indicate the location of the interfaces

Strength of the bound lines and strength and stiffness of the repaired fuselage. The FE results concerning the debonding parameter *d* showed that for both the Limit Load (LL) equal to 2.3 kN and the Failure Load (FL) equal to 10.65 kN, the debonding parameter *d*=0 along all the bounded areas, Fig. 7, showed that no damage of the bound lines occurred, so the bound lines remained intact, at least up to failure of the fuselage due to local buckling and the consecutive damage of the fuselage shell at some distance from the patch, Fig. 8. Results of the repair were also analysed in terms of stiffness changes. The deflections *f* of the ends of the pristine and repaired fuselage section under LL were practically the same. The calculated difference was less than 1 mm in favour of the latter. In case of twist, the

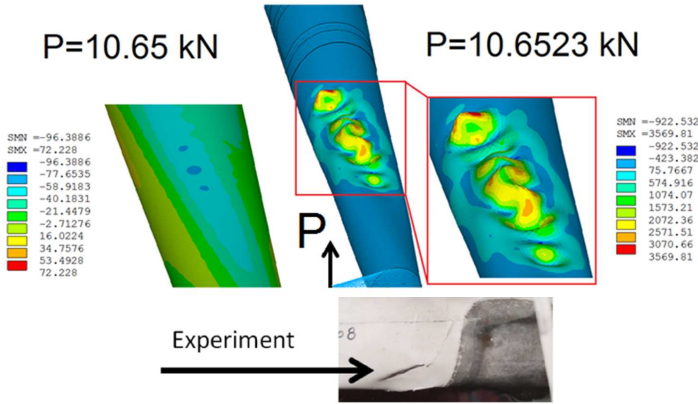
Fig. 8. Pre- and post-buckling stresses corresponding to the loads just before and just after buckling

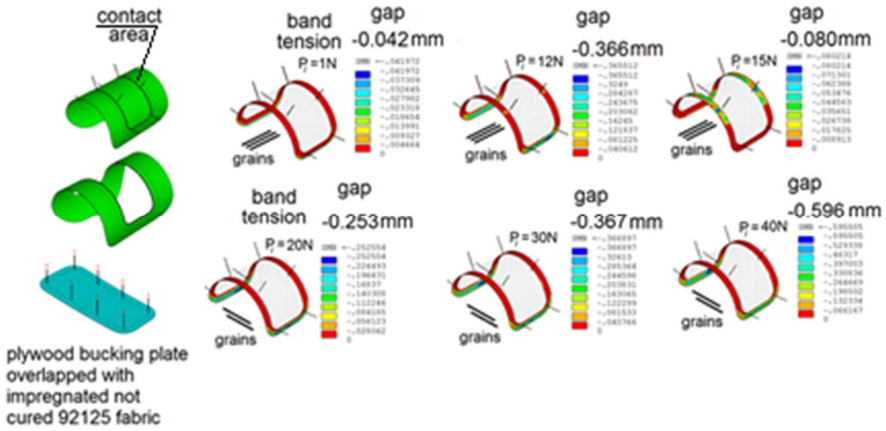
Such a loading produced double curvature of the backing plate resulting in some gaps between the contacting surfaces. Severity of this phenomenon was analysed with FEM and the results are shown in Fig. 11. It was found that for the chosen band location and the number of bands, the local separation of the contacting surfaces varied with location and the separation went down with decreasing band tension. Also, it was found that to

reduce the gap opening, the direction of higher stiffness of the backing plate should be parallel to the generator of the fuselage.

Fig. 11. Effect of band tension on the gap between the inner surface of the fuselage and the bottom layer of the patch

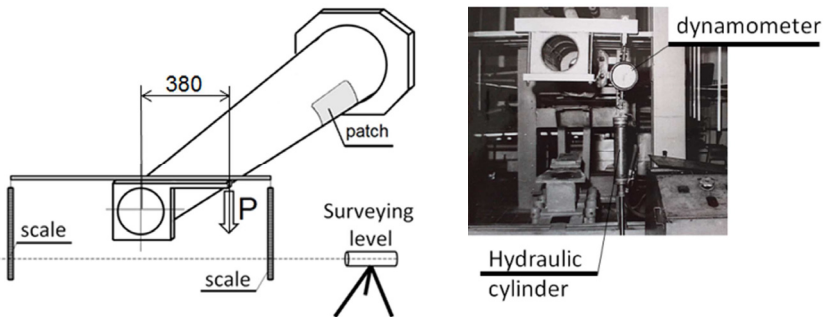
Fig. 12. Experimental stand for investigating the strength and stiffness of the repaired fuselage

The experimentally determined differences (corresponding to LL) between the bending and twist stiffnesses of the pristine and repaired fuselages were equal to 2.4 mm and 9 arcminutes, respectively, in favour of the repaired one, Fig. 9, and were higher than the calculated deformations. The experimentally determined FL of the repaired fuselage was 10.65 kN and it was negligibly lower than that calculated. The location of the failure and its mode obtained by numerical modelling and determined experimentally were very similar, Fig. 8. Visual inspection of the patch and the one done by tapping did not indicate any damage of the bound lines.
