# Geo-disasters induced by the recent earthquakes in Japan and Indonesia

**Abstract.** This paper is focusing on the geo-disasters induced by the 2018 Hokkaido Iburi-tobu earthquake in Japan and the 2018 Sulawesi earthquake in Indonesia. The Hokkaido Iburi-tobu earthquake occurred at east of Iburi region in Hokkaido, Japan on September 6th, 2018. Tremendous number of landslides occurred in the mountain areas at Iburi region. Uplift and sinking of road and inclination of houses were caused by liquefaction in the south eastern part of Sapporo city. The Sulawesi earthquake happened at Central Sulawesi Province, Indonesia on September 28th 2018. The ground displacement triggered by the fault movement caused damage to roads and houses. The large scale ground flows induced by liquefaction occurred in some different sites. This paper reviews the damage induced by the geo-disasters and considers the lessoned learnt from the damaging earthquakes happened in 2018.

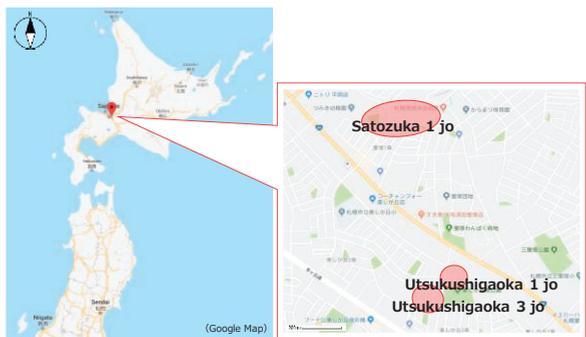
Fig. 2. Location of liquefied sites in Sapporo city

Utsukushigaoka towns in Kiyota ward, Sapporo city. Fig. 2 shows the location of Satozuka and Utsukushigaoka towns. Some photographs of the damage at each site are shown in Fig. 3. The ground deformation due to liquefaction was the largest and the ground was raised up to about 2m in Satozuka 1jo town shown as yellow portion in Fig. 3. Photo. ① in Fig. 3 shows settlement of the ground and inclination of the houses are remarkable and a puddle of water appeared in front of the house. The road shown in photo. ② collapsed, and the traffic of the vehicle was difficult. Since the ground level before the earthquake was at the top of this utility hole in photo. ③, it is considered that this road subsided about 1 to 2m. The inclination of the surrounding houses was large. Photo. ④ shows accumulated sand in height of about 50cm. It is thought that a large amount of liquefied sand ejected at the sites of photos ① to ③ was accumulated at the location of photo. ④ because the location of photo. ④ is lower than the sites of photos ① to ③.

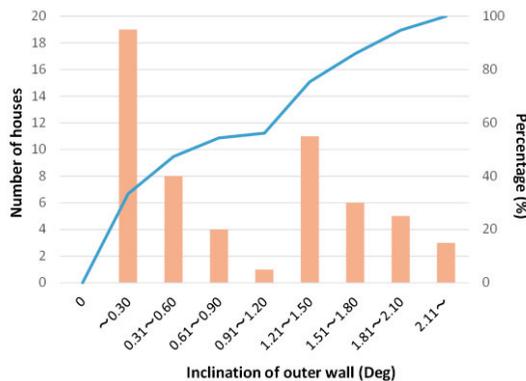
**Fig. 5.** Number of houses in each degree of inclination

**Fig. 4** shows inclination of the outer wall of the houses in Utsukushigaoka 1jo and 3jo towns. The inclination was shown in color-coded of every 0.25 ° on the map. Vector synthesis was performed in two orthogonal directions with larger inclination and the direction of inclination is indicated by an arrow in this figure. If the maximum inclination and the synthesized inclination are less than 0.25 °, vector synthesis is not performed and only the direction of the maximum inclination is shown in this figure. The location of the largest subsidence of road is also indicated by red × in this figure. This figure suggests that the houses that were greatly inclined were adjacent and that such houses are inclined in the same direction. Also, the houses were inclined in the direction of the largest subsided road. The number of houses in each inclination angle is shown in **Fig. 5**. Health problems may occur at the houses with an inclination of 0.6 ° or more, and about 53% of the surveyed houses exceeded this value.

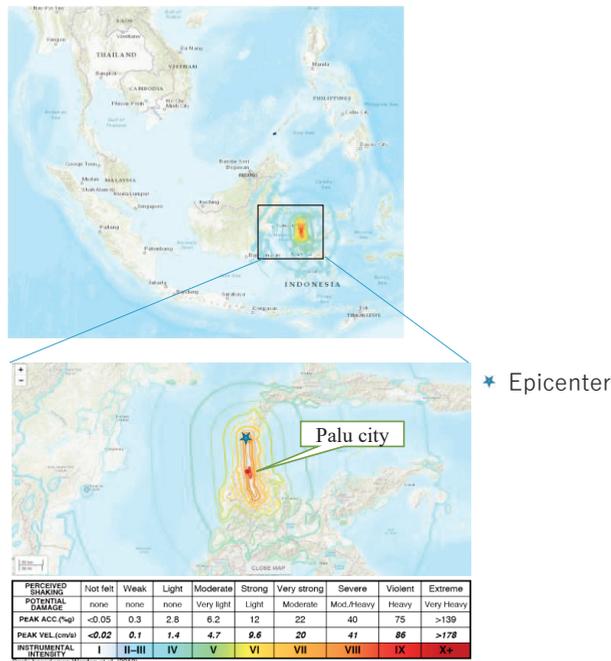
Fig. 7. Location of epicenter and MMI estimated by USGS [4]

On September 28<sup>th</sup>, 2018, at 18:02 local time (10:02 UTC), a strong earthquake of magnitude  $M_w=7.5$  struck Central Sulawesi Province, Indonesia. **Fig. 7** shows the location of the epicenter. The epicenter was located at around 77 km from Palu city and 20 km in depth. This event was preceded by several foreshocks, the largest recorded as  $M_w=6.1$  and occurred at 14:59 local time (06:59 UTC), three hours earlier of that day. **Fig. 7** also shows MMI estimated by USGS [4]. According to this figure, MMI=IX is estimated at Palu city and higher intensity is along the fault line (See **Fig. 9**). The casualties were approximately 2,256 persons, more than 1,000 persons missing, and around 10,000 persons injured in three most affected regions which are Palu city, Donggala and Sigi villages.

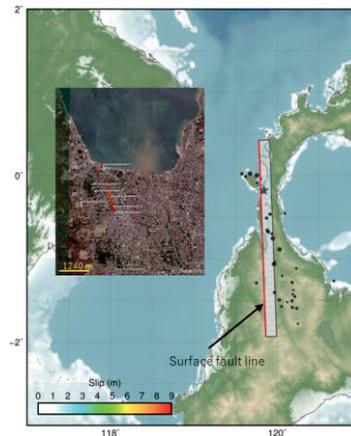
**Fig. 9.** Fault line at surface estimated by USGS [4]

Large ground displacement was found in some particular areas, such as Kedondong, Pipa Air, Pangeran Diponegoro and Cemara streets in Palu city. **Fig. 8** indicates the locations of the large ground displacement found in Palu city. These large ground displacements agree with the fault movement of left lateral slip. **Fig. 9** shows the fault line at surface estimated by USGS [4]. The legend of this figure indicates estimated amount of slip of fault itself.

The epicenters of aftershocks were also indicated in this figure. According to this figure, the locations of large ground displacements appeared at surface coincide well with the estimated fault line. Therefore, the large ground displacements seem to be induced by the fault movement.

The ground displacement triggered by the fault movement appeared in Pangaran Diponegoro, Cemara, Kedondong and Pipa Air, streets. The horizontal displacement of the four roads are 2.7m of Pangaran Diponegoro street, 3.8m of Cemara street, 4.5m of Kedondong street and 5.0m of Pipa Air street, respectively. These displacements make roads bent.

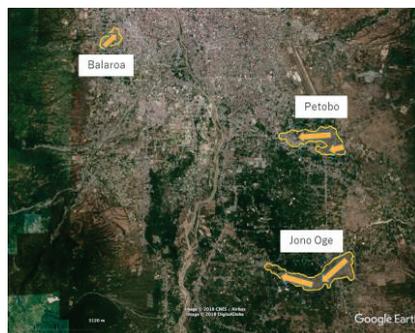
**Fig. 10.** Location of large ground flows in Palu city

The earthquake triggered large-scale ground flow in some different sites, such as Balaroa and Petobo districts in Palu city and Jono Oge and Sibalaya Villages. The locations large ground flow of Balaroa and Petobo districts in Palu city and Jono Oge village and the direction of the ground flow are illustrated in **Fig.10** by using Google Earth. **Table 1** lists the areas and average slope before the earthquake of each site of large ground flow estimated by using a function of Google Earth. A satellite photo of Sibalaya village after the earthquake cannot be obtained, so the area of large ground flow cannot be estimated. Average ground slope of Sibalaya village before the earthquake is about 3.1%. The ground slope before the earthquake was not so large. The cause of this phenomena was reported as soil liquefaction in the local media. The mechanism should be clarified by using many geotechnical data in near future.
