# Damage to Teluk Palu Bridge in the 2018 Sulawesi Earthquake, Indonesia

**Abstract.** The authors conducted a field survey in the affected area of the 2018 Sulawesi Earthquake, mainly focusing on the damage occurred to the Teluk Palu Bridge in Palu City. It was found that the area around the bridge received approximately 200 gal acceleration and 3 to 6 m tsunami height. From the traces of the tsunami, we estimated that the tsunami reached up to the girder but not up to the arch rib of the bridge. The arch ribs sustained buckling and displaced 2 to 5 m into the water. The main cause of bridge collapse was the earthquake force as local eyewitnesses said the bridge collapsed immediately after the earthquake and before the arrival of the tsunami. In terms of earthquake-resistant design, the following three problems were identified regarding this arch bridge: resisting capacity of the arch rib, resisting capacity of the bearing system, and design concept about the seating length at the pier.

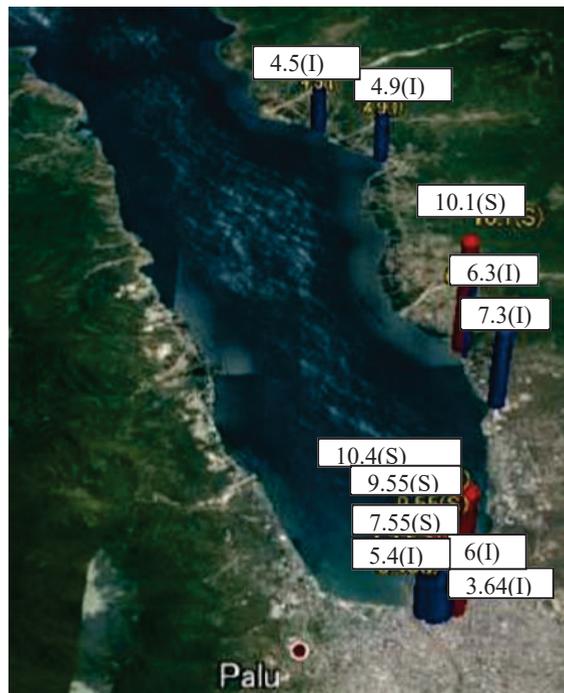
**Fig. 2.** Inundation height and splash height measured by Imamura et al.

Figure 2 shows the splash height and the inundation height measured by Imamura et al. The splash height and the inundation height without tidal level correction are indicated in red and blue, respectively. The splash height and the inundation height measured in the bay area were 7-10 m and 3-7 m, respectively. The inundation height around the Teluk Palu Bridge located in the center area of Palu City was 3-6 m<sup>[2]</sup>. The inundation area was limited to within 200-300 m from the coastline.

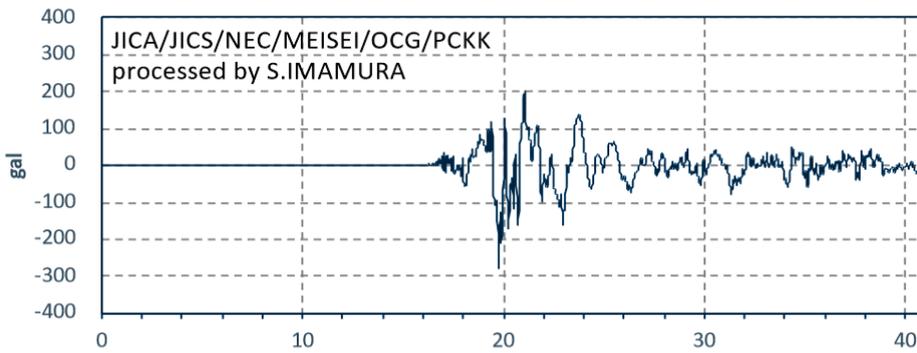
Fig. 3. Waveform in the N-S direction observed in Palu City .

Figure 3 shows the waveform in the N-S direction recorded in Palu City and processed by Imamura et al. A maximum acceleration of 200 gal continued for at least 40 seconds.

As shown in Fig. 3, the maximum acceleration of the earthquake was 200 gal. This level of acceleration is not strong enough to cause the collapse of the bridge. The seating length should be 1.13 m for this length of bridge if the Japanese design code is applied.

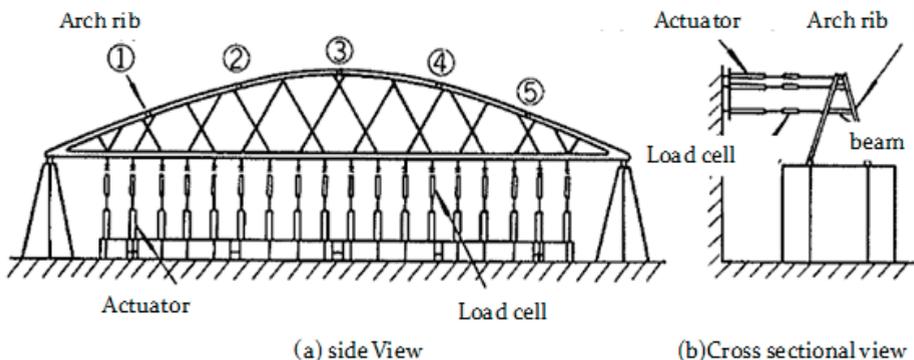
Fig. 10. Experimental setup

An experimental setup for Specimens No.1 and No. 2 are shown in Figs. 10 (a) and 10 (b), respectively. For Specimen No. 1, uniform vertical load was applied to the lower chord in an incremental manner until the failure of the specimen, using 18 actuators. For Specimen No. 2, horizontal load equivalent to the wind load was applied to the arch rib using five actuators while maintaining a uniform vertical load equivalent to 1.3 times the design dead load.
